H.P. FOREST DEPARTMENT

***Report of Monitoring of 10%
CAMPA Works 2022-23***

**MONITORING OF CAMPA WORKS
(2ND TIER MONITORING)
DURING 2022-23**

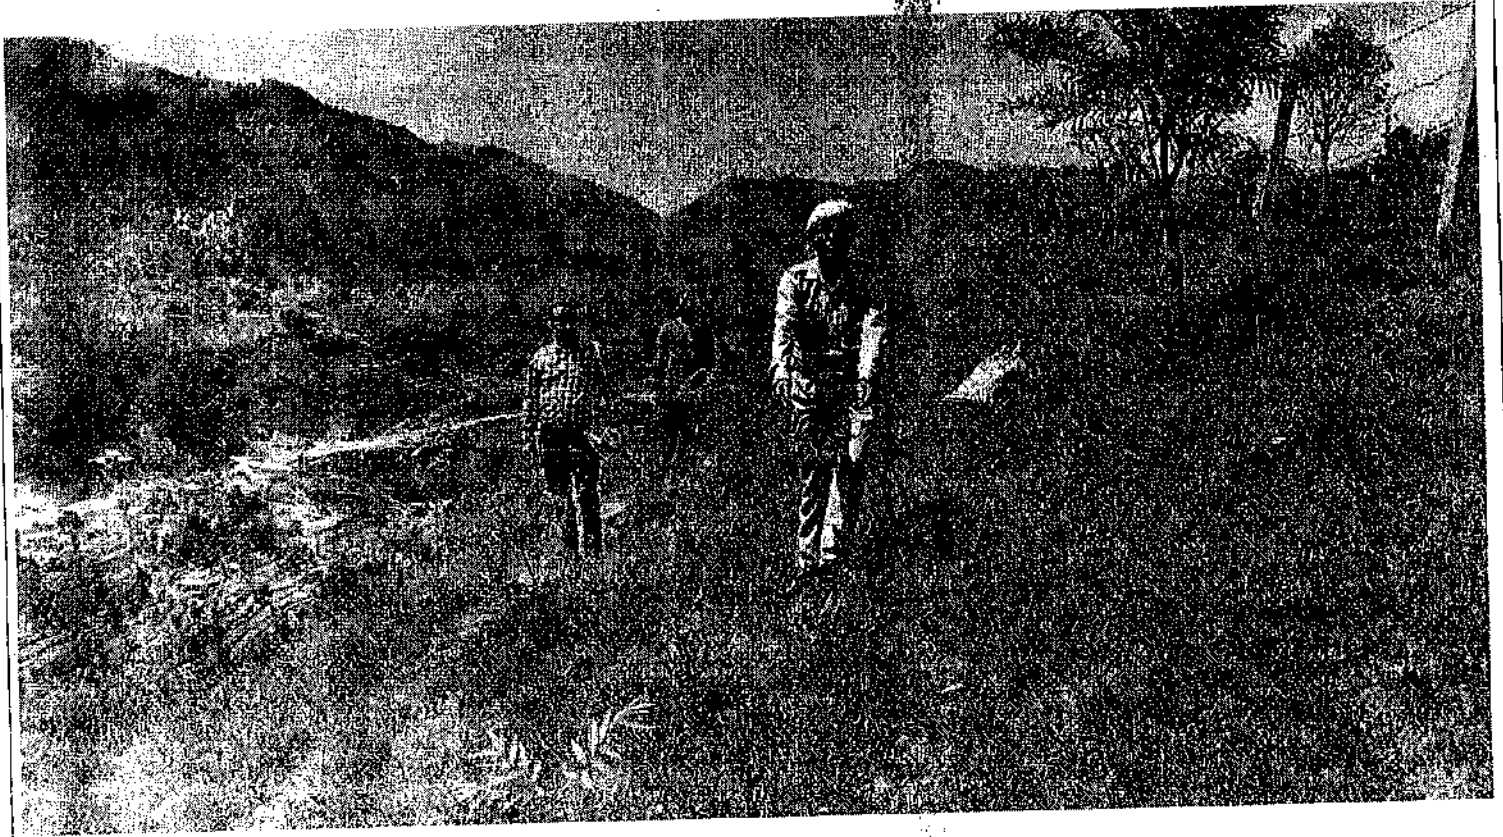
1. Mandi/ Shiv dadar

Name of Plantation Area- Banoul- UPF
Area= 19 Hectare
Total Plants=8200, Ritha, Kachnar, Ban
Survival Percentage=80.6%
Date of Inspection-12.04.2022 to 14.04.2022

1. The Plantation Journal has not been maintained properly.
2. The height of the normal plant is as per protocol.
3. Reasons for failure of plants are due to grazing / trampling of wild animals.
4. The staff may be advised to watch and ward the plantation area.

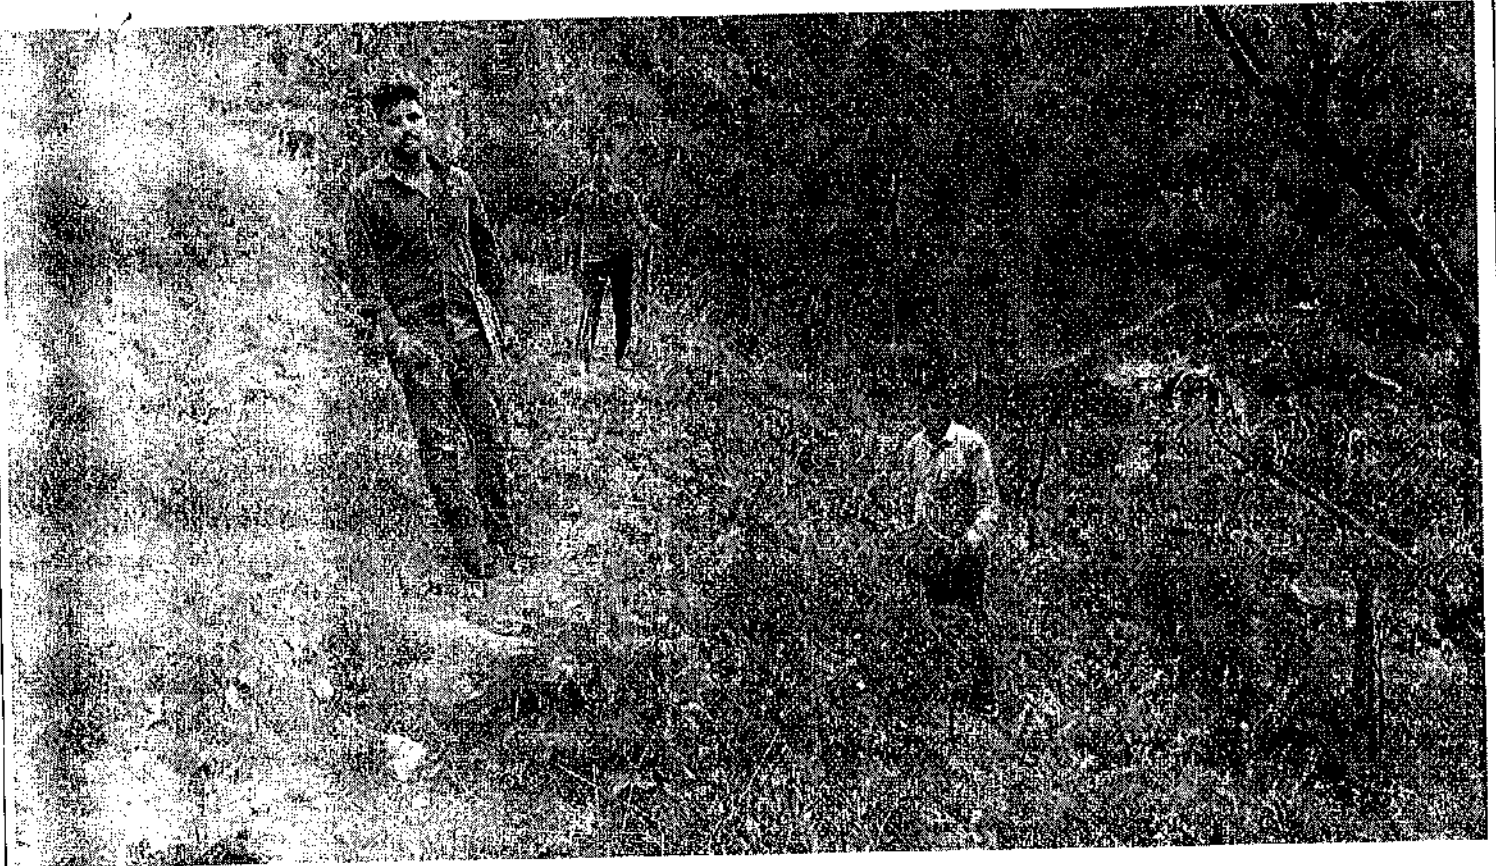
2. Mandi/ Kataula

Name of Plantation Area- Kuthar (Bashar- UPF)

Survival Percentage=72%

1. The Plantation Journal has been maintained with polygon but no photograph has been taken before and after plantation.
2. The height of the normal plant is as per protocol.
3. Reasons for failure of plants are due to grazing/ trampling by cattle and some plants dried due to drought.
4. The staff may be advised to watch and ward the plantation area from time to time.

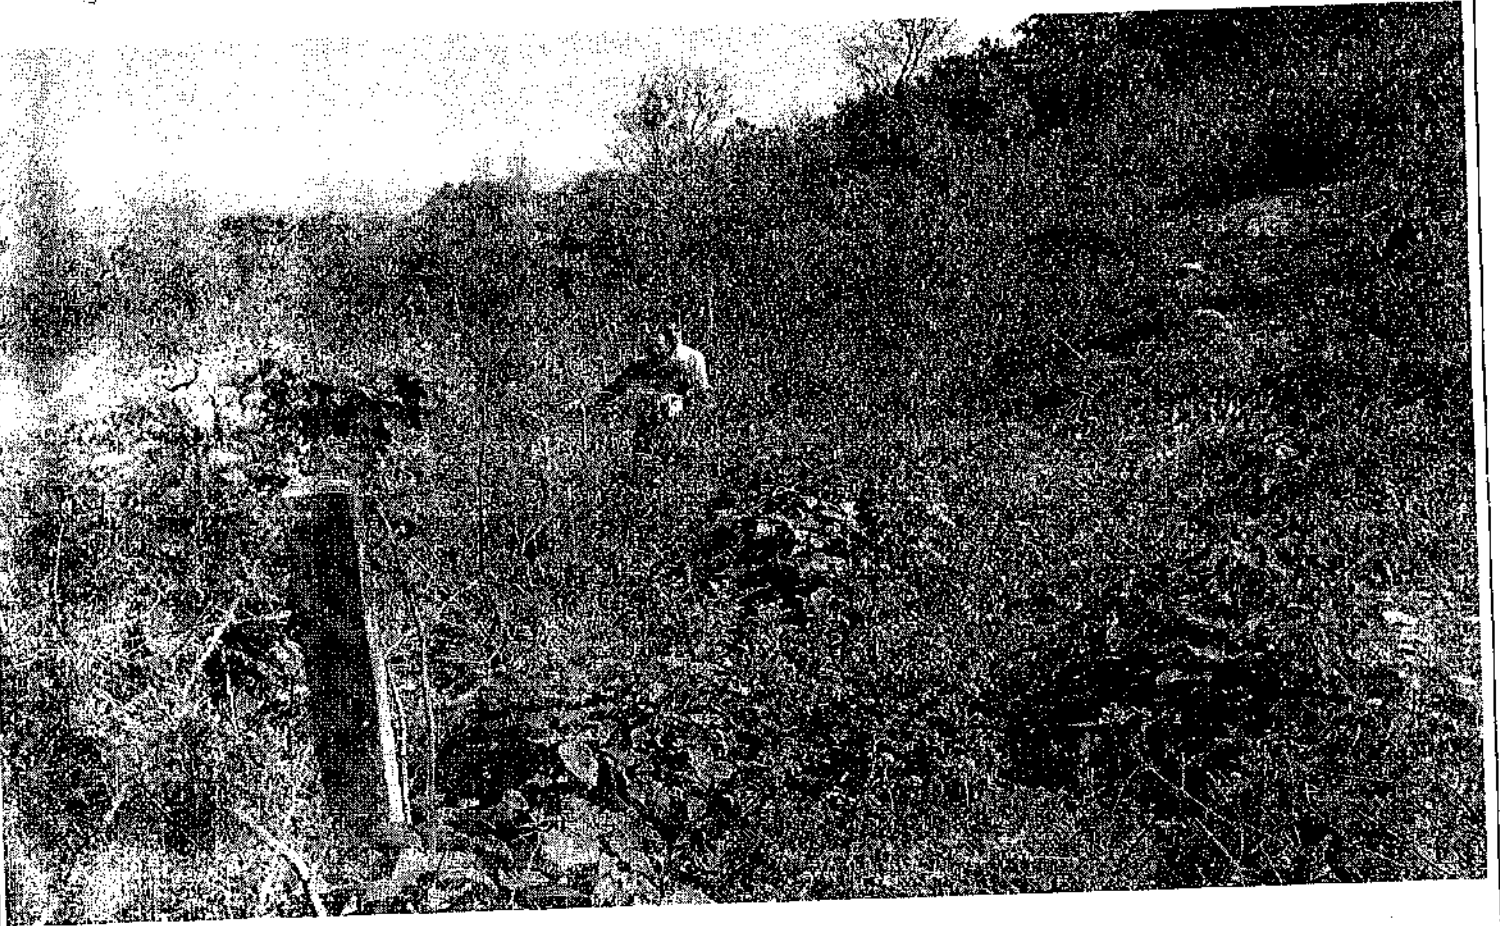
3. Hamirpur/ Nadaun

Name of Plantation Area- P-37 Kuthera C-1

Survival Percentage =74%

1. The Plantation Journal has been maintained no, polygon and no photograph before and after plantation have not been incorporated in plantation journal.
2. The height of the normal plant is less than as per protocol.
3. Reasons for failure of plants are due to grazing/ trampling by wild animals.
4. The staff may be advised to watch and ward the plantation area from time to time.

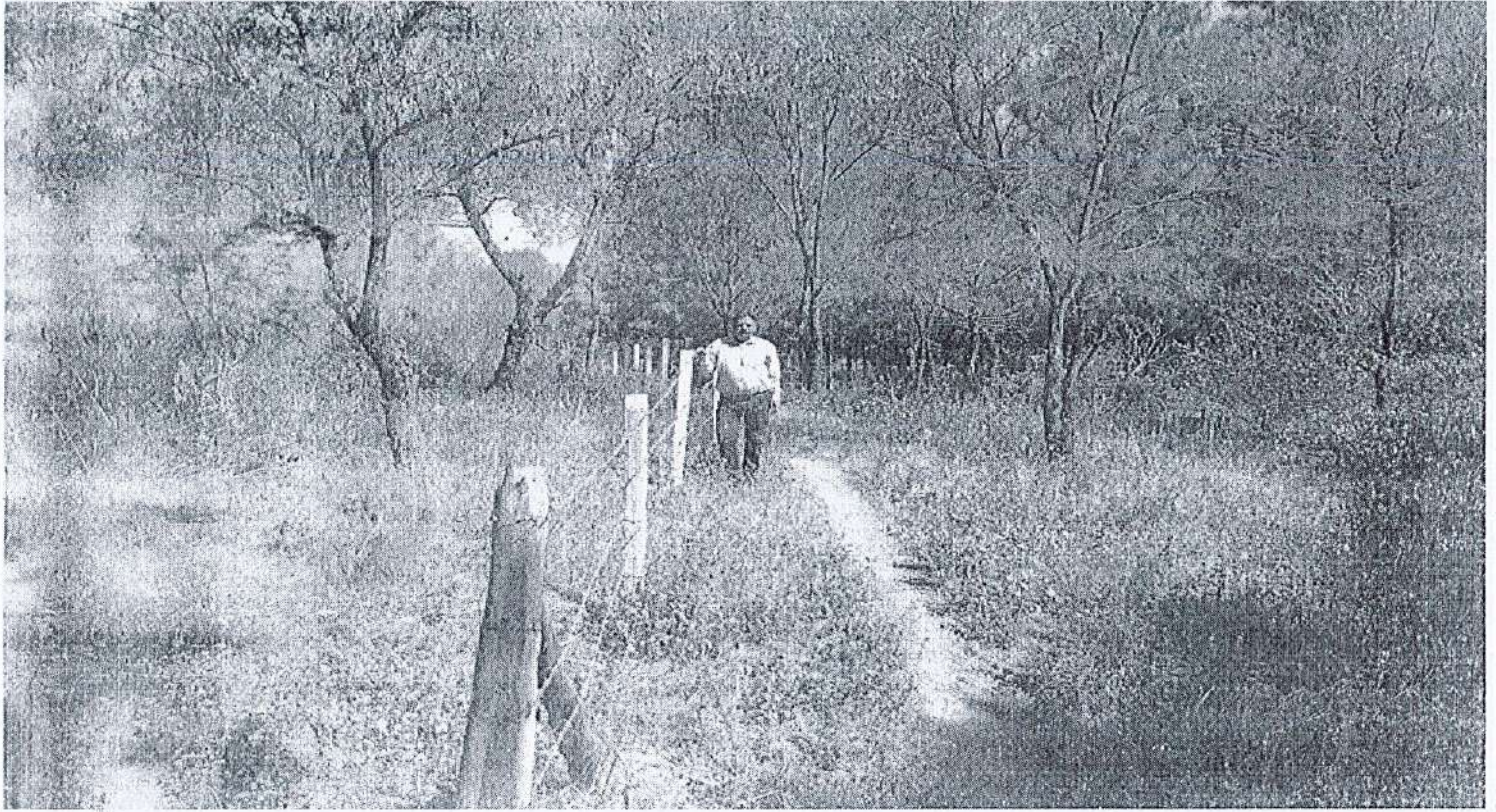
4. Hamirpur/ Hareta

Name of Plantation Area- U-203 Galore

Survival Percentage =82.5%

1. The Plantation Journal has been maintained no polygon and no photograph have been taken before and after plantation.
2. The height of the normal plant is less than as per protocol.
3. Reasons for failure of plants are due to grazing/ trampling by wild animals.
4. The staff may be advised to watch and ward the plantation area from time to time

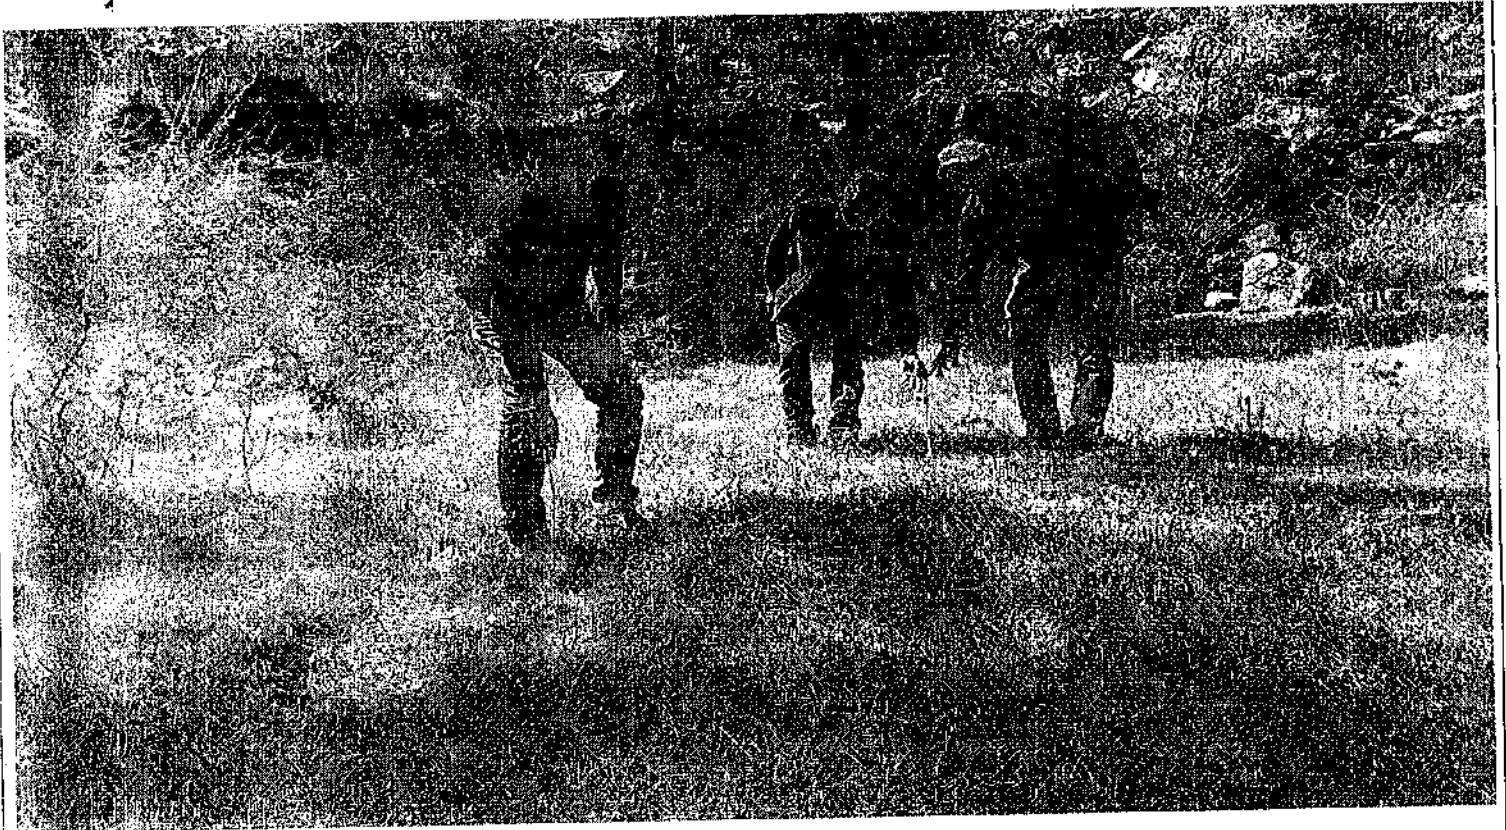
5. Parvati/Pini

Name of Plantation Area- Kais-III UPF1/35 Rasha

Survival Percentage =60%

1. The Plantation Journal has been maintained but no polygon and no photograph have been taken before and after plantation.
2. The height of the normal plant is less than as per protocol.
3. Reasons for failure of plants are due to grazing by cattle and rocky/ refractory soil.
4. The staff may be advised to watch and ward the plantation area from time to time.

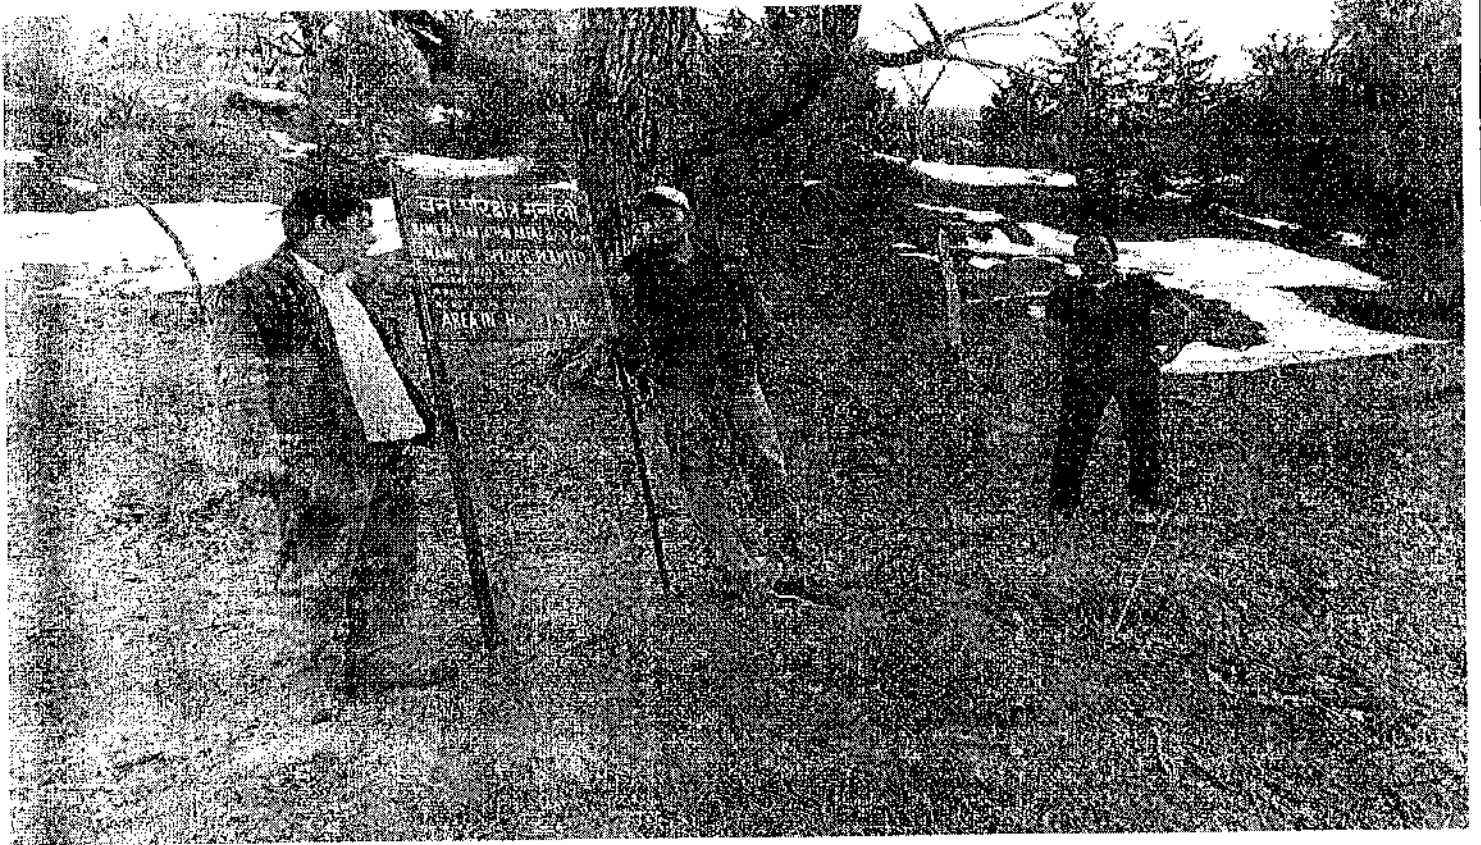
6. Kullu/Palchan

Name of Plantation Area- 2/3 Sangan Shill C-III a

Survival Percentage =69%

1. The Plantation Journal has been maintained but no polygon and no photograph have been taken before and after plantation.
2. The height of the normal plant is less than as per protocol.
3. Reasons for failure of plants are due to grazing by cattle and wild animals.
4. The staff may be advised to watch and ward the plantation area from time to time.

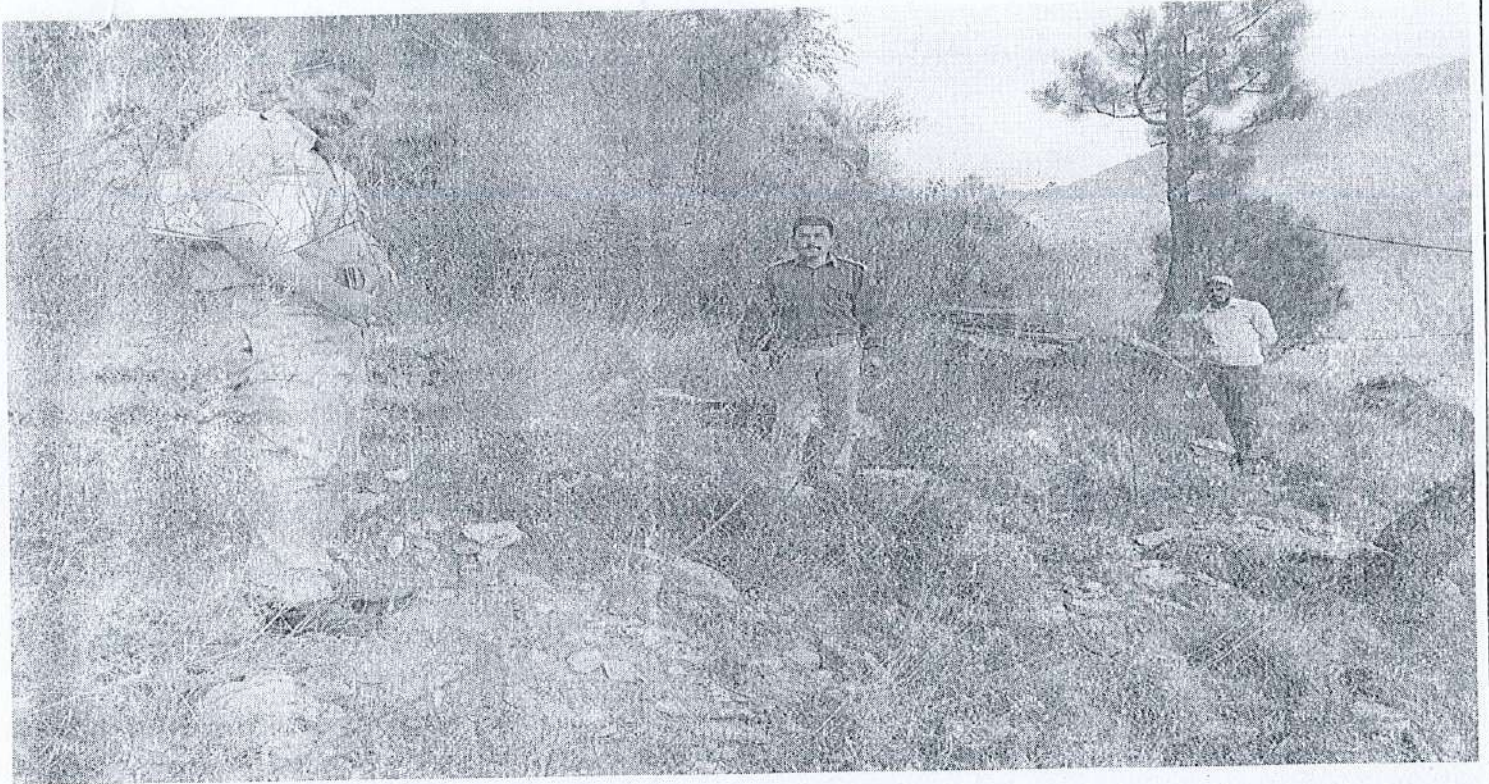
7. Seraj / Sainj

Name of Plantation Area- Phagla phat
Area =8 Hectare.

Total plants=8800, Shisham, Drek, Deodar, Daru, Ritha
Survival Percentage =78%

1. The Plantation Journal has been maintained with photograph but no polygon kept in plantation journal.
2. The height of the normal plant is as per protocol.
3. Reasons for failure of plants are due to grazing by wild animals and drought.
4. The staff may be advised to watch and ward the plantation area from time to time.

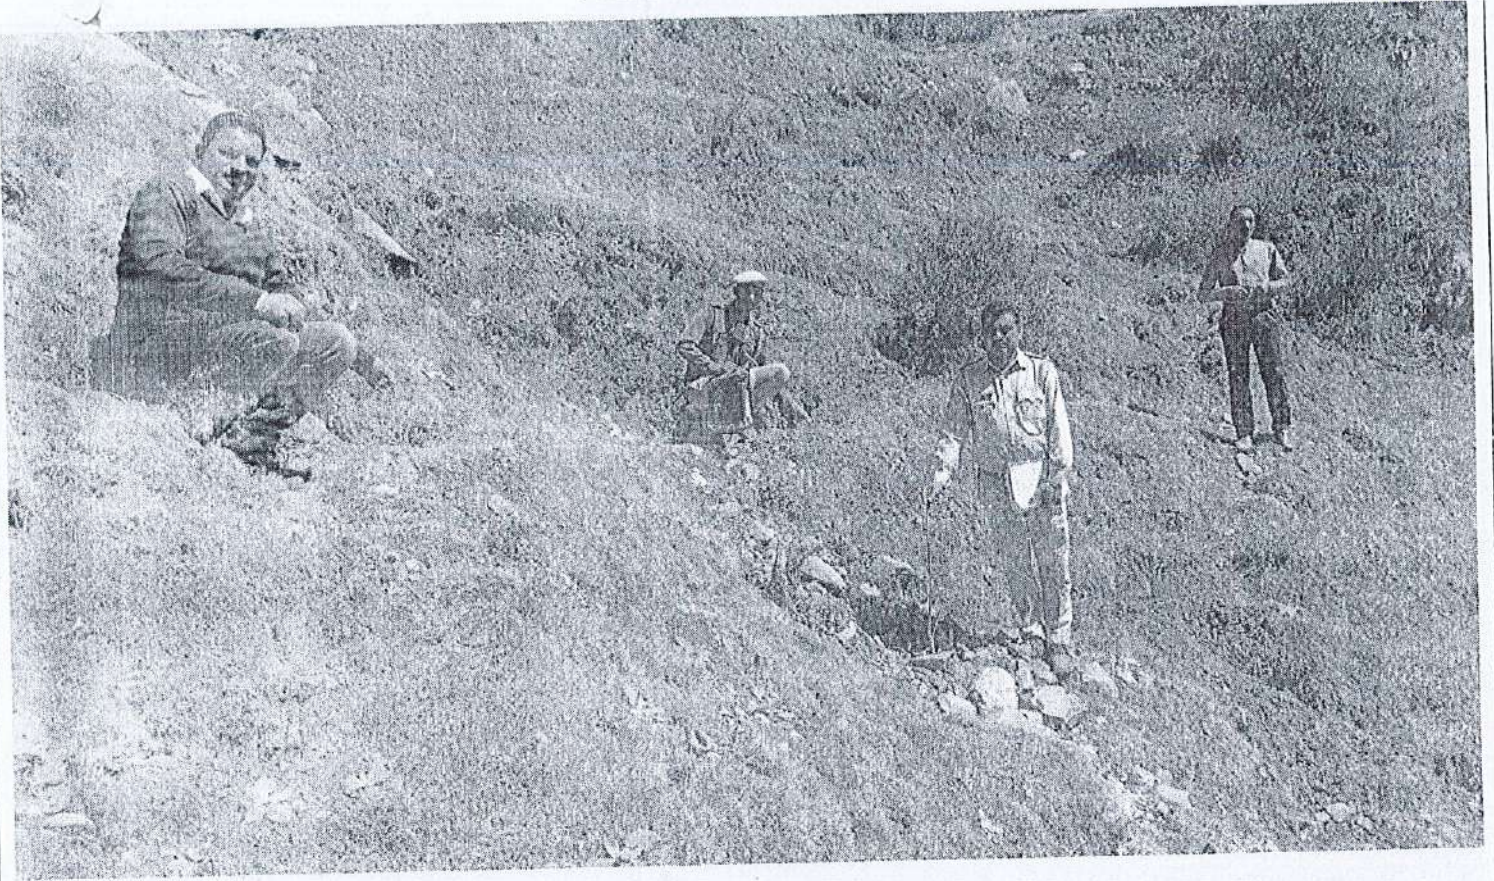
8. Bharmour/ Sandi

Name of Plantation Area- Kutason-1 Polan Palan DPF
Area =10 Hectare.
Total Plants=11000, Kail, Deodar, H/C Nut, W/C Nut
Survival Percentage =56%
Date of Inspection- 29.03.2022 to 01.04.2022

1. The Plantation Journal has been maintained but no polygon and no photograph have been taken before and after plantation.
2. The height of the normal plant is less than as per protocol.
3. Reasons for failure of plants are due to grazing/trampling by cattle and drought etc.
4. The staff may be advised to watch and ward the plantation area from time to time.

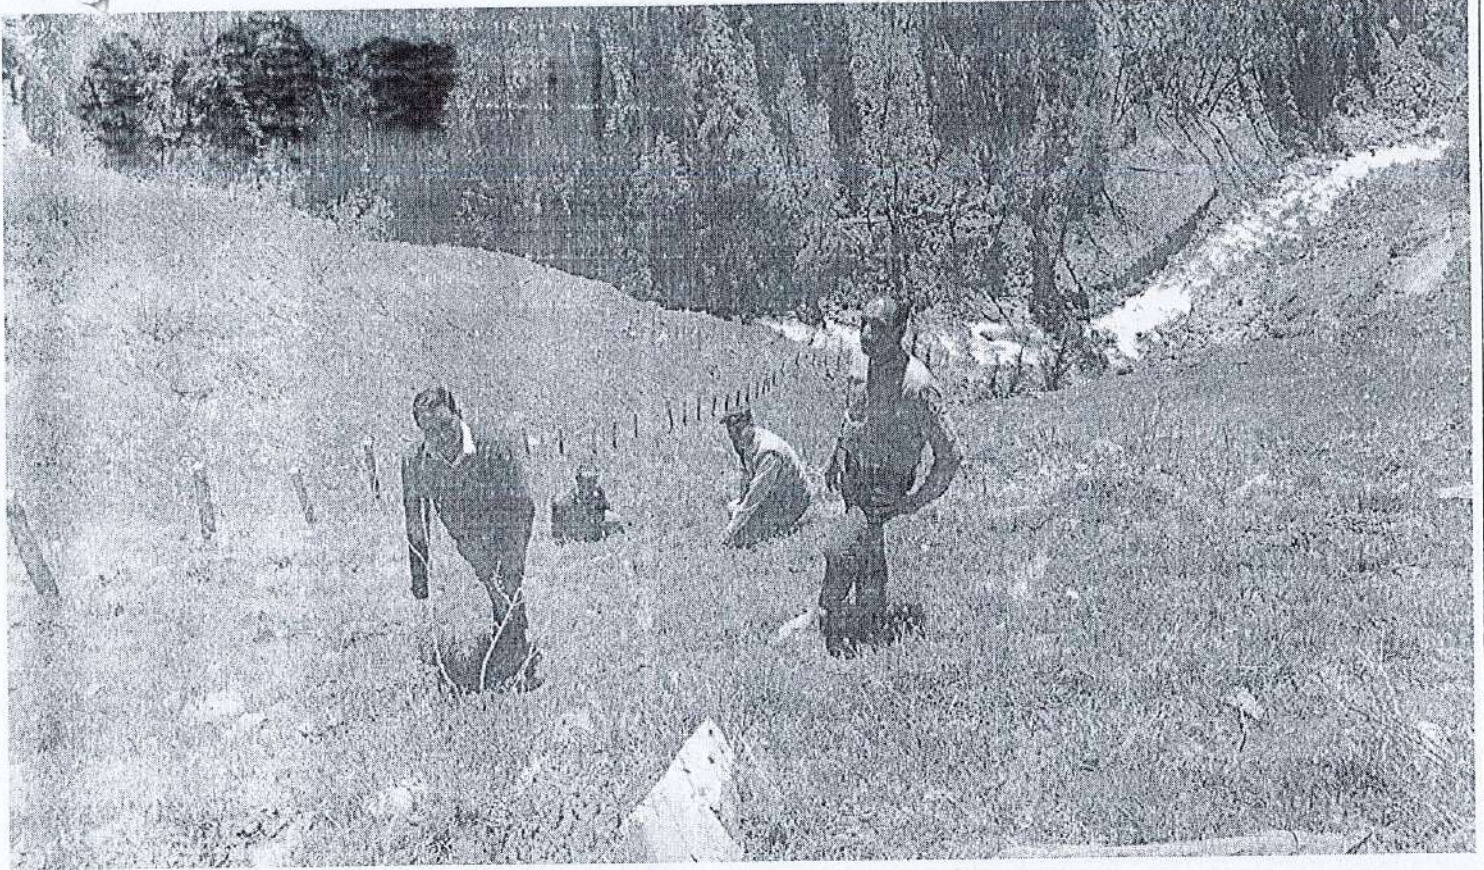
9. Bharmour/ Sandi

Name of Plantation Area- Thala Ghora-1 Bilmui-DPF

Survival Percentage =75%

1. The Plantation Journal has been maintained but no polygon and no photograph have been taken before and after plantation the area.
2. The height of the normal plant is less than as per protocol.
3. Reasons for failure of plants are due to grazing by cattle and wild animals and due to drought.
4. The staff may be advised to watch and ward the plantation area from time to time.

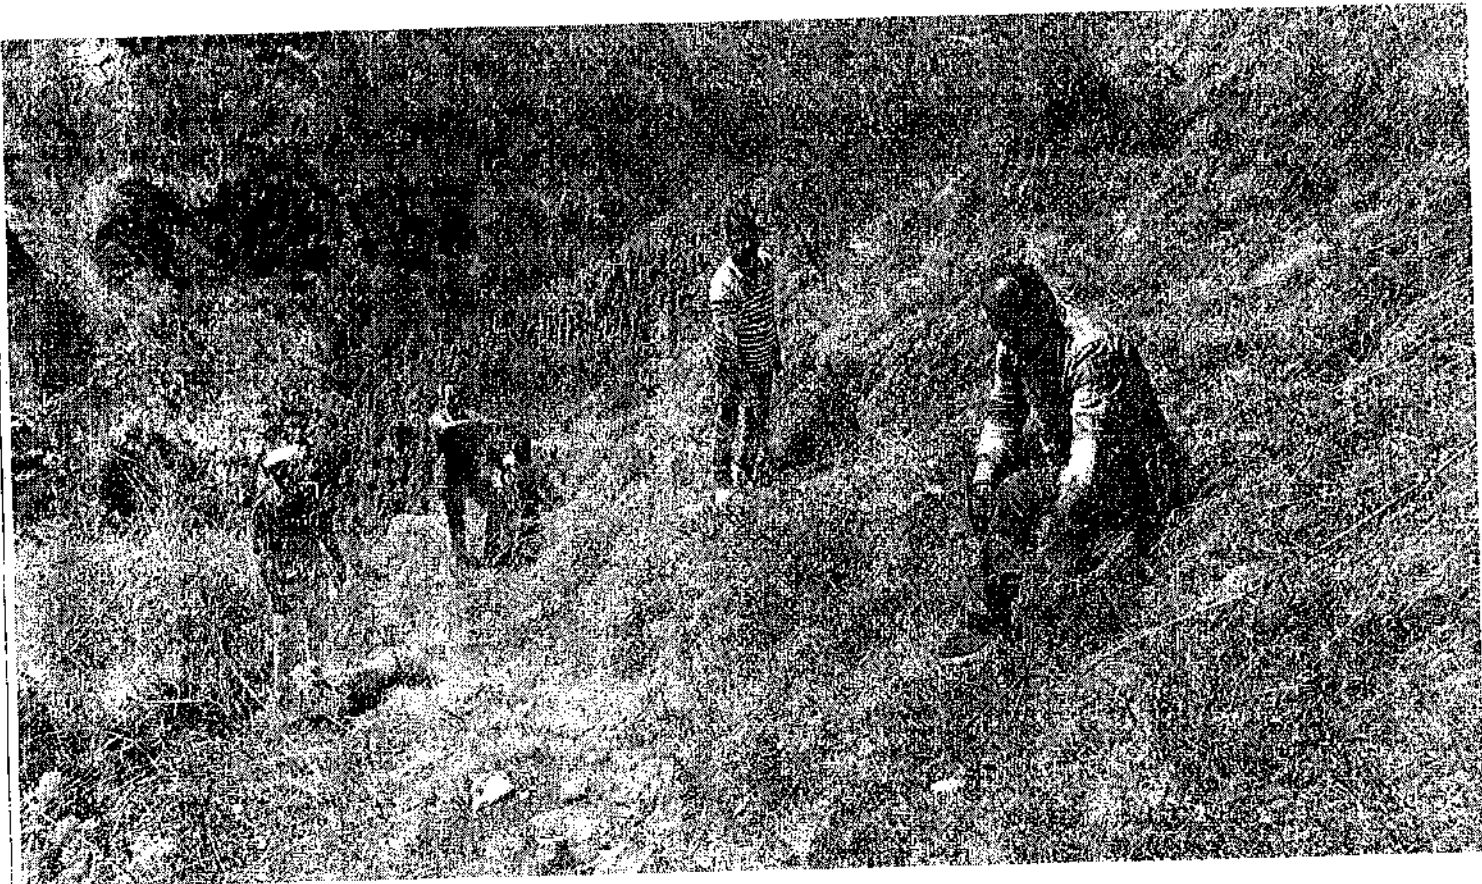
10. Chamba/ Chanju

Name of Plantation Area- Kunda DPF

Survival Percentage =74.3%

1. The Plantation Journal has been maintained but no polygon and no photograph have been taken before and after plantation the area.
2. The height of the normal plant is as per protocol.
3. Reasons for failure of plants are due to grazing by cattle and wild animals and due to drought.
4. The staff may be advised to watch and ward the plantation area from time to time.

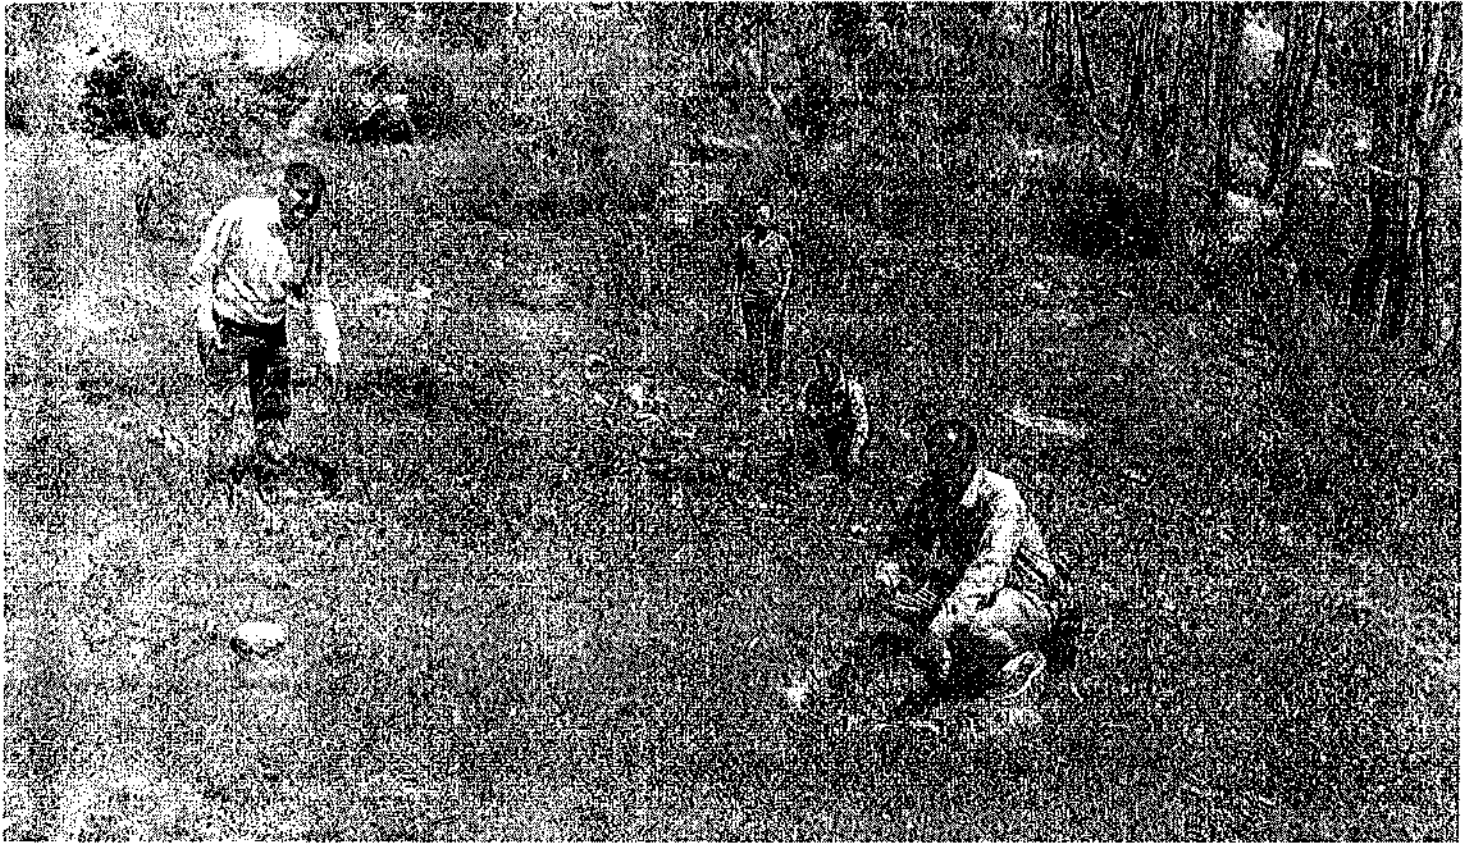
11. Chamba/ Chanju

Name of Plantation Area- Darsana NDPF

Survival Percentage =77%

1. The Plantation Journal has been maintained but no polygon and no photograph have been taken before and after plantation the area.
2. The height of the normal plant is as per protocol.
3. Reasons for failure of plants are due to grazing by cattle and wild animals and due to drought.
4. The staff may be advised to watch and ward the plantation area from time to time.

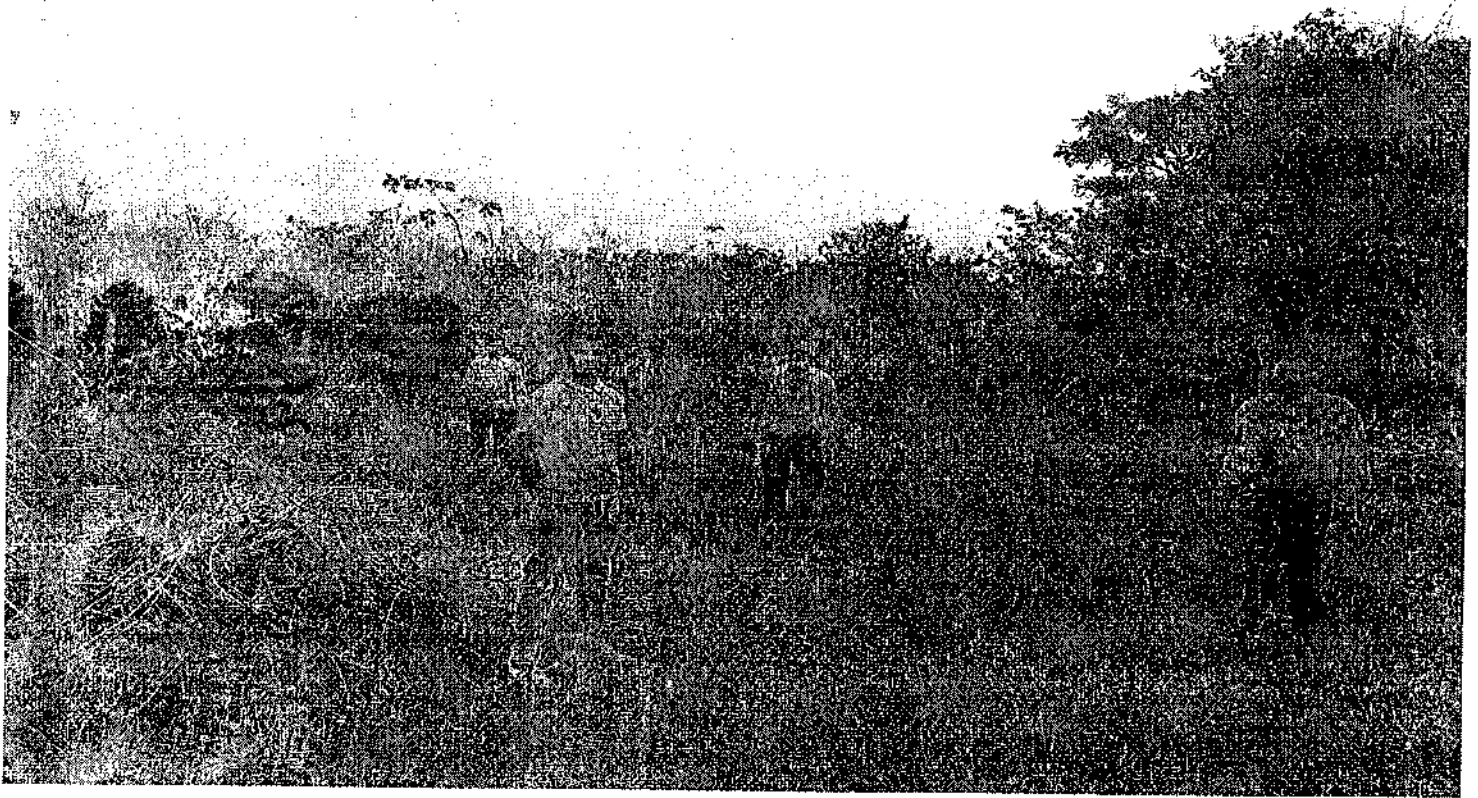
12. Nurpur/ Sadwan

Name of Plantation Area- UP-Ther C-4

Survival Percentage =81.75%

1. The Plantation Journal has been maintained but no polygon and no photograph have been taken before and after plantation the area.
2. The height of the normal plant is as per protocol.
3. Reasons for failure of plants are due to grazing/ trampling by wild animals and due to drought.
4. The staff may be advised to watch and ward the plantation area from time to time.

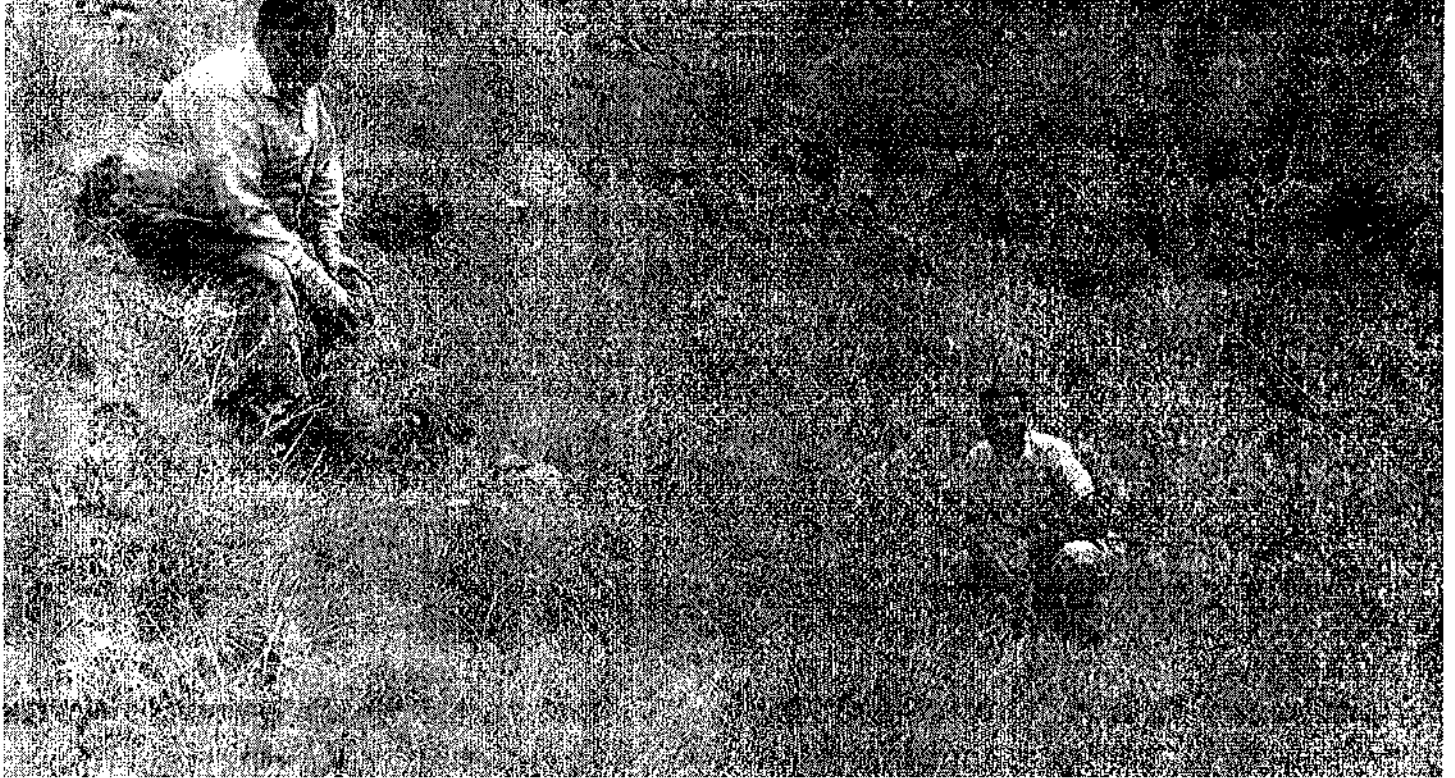
13. Shamshi/ Shamshi

Name of Plantation Area- Tung UPF-III (Chipni)

Survival Percentage =67%

1. The Plantation Journal has been maintained with polygon and photographs.
2. The height of the normal plant is less than as per protocol.
3. Reasons for failure of plants are due to grazing/ trampling by wild animals and drought.
4. The staff may be advised to watch and ward the plantation area from time to time.

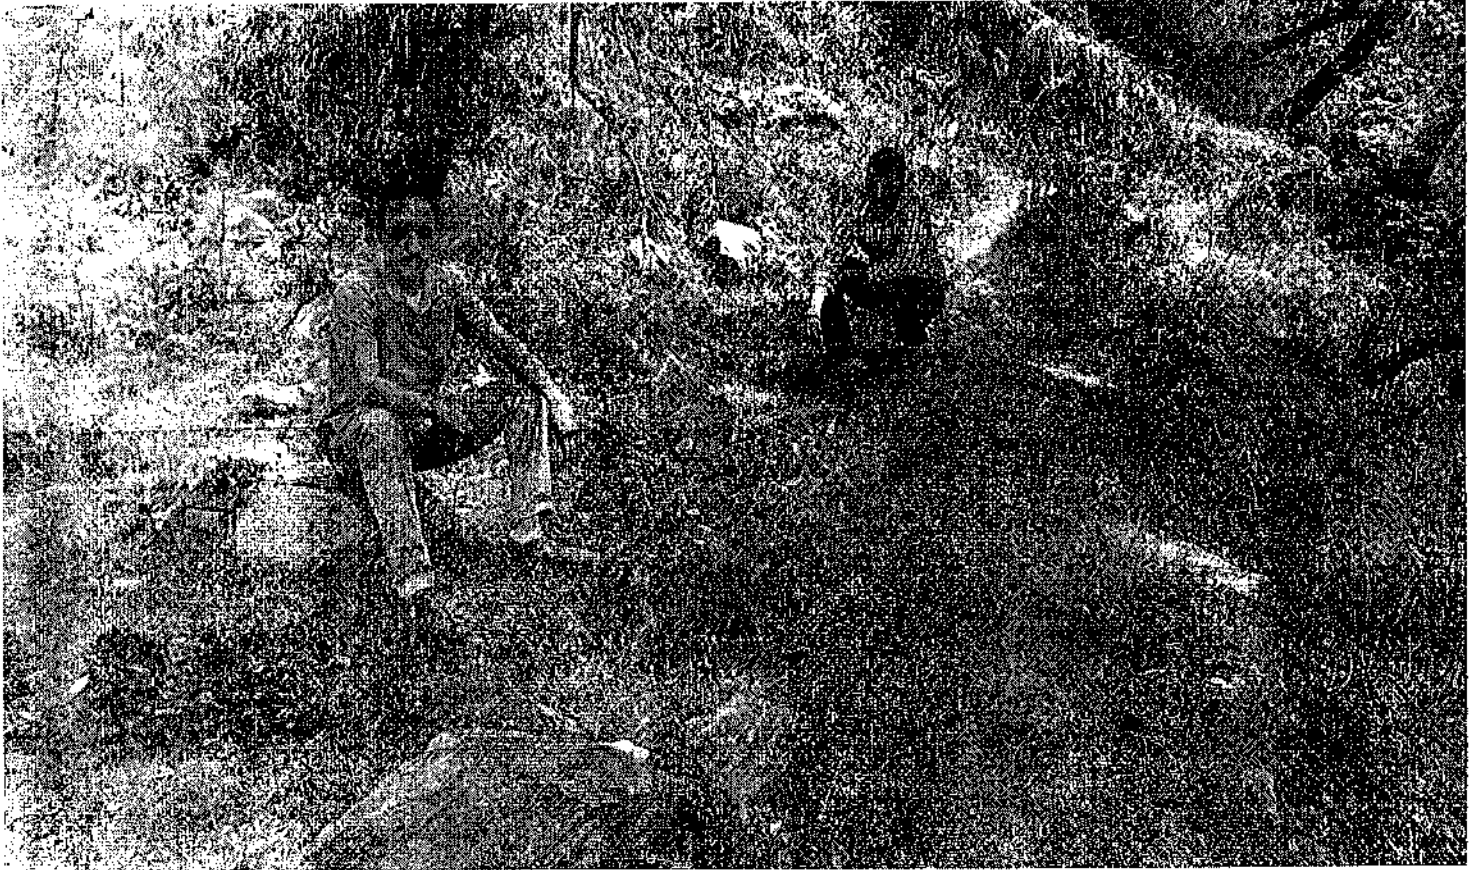
14. Shamshi/ Shamshi

Name of Plantation Area- Jugnidhar (DPF Tandi Dhar)

Survival Percentage =75%

1. The Plantation Journal has been maintained but no polygon and photographs have been taken after plantation.
2. The height of the normal plant is less than as per protocol.
3. Reasons for failure of plants are due to grazing/ trampling by wild animals and drought.
4. The staff may be advised to watch and ward the plantation area from time to time.

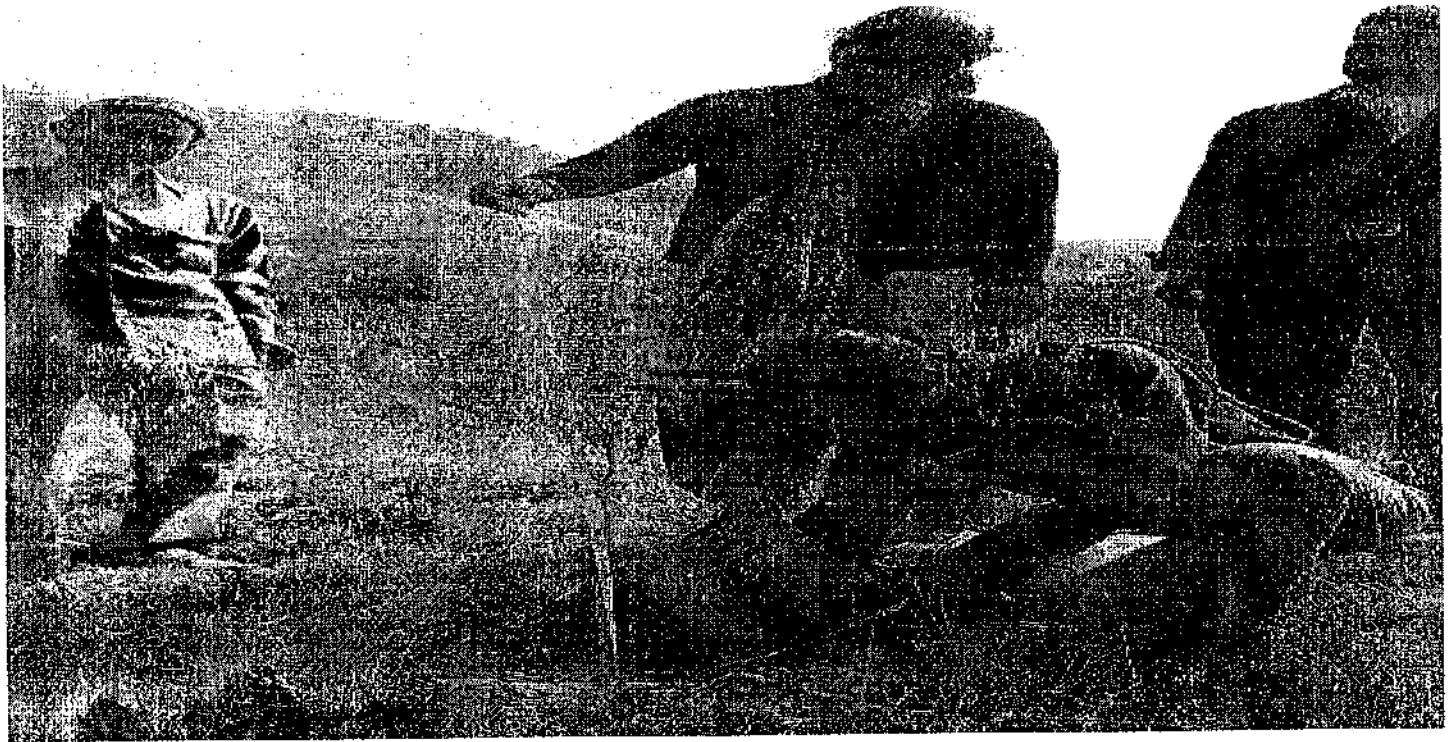
15. Bilaspur/ Panjgain

Name of Plantation Area- UPF Dhoun Kathi

Survival Percentage = 70%

1. Barbed wire was not properly stretched and standard gap has not been kept in view.
2. Less work has been executed on spot of Rs. 63,210/-
3. Plantation signboard has not been installed.
4. Inspection path was not prepared properly.
5. Less moisture regime in the area because most of the area is shallow and dry. Also no efforts have been made to retain moisture in the plantation area.
6. Planting few species Block wise is important to enhance evenness, better management and aesthetic view of the forest.

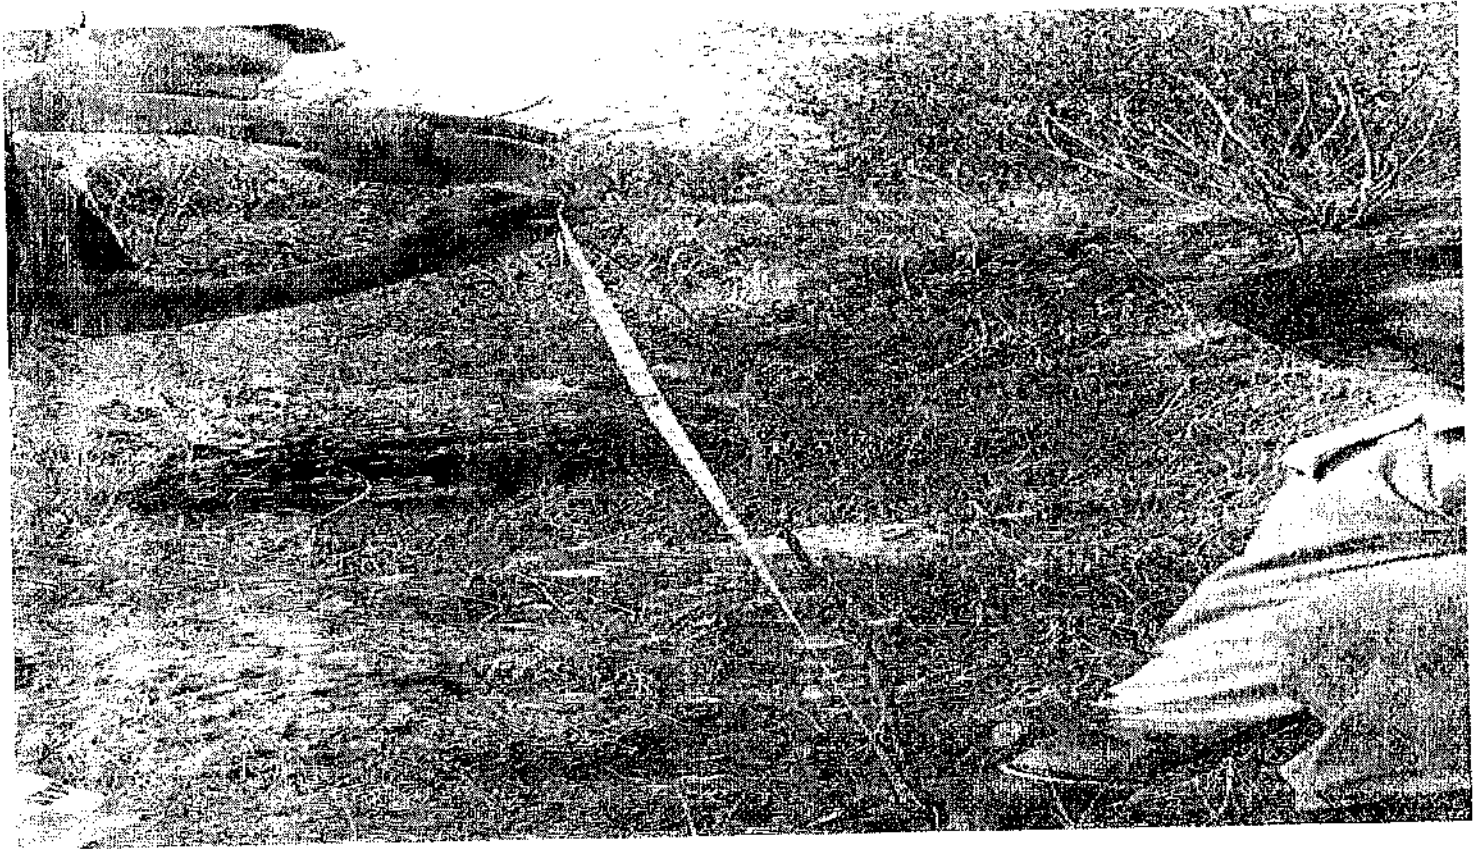
1. Plantation signboard has not been installed.
2. Inspection path was not prepared in proper width.
3. Barbed wire was not properly stretched and standard gap has not been kept in view.
4. Less work has been executed on spot of Rs. 28,041/-
5. Less moisture regime in the area because most of the area is shallow and dry. Also no efforts have been made to retain moisture in the plantation area.
6. Local people in the vicinity are not involved in protection and management of plantation.
