H.P. FOREST DEPARTMENT

***Report of Monitoring of 10%
CAMPA Works 2022-23***

**MONITORING OF CAMPA WORKS
(2ND TIER MONITORING)
DURING 2022-23**

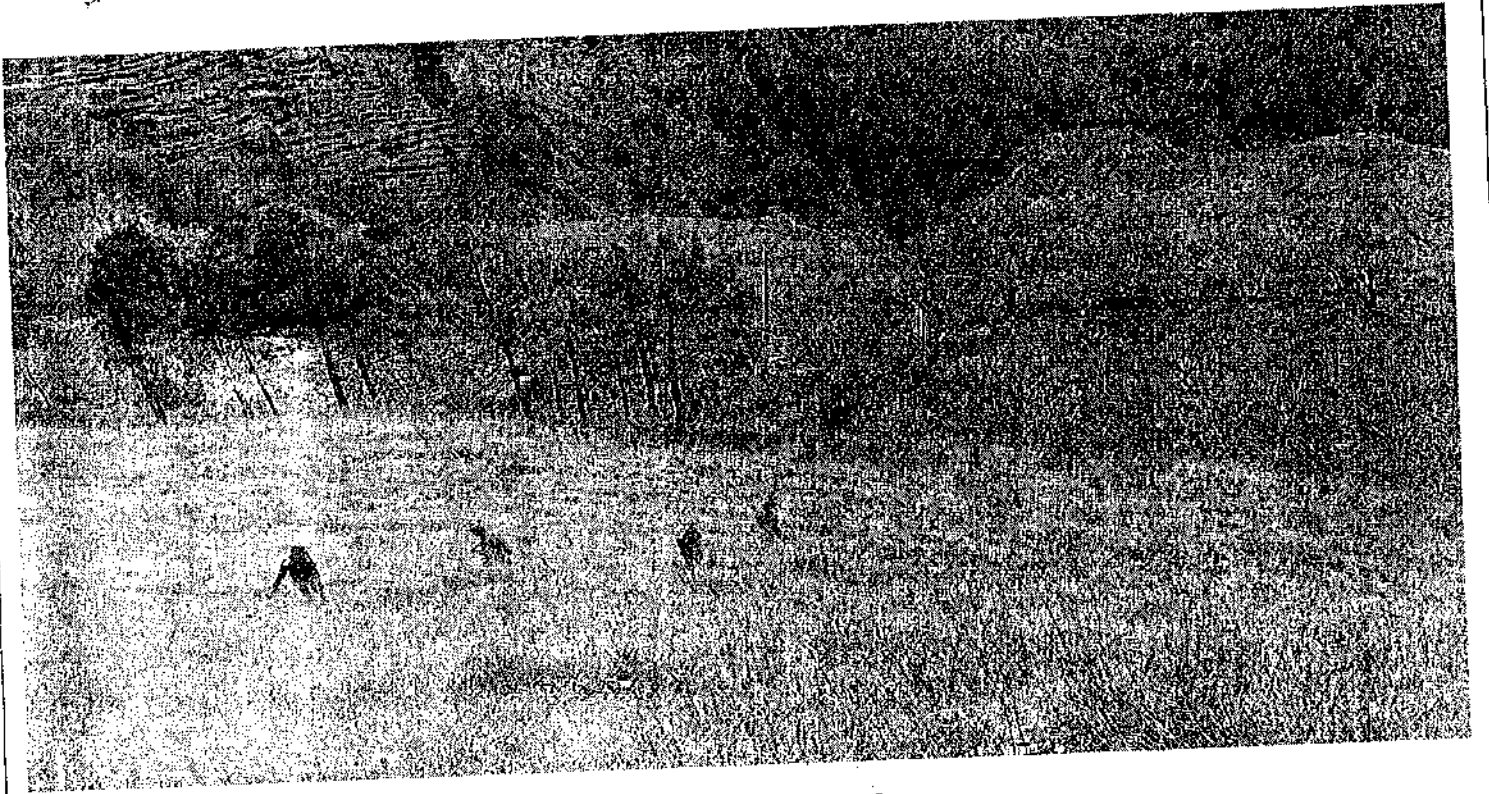
Division/Block17. Rampur/ Ani

1. Plantation signboard was not installed.
2. Less moisture regime in the area because most of the area is shallow and dry clay. Also no efforts have been made to retain moisture in the plantation area.
3. Improper soil works.
4. Inspection path was not maintained.
5. Wrong choice of species. Mixed species even those, which do not exist naturally in the vicinity, have been planted in Valley/depression. Poplar, Chulli, Jamun, Ban & Amla are not suitable species for this area as is evident from their survival percentage.

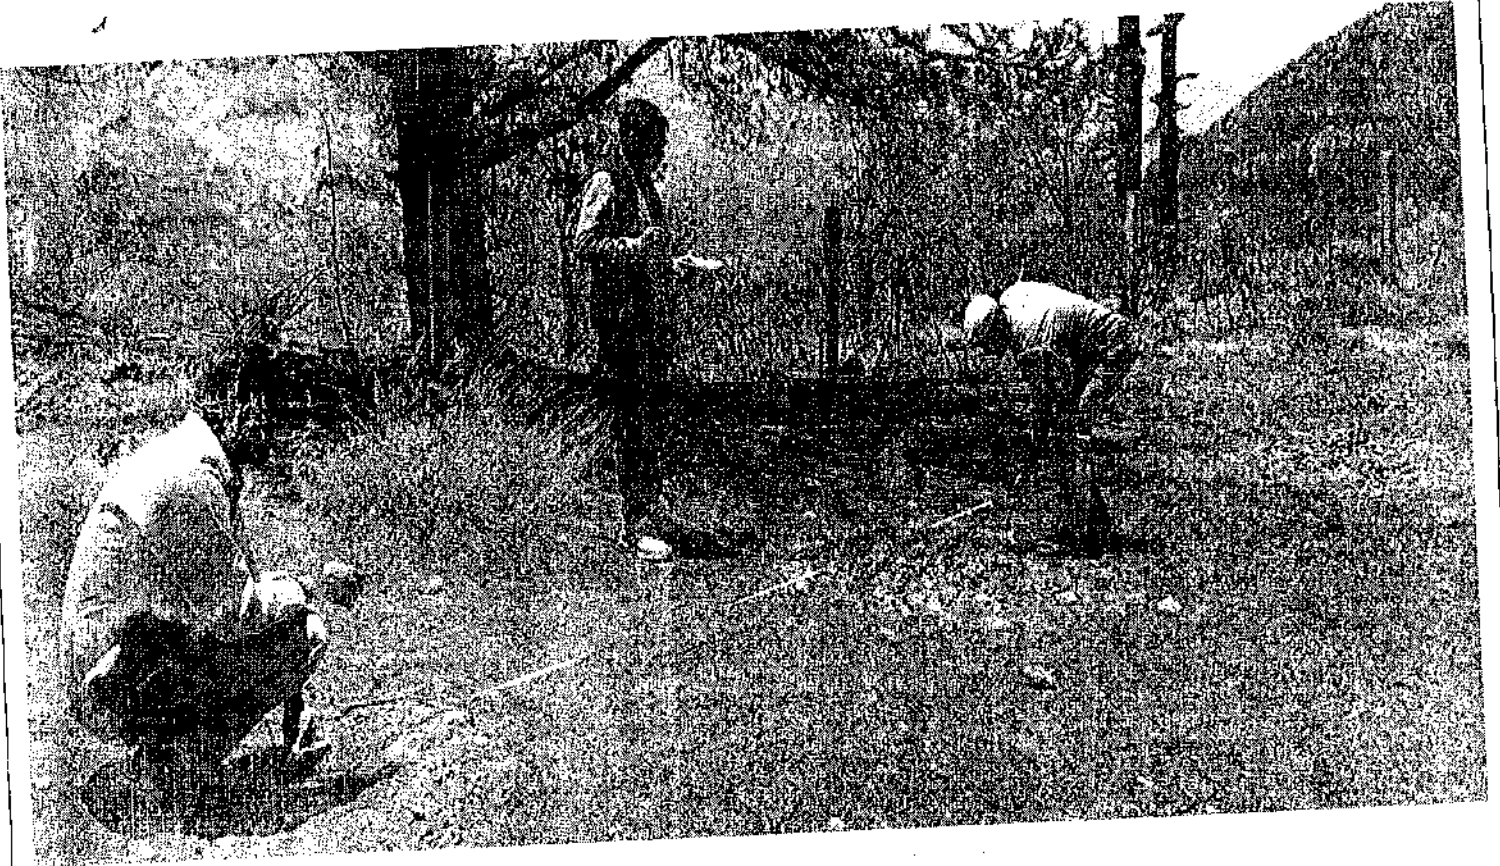
1. Plantation signboard was not installed.
2. Barbed wire was not properly stretched.
3. Improper soil work.
4. Mulching has not been done in the whole plantation area.
5. Some plants of Neoza specie were found undersized.
6. Less moisture regime in the area because most of the area is dry. Also no efforts have been made to retain moisture in the plantation area.

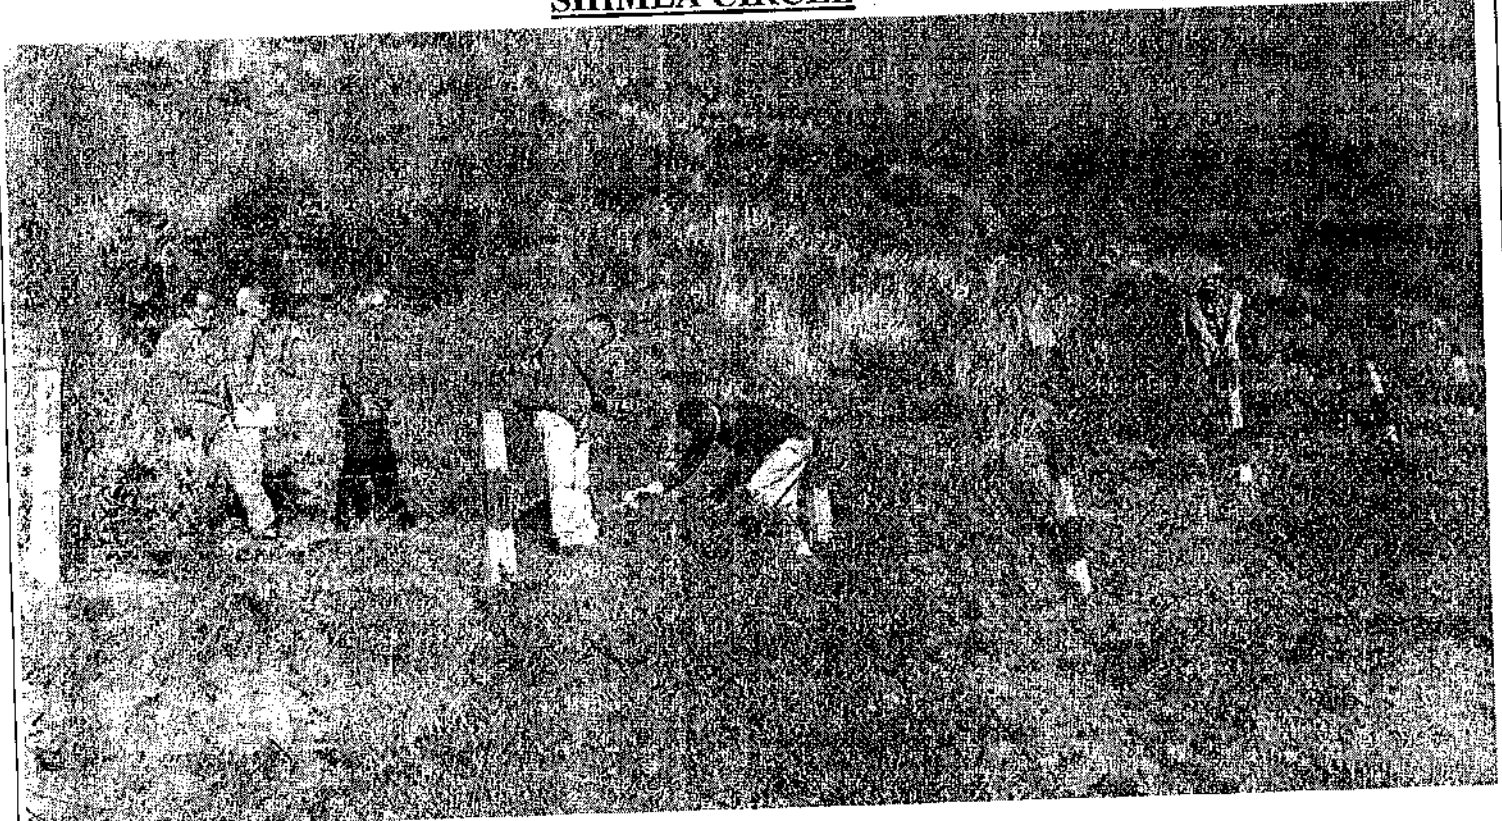
1. Out of 20 Hec. area fenced, plantation have been done only in 10 Hec. area due to infestation of Lantana in the area.
2. The selection of site for plantation area is rocky and clay loam.
3. Soil moisture is lacking in the area. Although, thousand meter trenches have been dug in the plantation area but the same has been dug haphazardly where as trench should have been dug just above the plant so that moisture is available to plant.

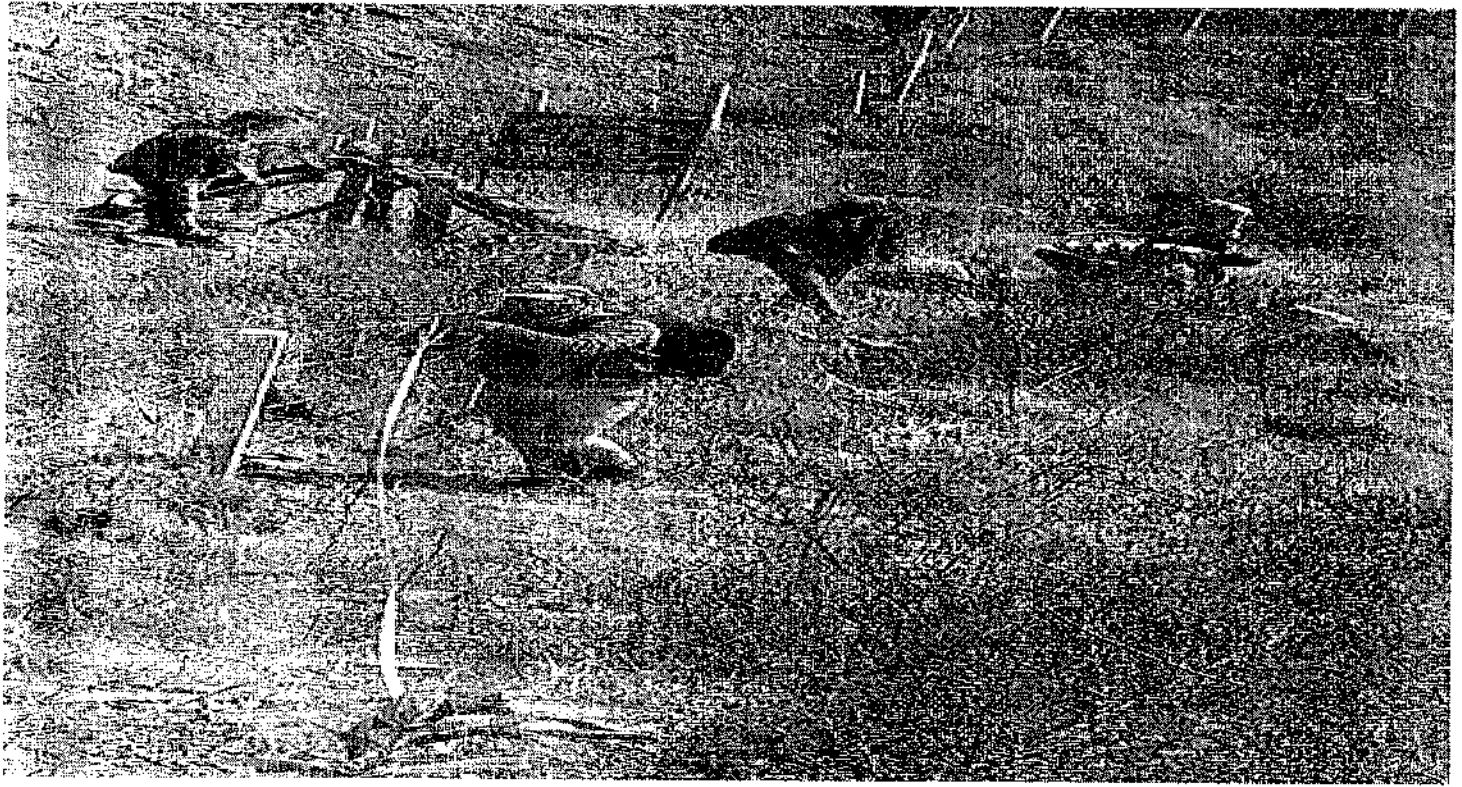
1. The variety of species has been planted with few numbers of plants of each species in the area.
2. Mixed species even those, which do not exist naturally in the vicinity, have been planted in Valley/depression.
3. Less moisture regime in the area because most of the area is shallow and dry. Also no efforts have been made to retain moisture in the plantation area.
4. Most of plants of Deodar specie were found undersized.

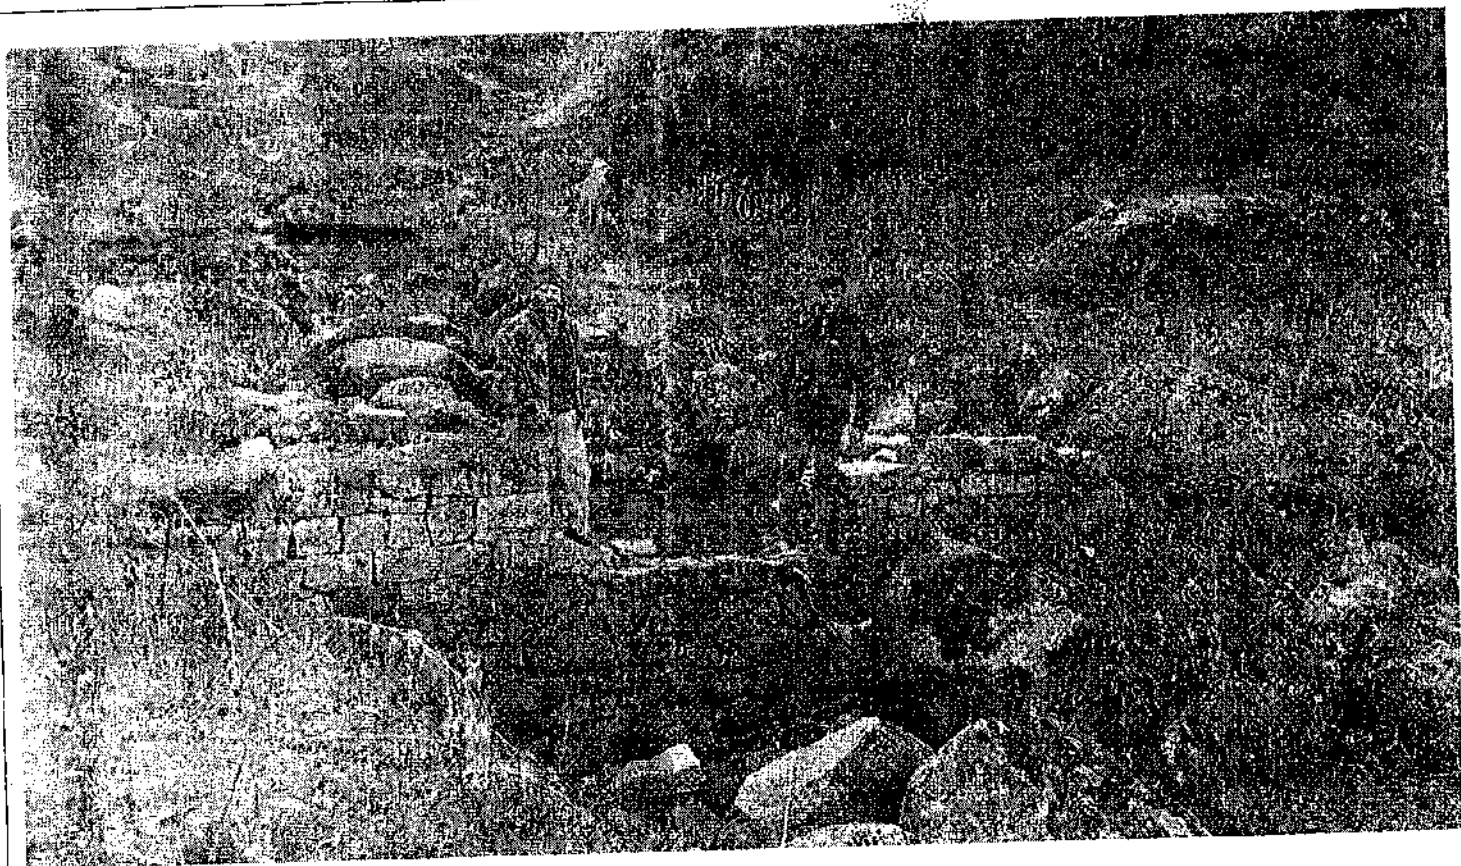
1. Soil conservation register to be prepared with basic information about site, detail of works as well as the photographs of the site before and after the treatment of should be incorporated in it.
2. Complete plan must be important before taking up the treatment of the Nallah.
3. Bio-engineering species must be planted around the soil conservation works.
4. By adding the diagonal wing wall anchorage towards upper side of the Nallah may slowdown the force and will provide direction to water flow in Nallah and also will become more effective to check soil erosion at Nallah beds.
5. Distance between check dams to checks dams should be as per soil conservation concept
6. Numbering of check dams and years of execution of work as well as the funding and executive agency should be marked on the check dams which help to recognize easily the construction done at site.

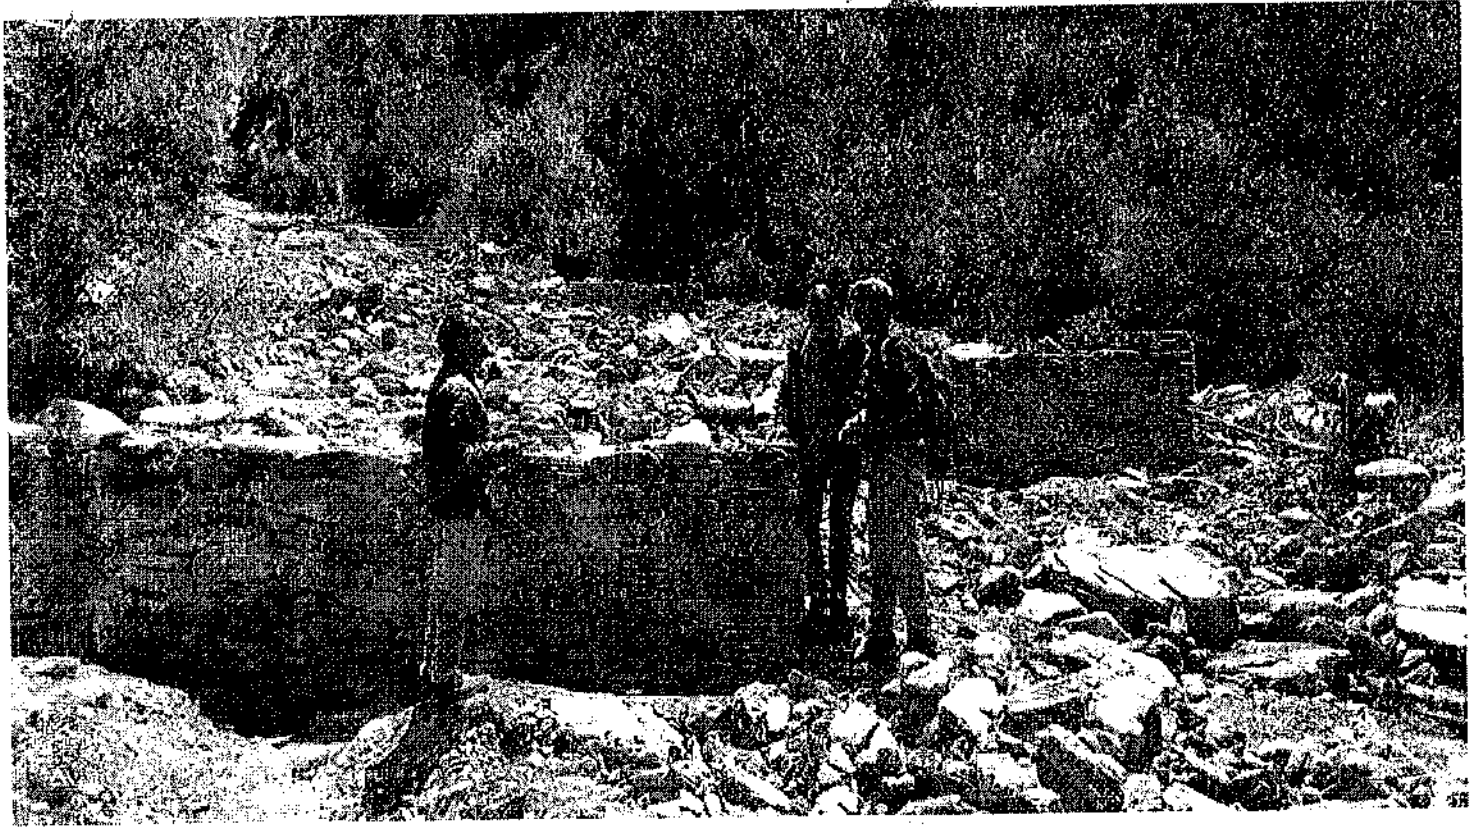
Circle /Division/Range/Block/Beat
2. Kullu/Keylong / Pattan/ Lower Pattan / Chowkhang

1. Soil conservation register to be prepared with basic information and GPS coordinates about site, detail of works as well as the photographs of the site before and after the treatment of should be incorporated in it.
2. Complete plan must be important before taking up the treatment of the area.
3. Bio-engineering species must be planted around the soil conservation works.
4. Numbering of check walls and years of execution of work as well as the funding and executive agency should be marked on the check walls which help to recognize easily the construction done at site.
5. No variation. All the works carried out have thoroughly been checked/ Measured on the spot and found that all the works executed tally with M.B.
6. The staff may be advised to maintain the record properly.

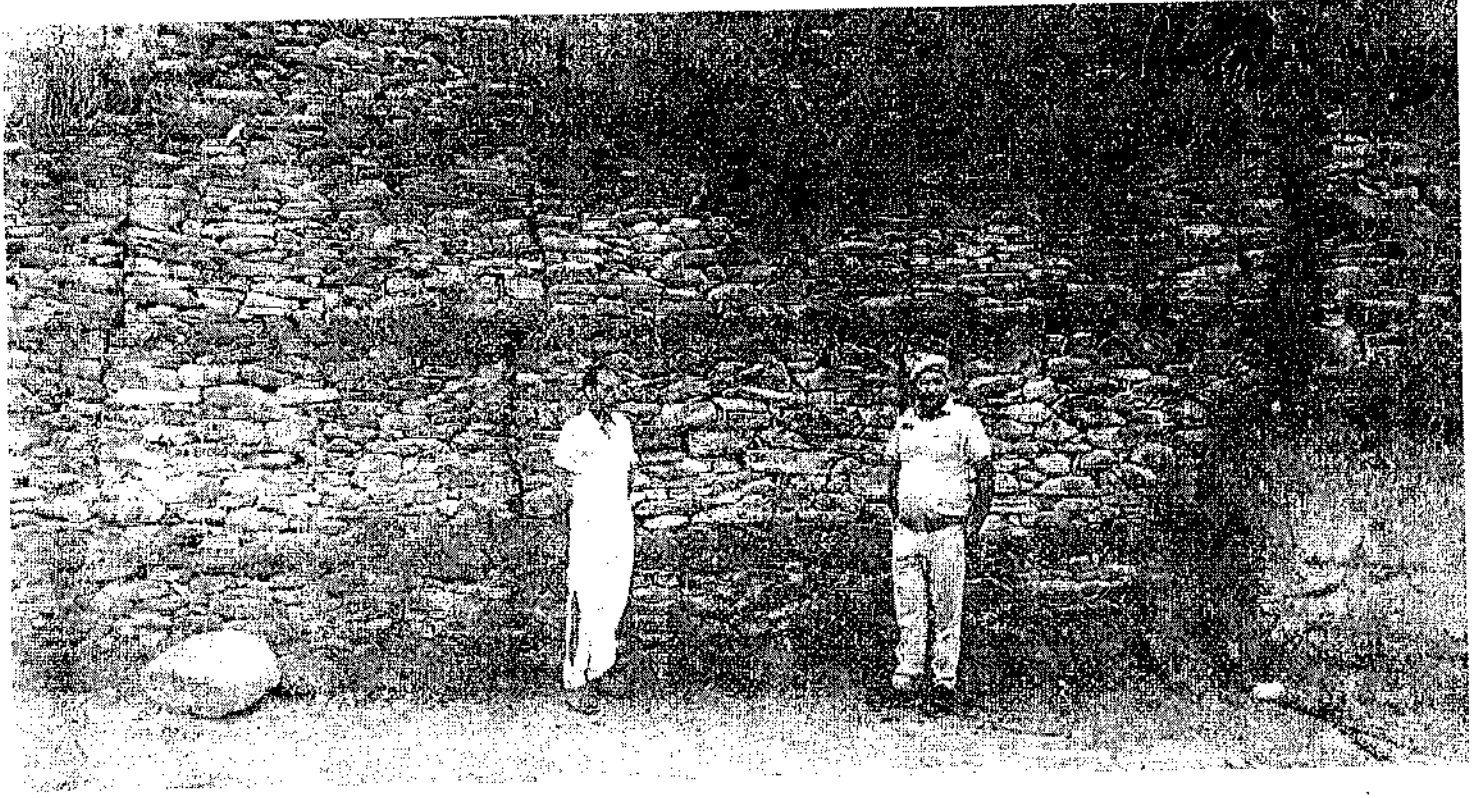
Circle /Division/Range/Block/Beat
3.Chamba/Bharmour / Tretha/Holi/Deol

1. Soil conservation register to be prepared with basic information about site, detail of works as well as the photographs of the site before and after the treatment should be incorporated in it.
2. Complete plan must be important before taking up the treatment of the Nallah.
3. Bio-engineering species must be planted around the soil conservation works.
4. Numbering of check walls and year of execution of work as well as the funding and executive agency should be marked on the check walls. Which may help to recognize easily the construction done at the site.

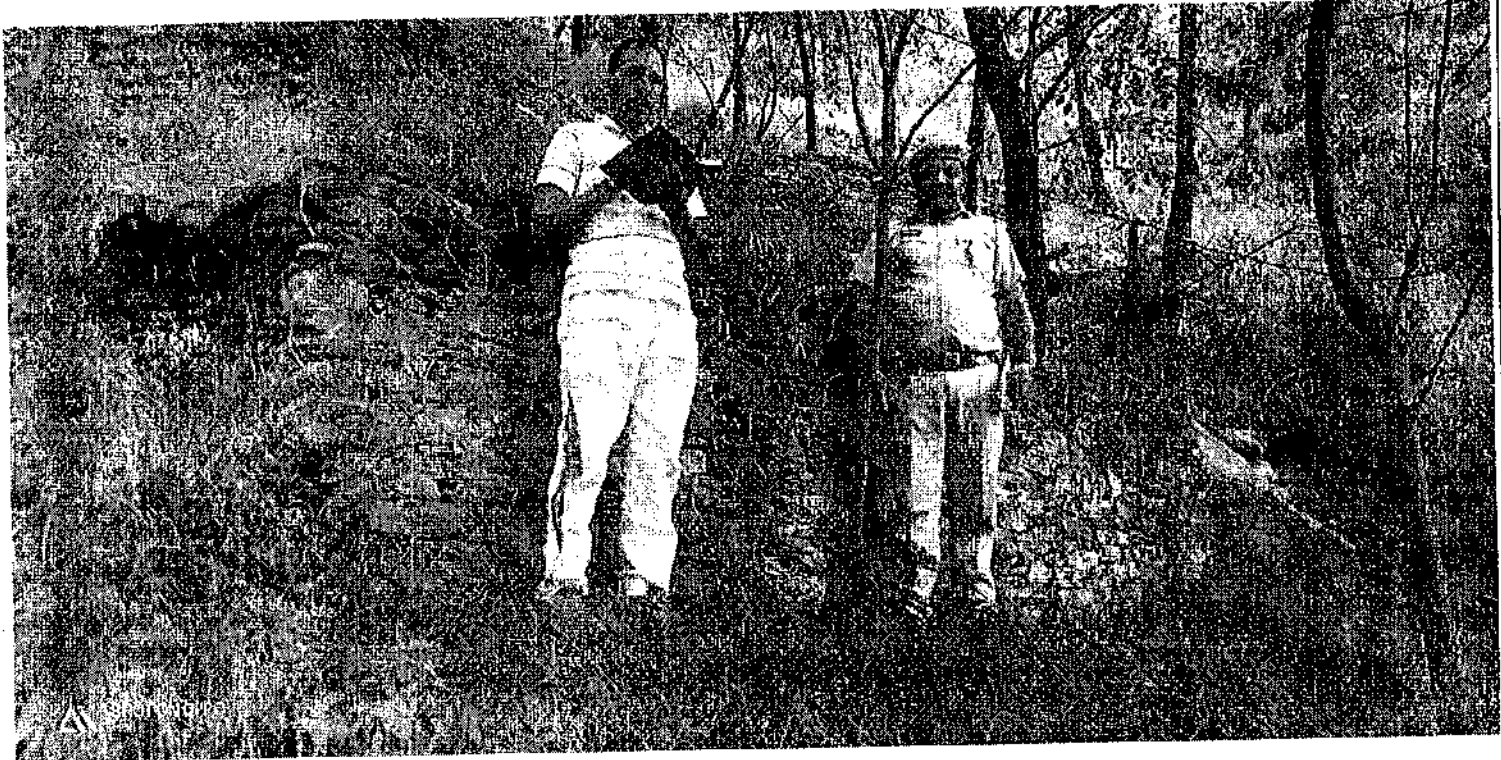
Circle /Division/Range/Block/Beat
4. Chamba/Bharmour / Tretha/Holi/Deol

1. Soil conservation register to be prepared with basic information about site, detail of works as well as the photographs of the site before and after the treatment should be incorporated in it.
2. Complete plan must be important before taking up the treatment of the Nallah.
3. Bio-engineering species must be planted around the soil conservation works.
4. Numbering of check walls and year of execution of work as well as the funding and executive agency should be marked on the check walls. Which may help to recognize easily the construction done at the site.

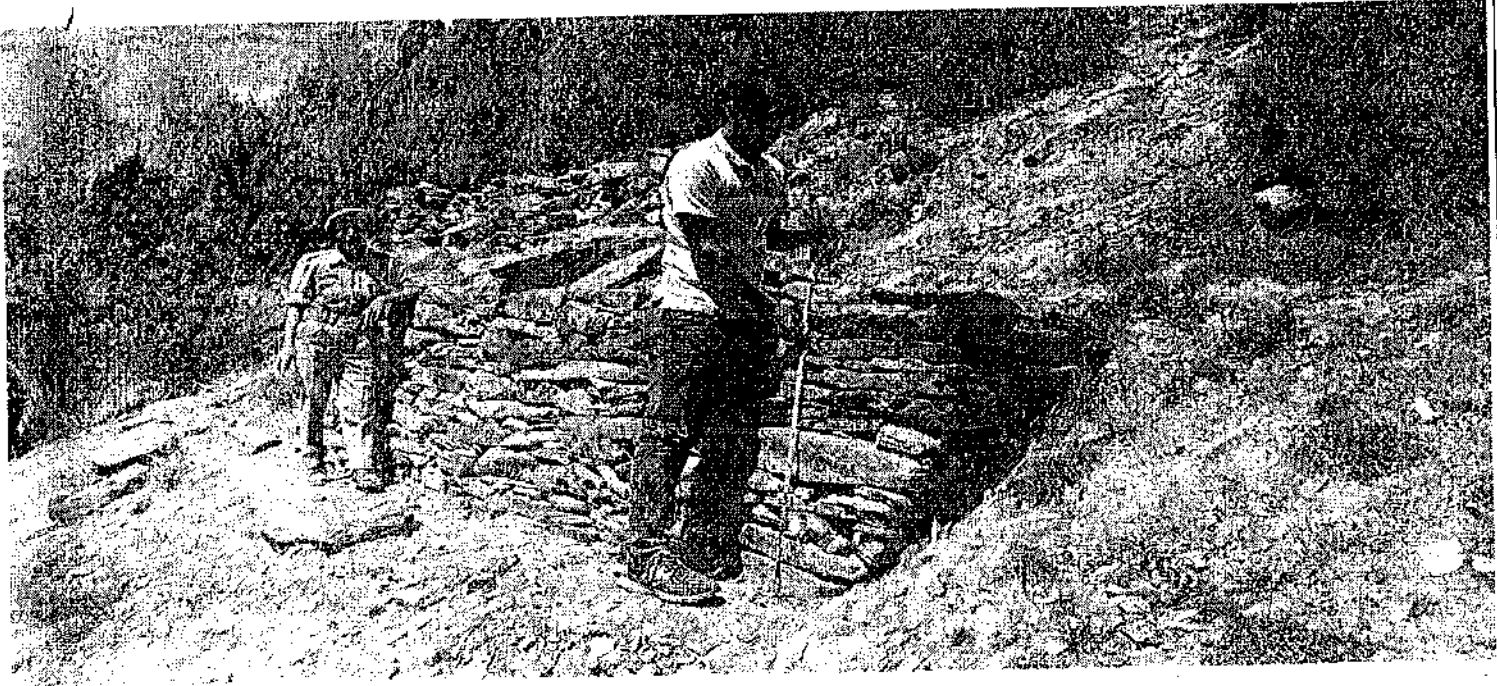
**Circle /Division/Range/Block/Beat
5. Kullu/Keylong / Keylong/ Bhaga / Stingri**

1. Soil conservation register to be prepared with basic information and GPS coordinates about site, detail of works as well as the photographs of the site before and after the treatment of should be incorporated in it.
2. Bio-engineering species must be planted around the soil conservation works.
3. Numbering of check walls and years of execution of work as well as the funding and executive agency should be marked on the check walls which help to recognize easily the construction done at site.
4. No variation. All the works carried out have thoroughly been checked/ Measured on the spot and found that all the works executed tally with M.B.
5. The staff may be advised to maintain the record properly.

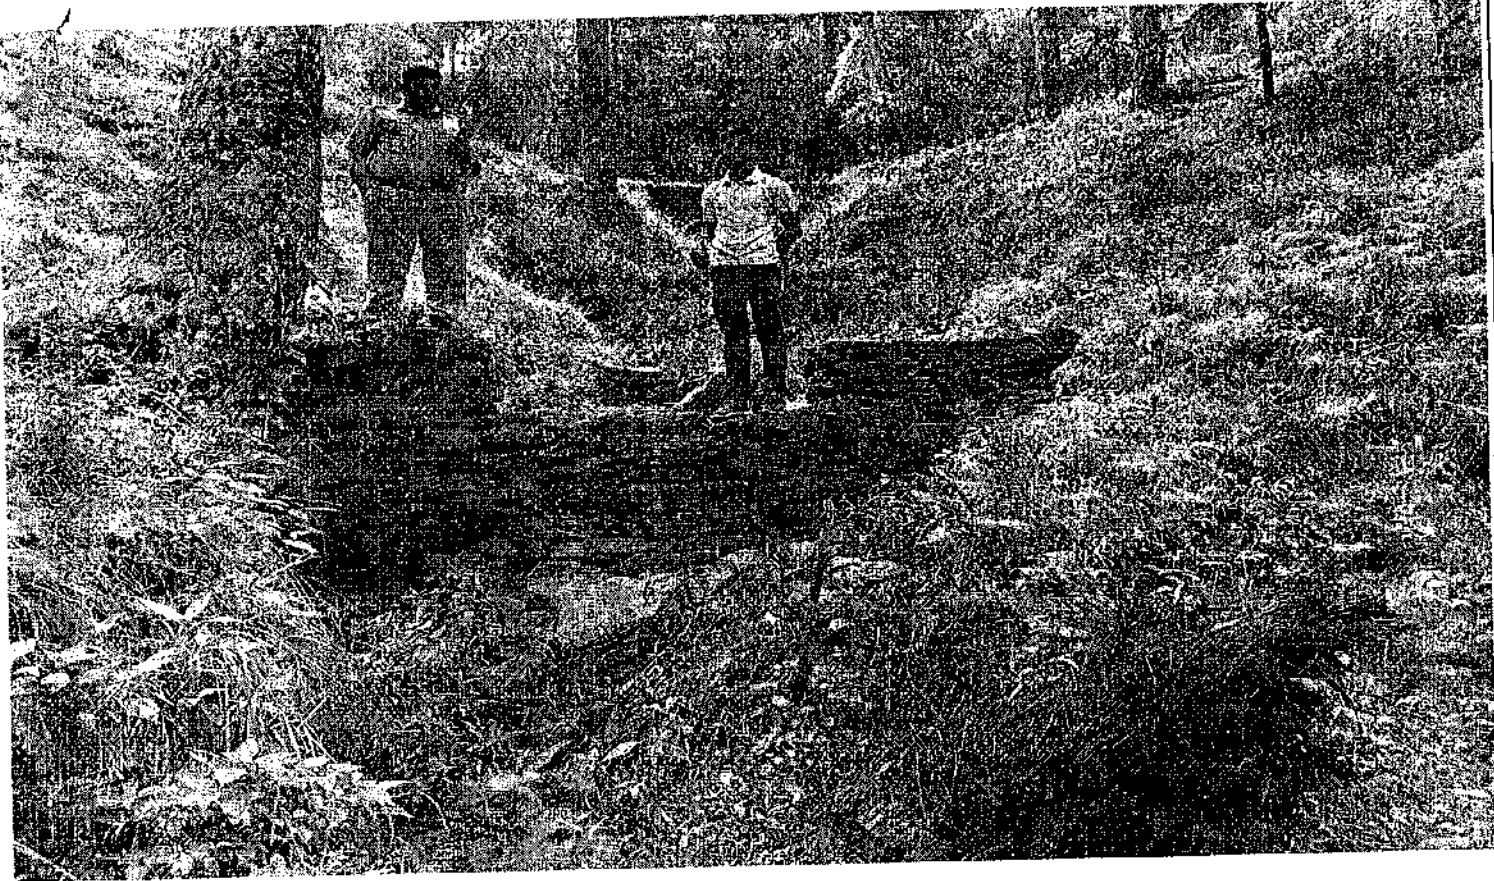
Circle /Division/Range/Block/Beat
6. Mandi/Karsog / Seri/Seri/NihariNal

1. Soil conservation register to be prepared with basic information about site, detail of works as well as the photographs of the site before and after the treatment of should be incorporated in it.
2. Complete plan must be important before taking up the treatment of the Nallah.
3. Bio-engineering species must be planted around the soil conservation works.
4. By adding the diagonal wing wall anchorage towards upper side of the Nallah may slowdown the force and will provide direction to water flow in Nallah and also will become more effective to check soil erosion at Nallah beds.
5. Distance between check dams to checks dams should be as per soil conservation concept
6. Numbering of check dams and years of execution of work as well as the funding and executive agency should be marked on the check dams, which help to recognize easily the construction done at site.

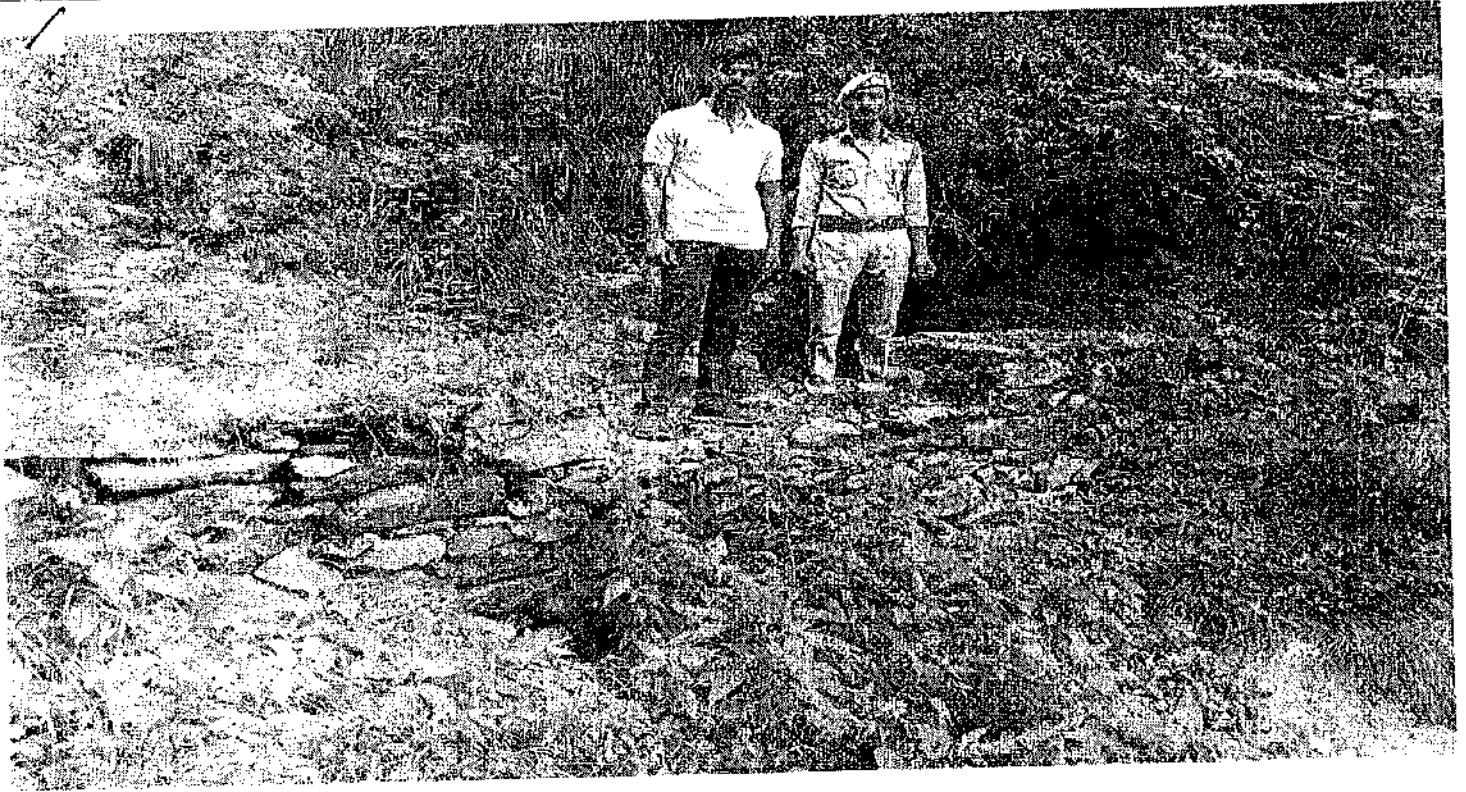
**Circle /Division/Range/Block/Beat
7. Mandi/Karsog / Seri/Seri/NihariNai**

1. Soil conservation register to be prepared with basic information about site, detail of works as well as the photographs of the site before and after the treatment of should be incorporated in it.
2. Complete plan must be important before taking up the treatment of the Nallah.
3. Bio-engineering species must be planted around the soil conservation works.
4. By adding the diagonal wing wall anchorage towards upper side of the Nallah may slowdown the force and will provide direction to water flow in Nallah and also will become more effective to check soil erosion at Nallah beds.
5. Distance between check dams to checks dams should be as per soil conservation concept
6. Numbering of check dams and years of execution of work as well as the funding and executive agency should be marked on the check dams, which help to recognize easily the construction done at site.

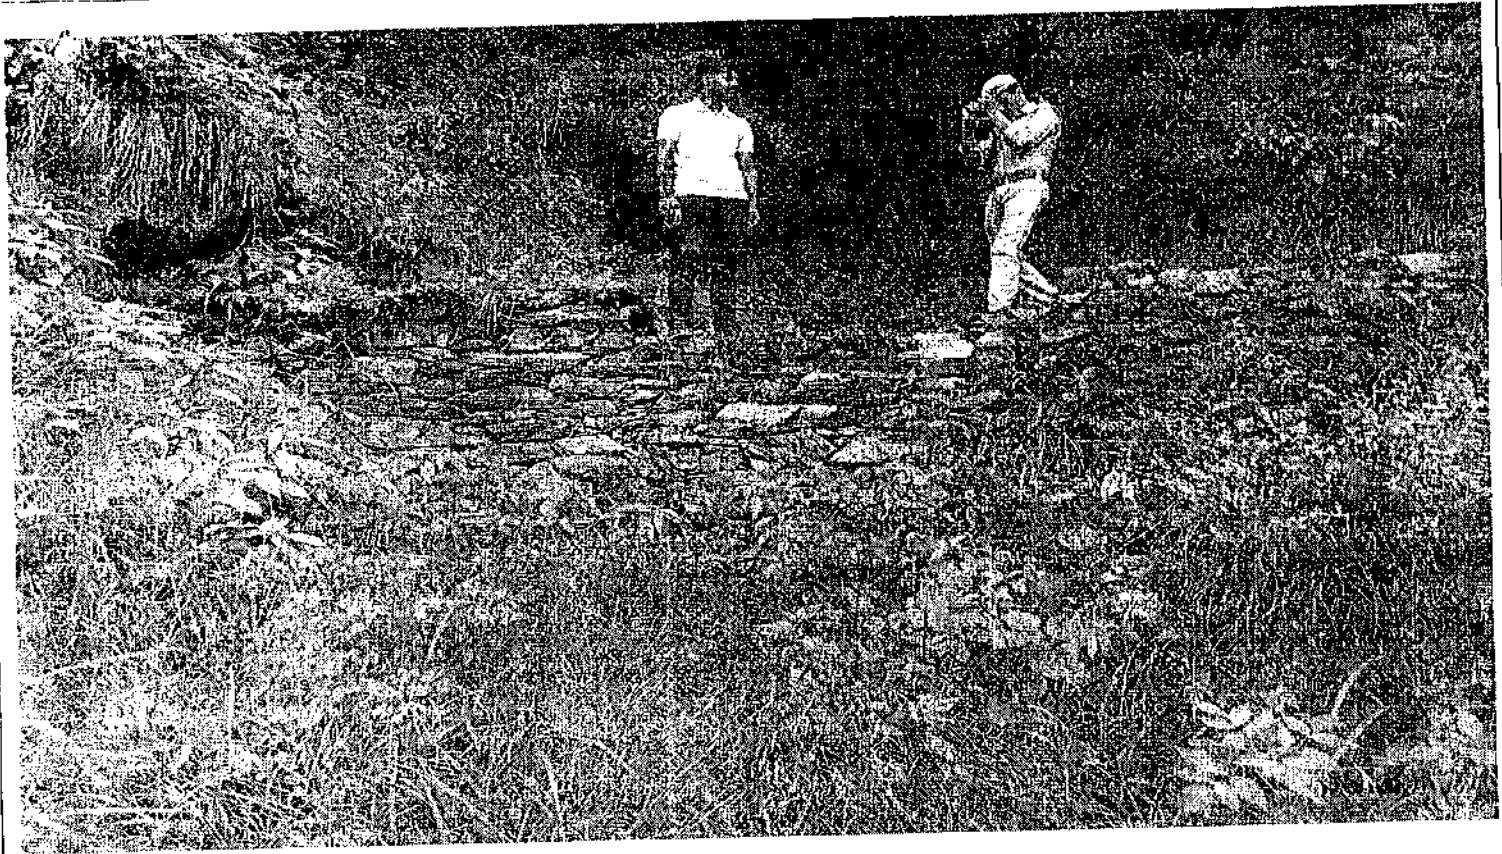
Circle /Division/Range/Block/Beat
8. Mandi/Karsog / Seri/Seri/NihariNal

1. Soil conservation register to be prepared with basic information about site, detail of works as well as the photographs of the site before and after the treatment of should be incorporated in it.
2. Complete plan must be important before taking up the treatment of the Nallah.
3. Bio-engineering species must be planted around the soil conservation works.
4. By adding the diagonal wing wall anchorage towards upper side of the Nallah may slowdown the force and will provide direction to water flow in Nallah and also will become more effective to check soil erosion at Nallah beds.
5. Distance between check dams to checks dams should be as per soil conservation concept
6. Numbering of check dams and years of execution of work as well as the funding and executive agency should be marked on the check dams which help to recognize easily the construction done at site.

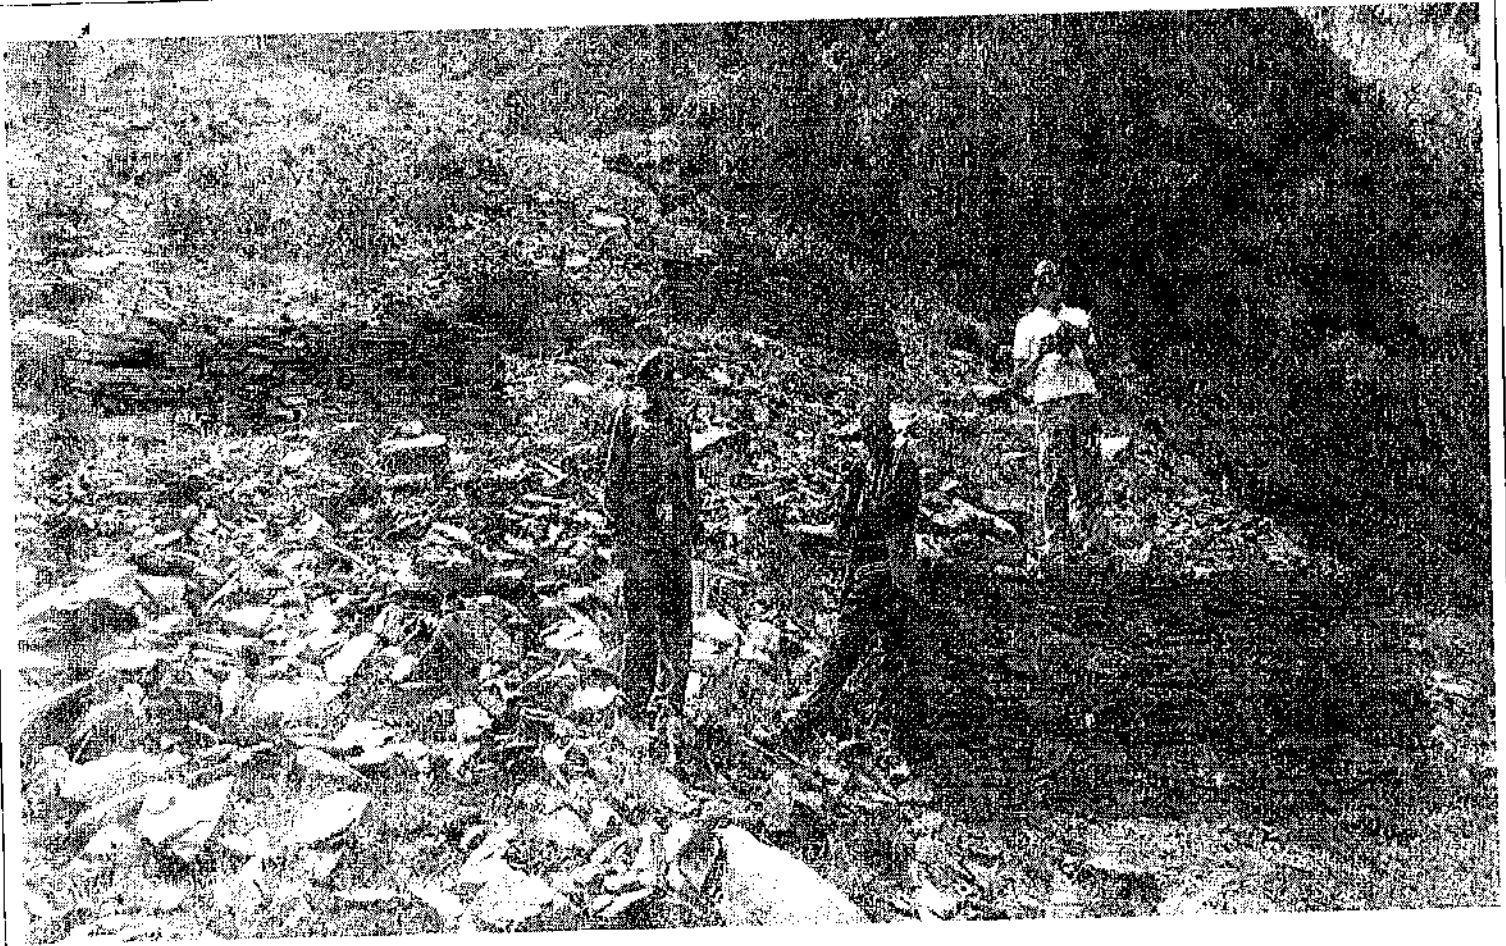
Circle /Division/Range/Block/Beat
9. Chamba/Pangi Purthi /Purthi/Shour

1. Soil conservation register to be prepared with basic information and GPS coordinates about site, detail of works as well as the photographs of the site before and after the treatment of should be incorporated in it.
2. Complete plan must be important before taking up the treatment of the area.
3. Bio-engineering species must be planted around the soil conservation works.
4. Numbering of check walls and years of execution of work as well as the funding and executive agency should be marked on the check walls which help to recognize easily the construction done at site.
5. No variation. All the works carried out have thoroughly been checked/ Measured on the spot and found that all the works executed tally with M.B.
6. The staff may be advised to maintain the record properly.

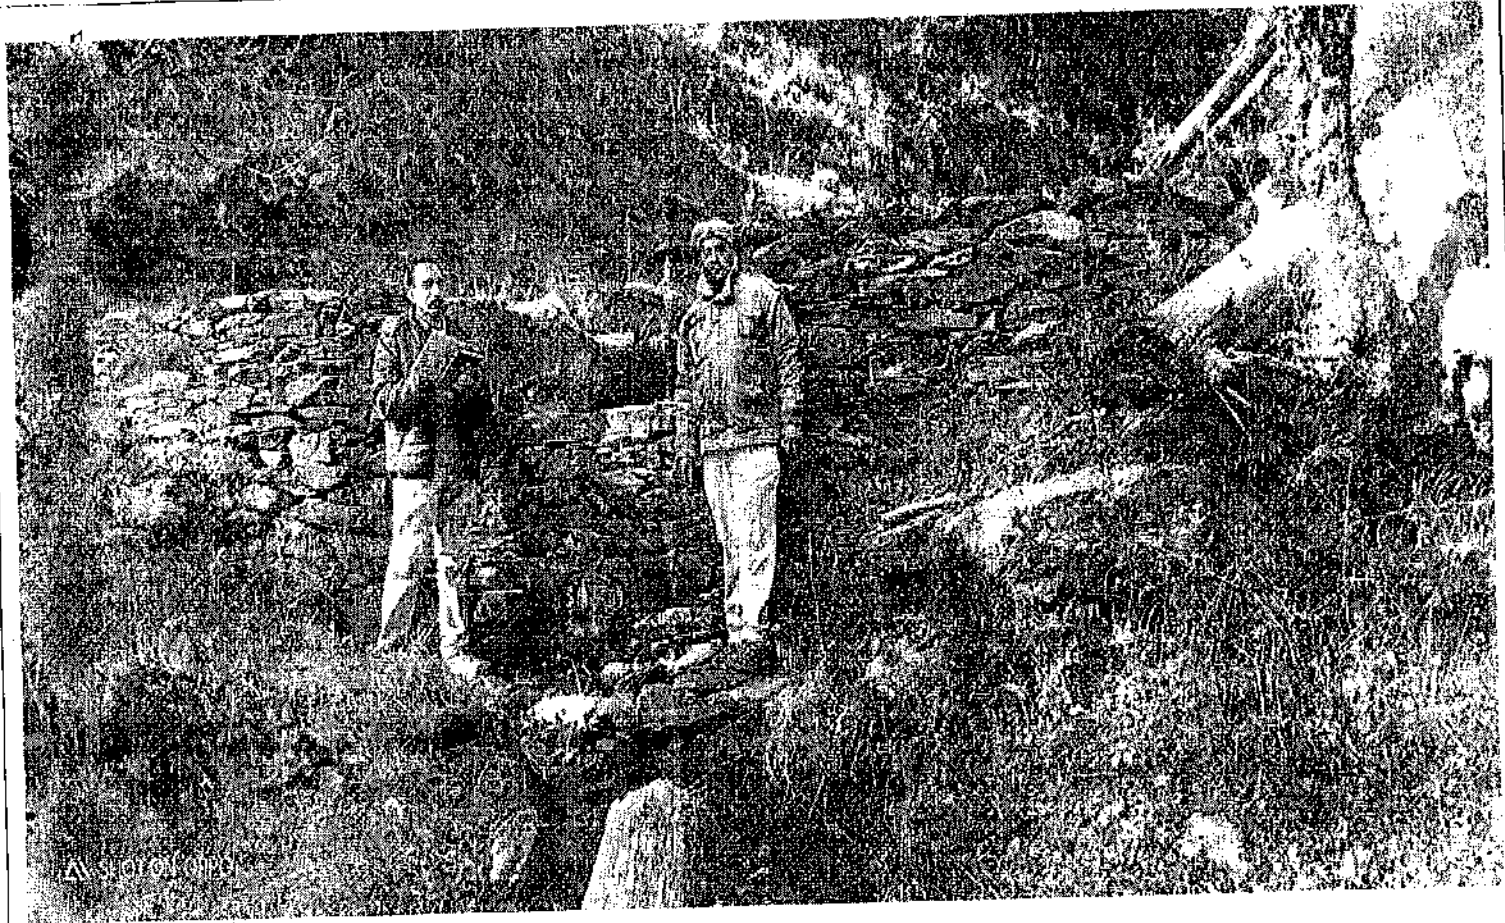
1. Soil conservation register to be prepared with basic information about site, detail of works as well as the photographs of the site before and after the treatment of should be incorporated in it.
2. Complete plan must be important before taking up the treatment of the Nallah.
3. Bio-engineering species must be planted around the soil conservation works.
4. By adding the diagonal wing wall anchorage towards upper side of the Nallah may slowdown the force and will provide direction to water flow in Nallah and also will become more effective to check soil erosion at Nallah beds.
5. Distance between check dams to checks dams should be as per soil conservation concept
6. Numbering of check dams and years of execution of work as well as the funding and executive agency should be marked on the check dams, which help to recognize easily the construction done at site.

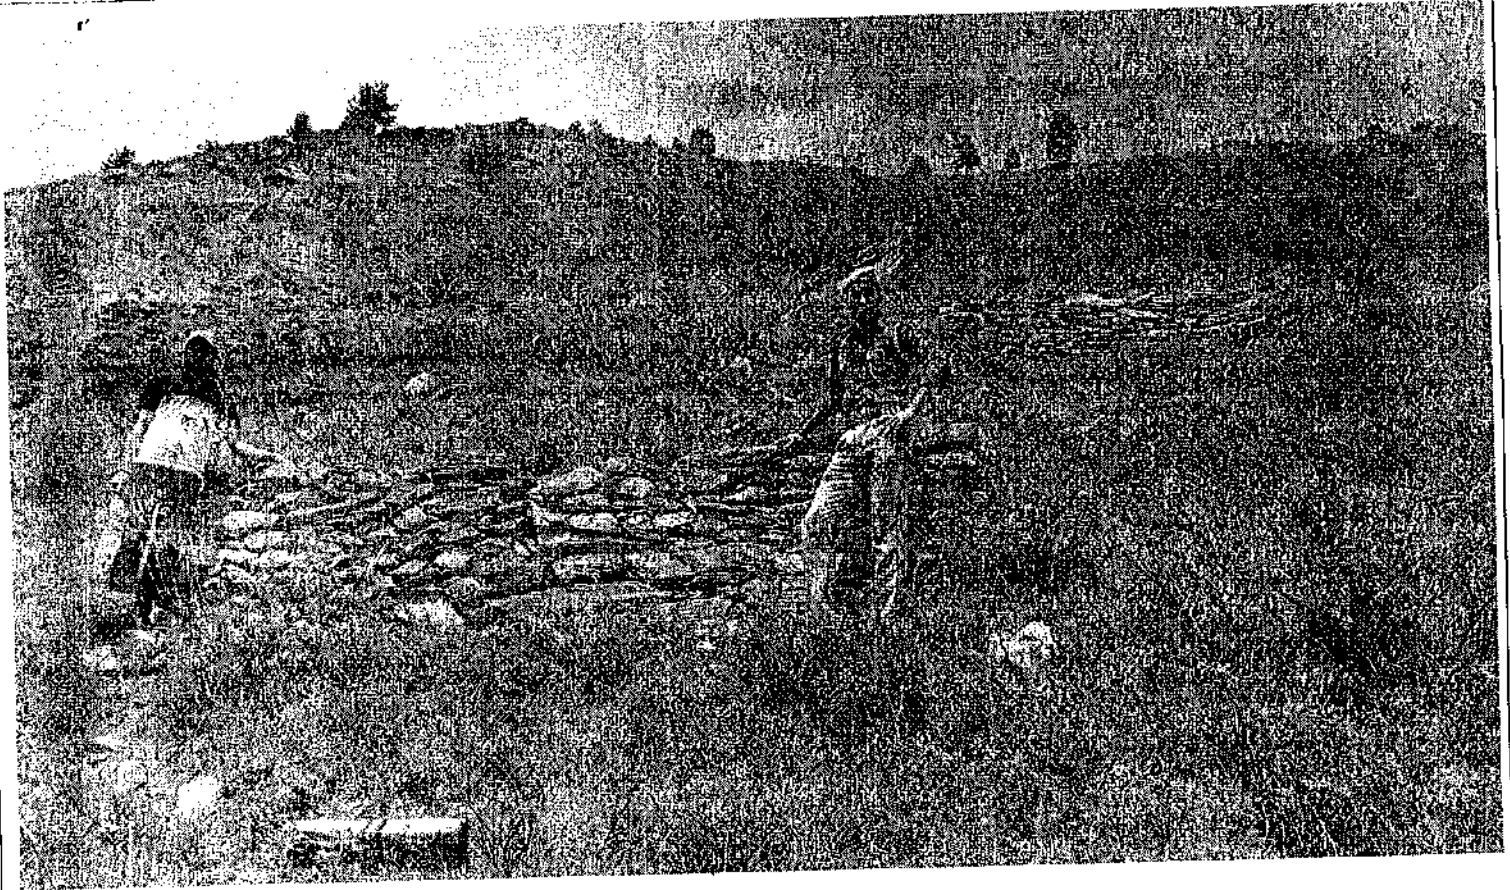
**Circle /Division/Range/Block/Beat
11.Chamba/Pangi / Sach /Sach/Sach**

1. Soil conservation register to be prepared with basic information and GPS coordinates about site, detail of works as well as the photographs of the site before and after the treatment of should be incorporated in it.
2. Complete plan must be important before taking up the treatment of the area.
3. Bio-engineering species must be planted around the soil conservation works.
4. Numbering of check walls and years of execution of work as well as the funding and executive agency should be marked on the check walls which help to recognize easily the construction done at site.
5. No variation. All the works carried out have thoroughly been checked/ Measured on the spot and found that all the works executed tally with M.B.
6. The staff may be advised to maintain the record properly.
