H.P. FOREST DEPARTMENT

***Report of Monitoring of 10%
CAMPA Works 2022-23***

**MONITORING OF CAMPA WORKS
(2ND TIER MONITORING)
DURING 2022-23**

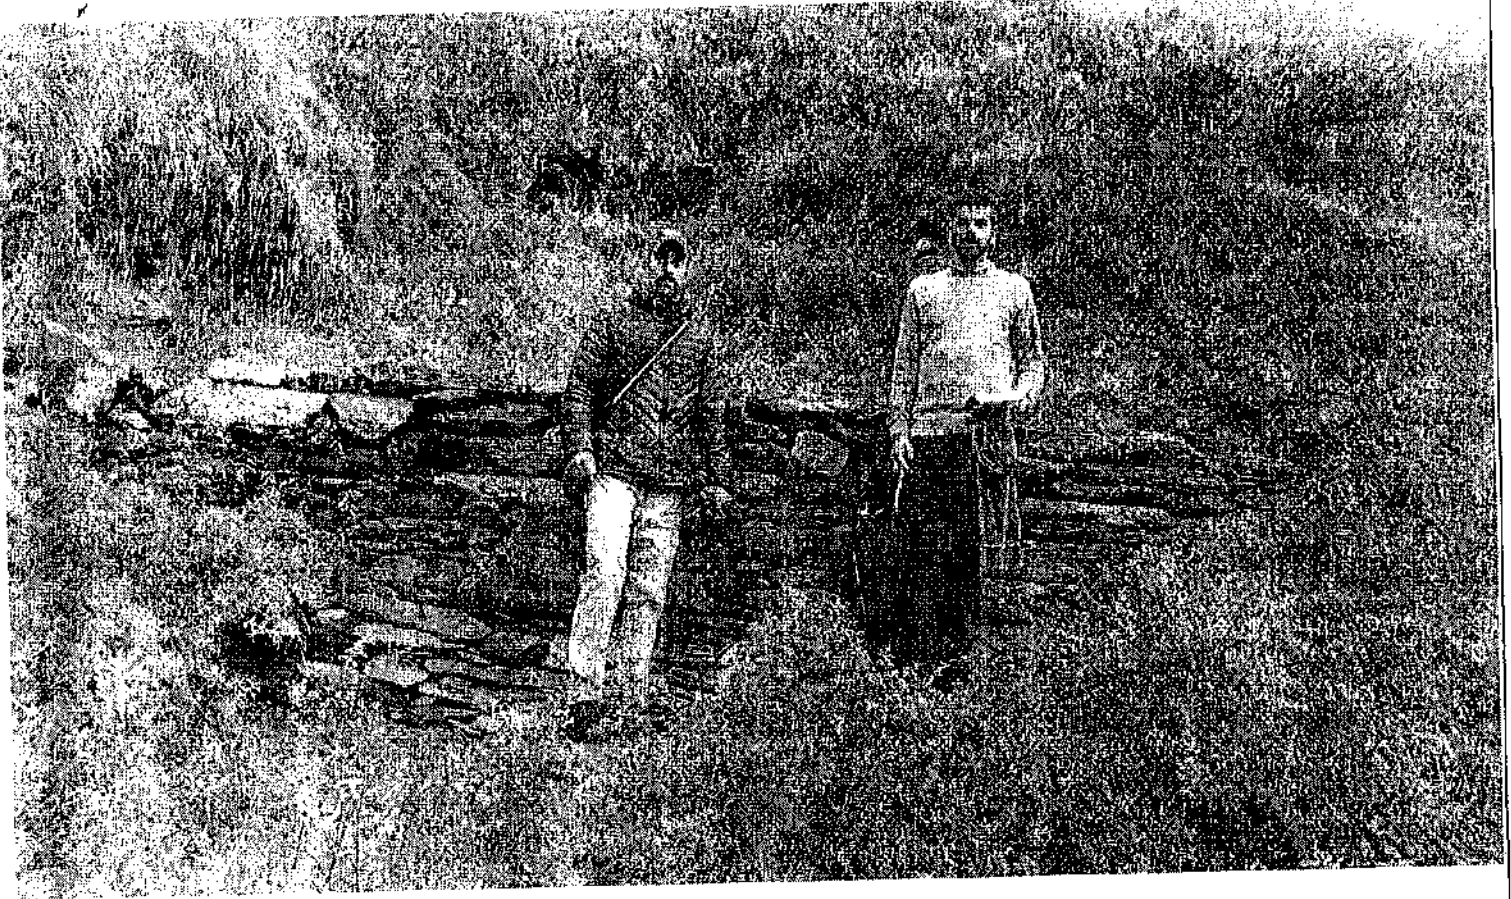
Circle /Division/Range/Block/Beat
12. Chamba/Bharmour / Tretha/Holi/Sutkar

1. Soil conservation register to be prepared with basic information about site, detail of works as well as the photographs of the site before and after the treatment should be incorporated in it.
2. Complete plan must be important before taking up the treatment of the Nallah.
3. Bio-engineering species must be planted around the soil conservation works.
4. Numbering of check walls and year of execution of work as well as the funding and executive agency should be marked on the check walls. Which may help to recognize easily the construction done at the site.

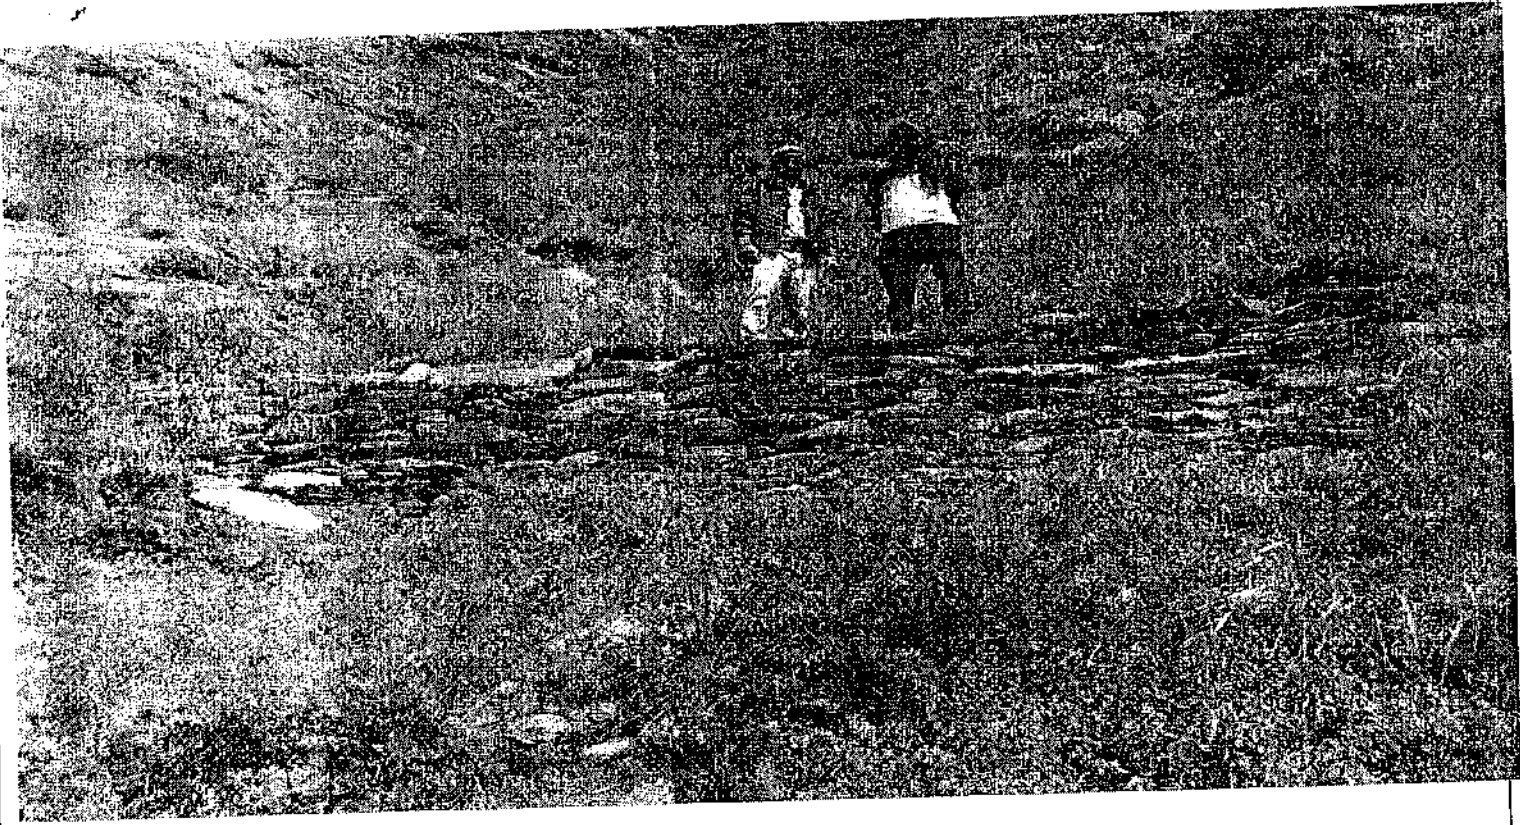
**Circle /Division/Range/Block/Beat
13. Chamba/Bharmour / Tretha/Holi/Tiyari**

1. Soil conservation register to be prepared with basic information about site, detail of works as well as the photographs of the site before and after the treatment should be incorporated in it.
2. Complete plan must be important before taking up the treatment of the Nallah.
3. Bio-engineering species must be planted around the soil conservation works.
4. Numbering of check walls and year of execution of work as well as the funding and executive agency should be marked on the check walls. Which may help to recognize easily the construction done at the site.

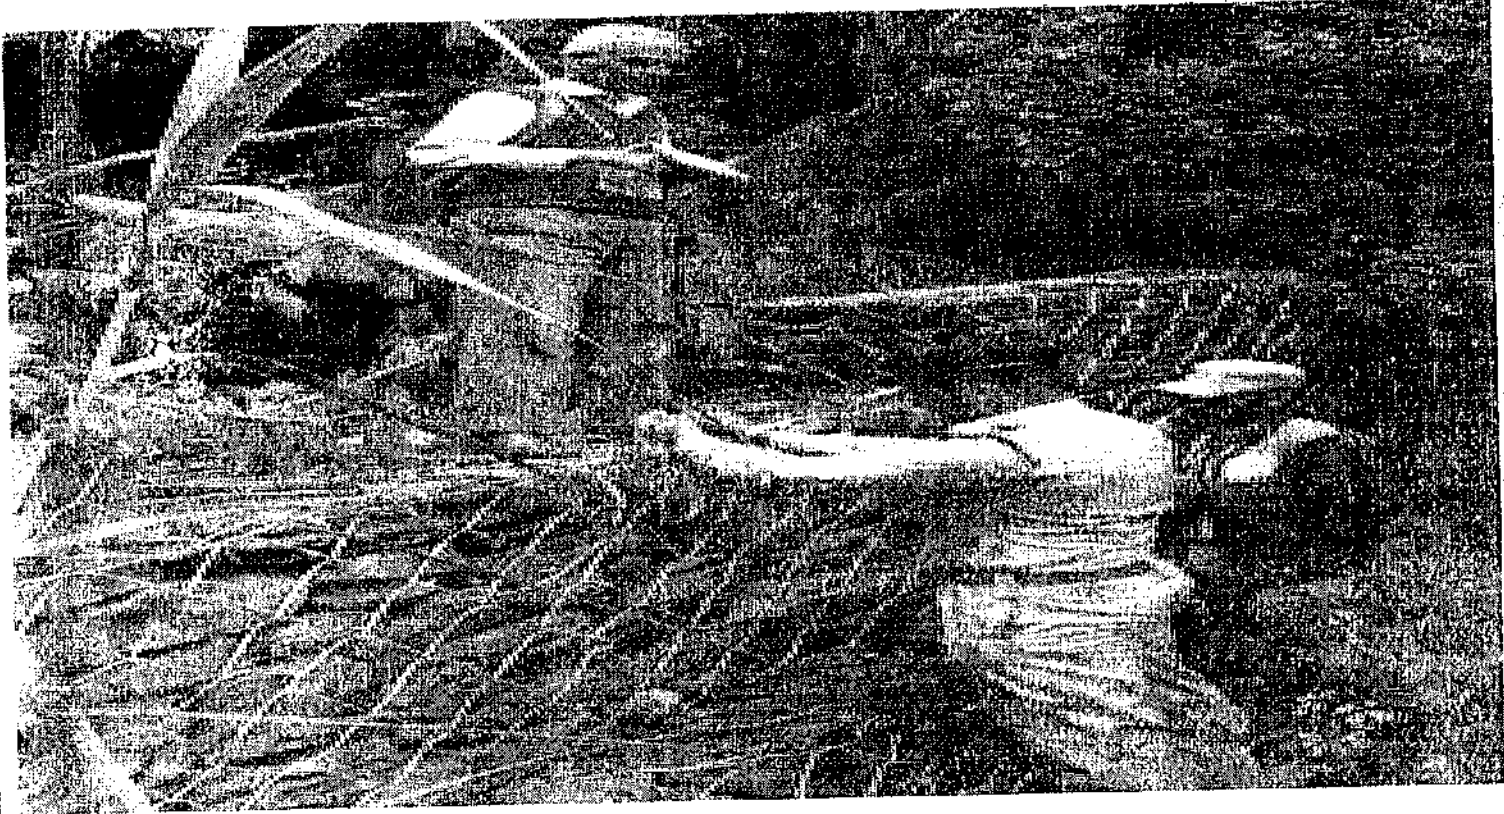
Circle /Division/Range/Block/Beat
14. Rampur/Rampur / Nankhari/Bai- Bahali

1. Soil conservation work register has not been prepared.
2. No plan has been made before treatment of nallah. 500 m nallah has been left untreated.
3. Numbering and year of execution of work has not been done on the check dams.
4. Stones used in soil conservation work have been charged on through rate but there is no mention of source of stone and registered mine from where stones have been obtained by the contractor.

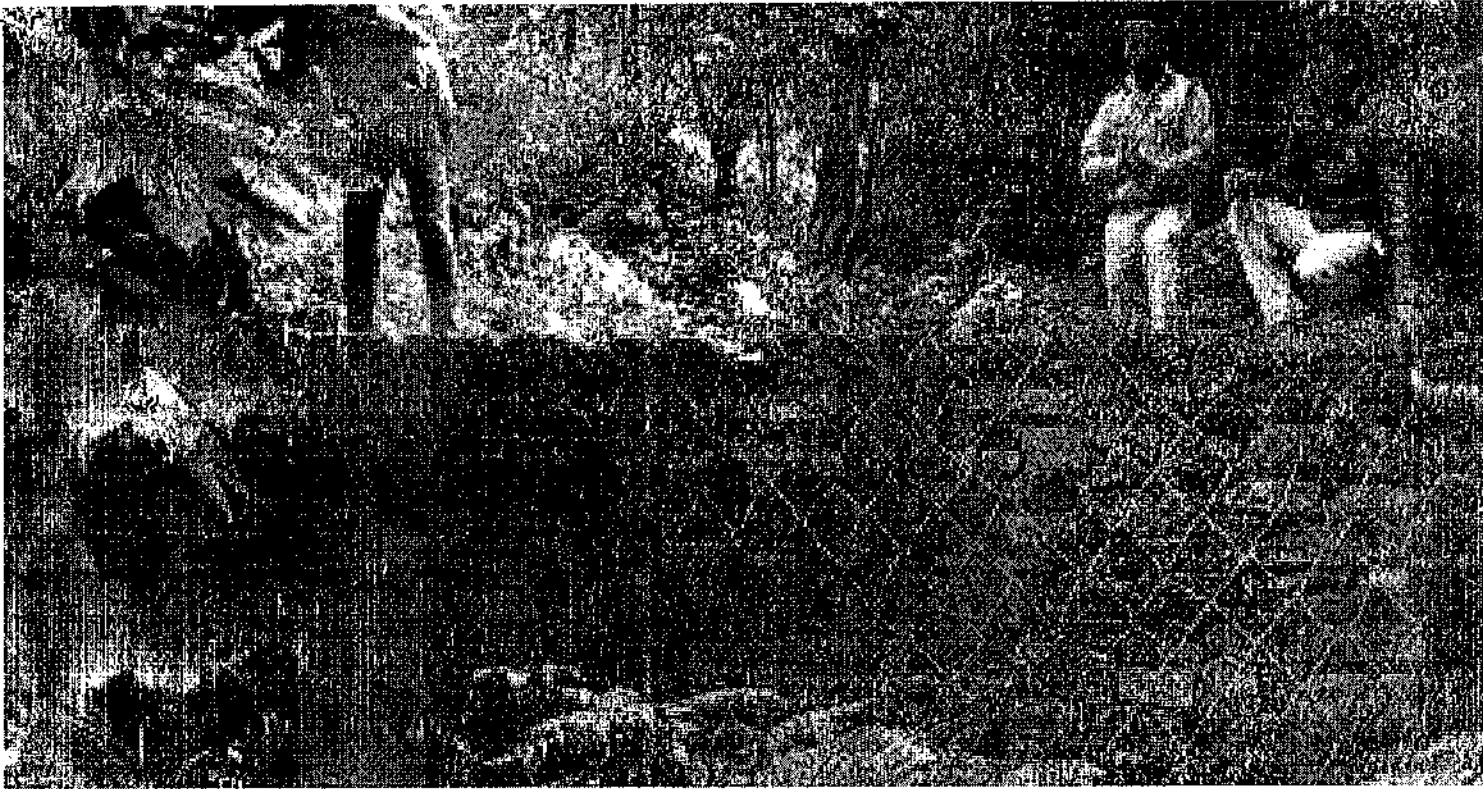
Circle /Division/Range/Block/Beat
15. Rampur/Rampur / Nankhari/Bai- Bahali

Quality of work:- Damaged = 3 Nos.(Appropriate)

1. No plan has been made before treatment of nallah. About 500 m nallah has been left untreated.
2. The less work $9.46m^2$ in crate wire amounting Rs. 5080/- has been found on spot.
3. More structures at appropriate location needed.
4. More structures at appropriate location needed

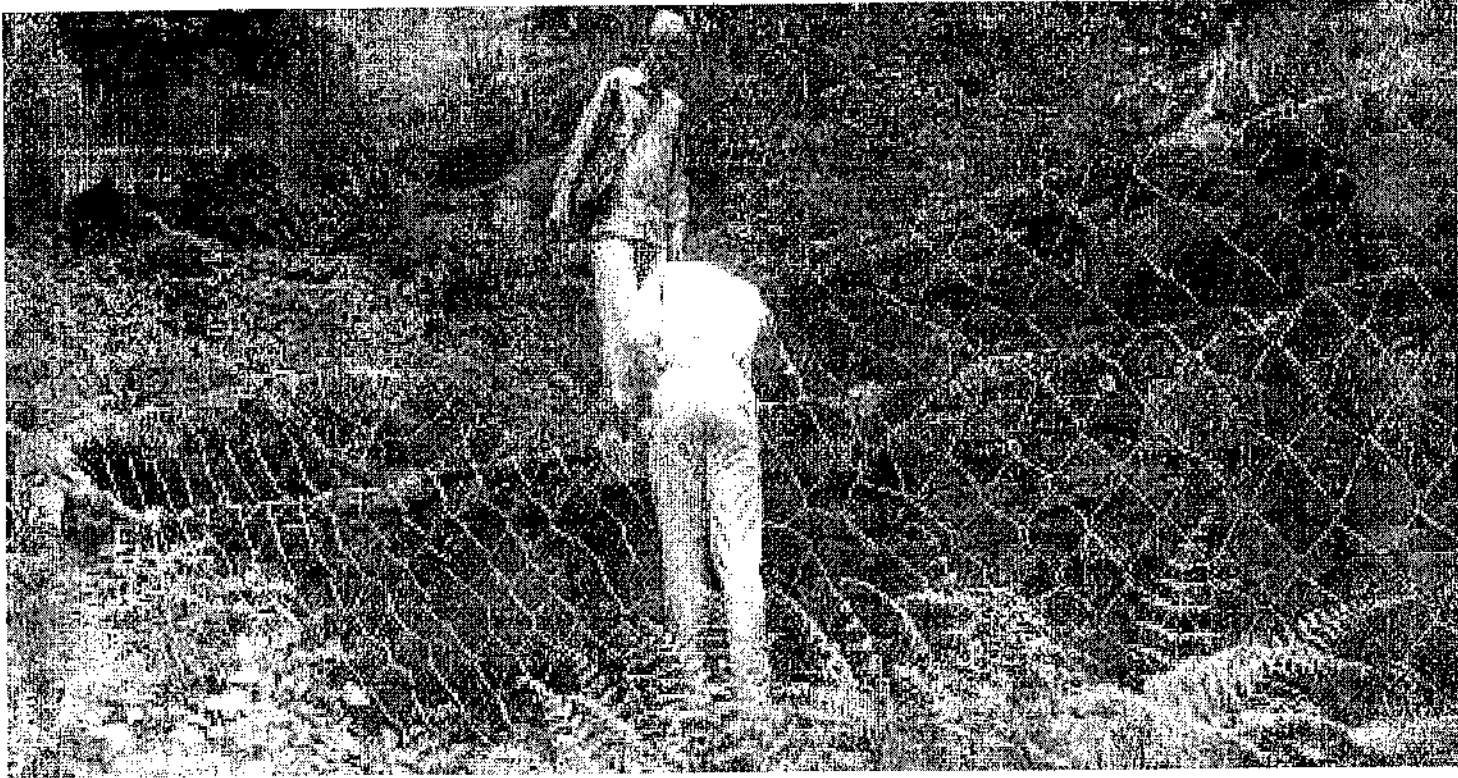
Circle /Division/Range/Block/Beat
16. Rampur/Rampur / Nankhari/Bai- Bahali

Quality of work: - Damaged (3Nos).

1. Soil conservation work register has not been prepared.
2. No plan has been made before treatment of nallah. 500 nallah has been left untreated.
3. Poor quality work by unskilled labour, that is why structures have been damaged.
4. Numbering and year of execution of work has not been done on the check dams.
5. 3 nos. check dams were found damaged on spot.
6. The selection of site for individual soil conservation structure is not appropriate.
7. The wing walls have not been properly constructed.

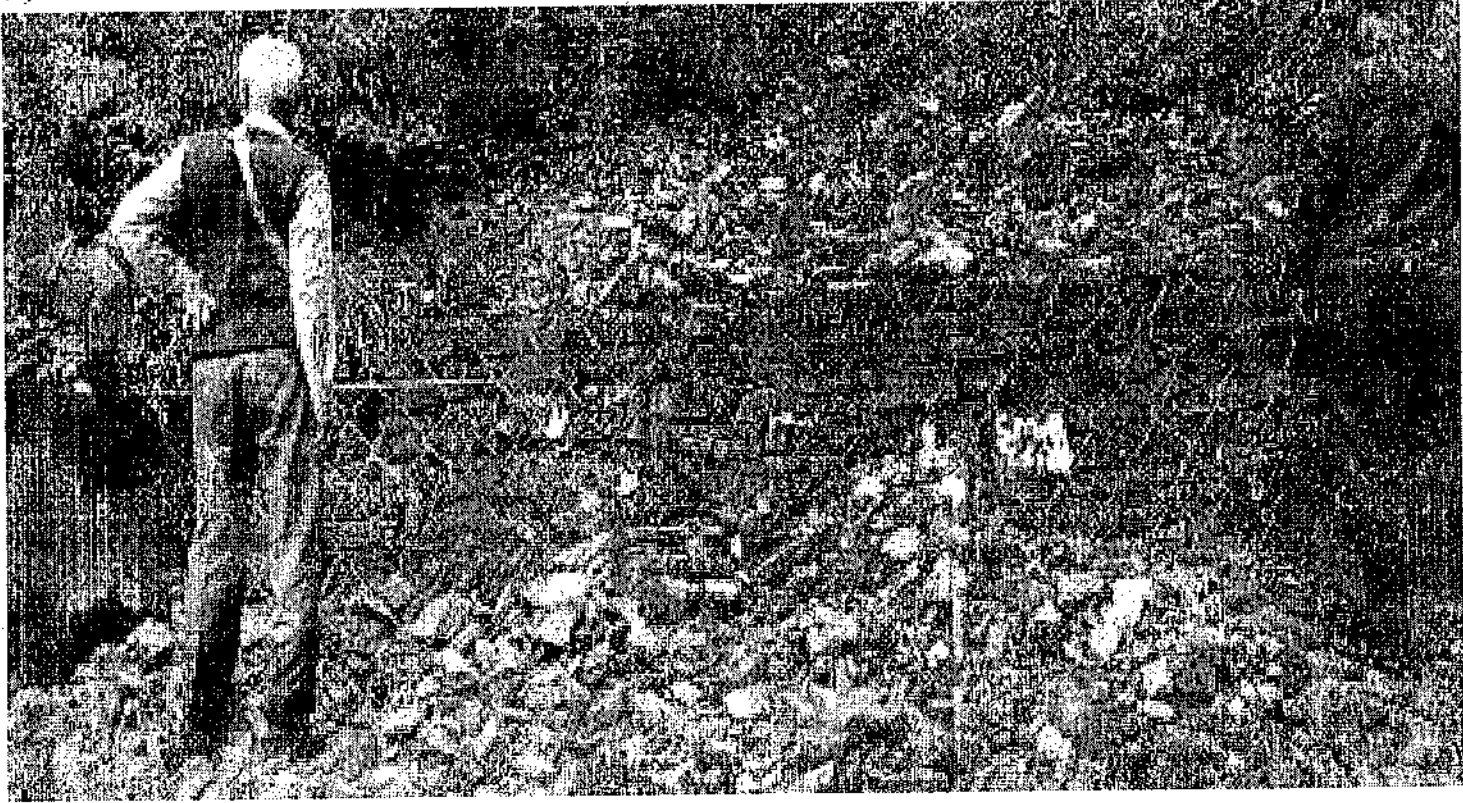
**Circle /Division/Range/Block/Beat
17. Rampur/Rampur / Nankhari/Kungal**

1. Soil conservation work register has not been prepared.
2. No plan has been made before treatment of nallah. 500 m nallah has been left untreated.
3. More Structures at appropriate location needed.
4. Stones used in soil conservation work have been charged on through rate but there is no mention of source of stone and registered mine from where stones have been obtained by the contractor.

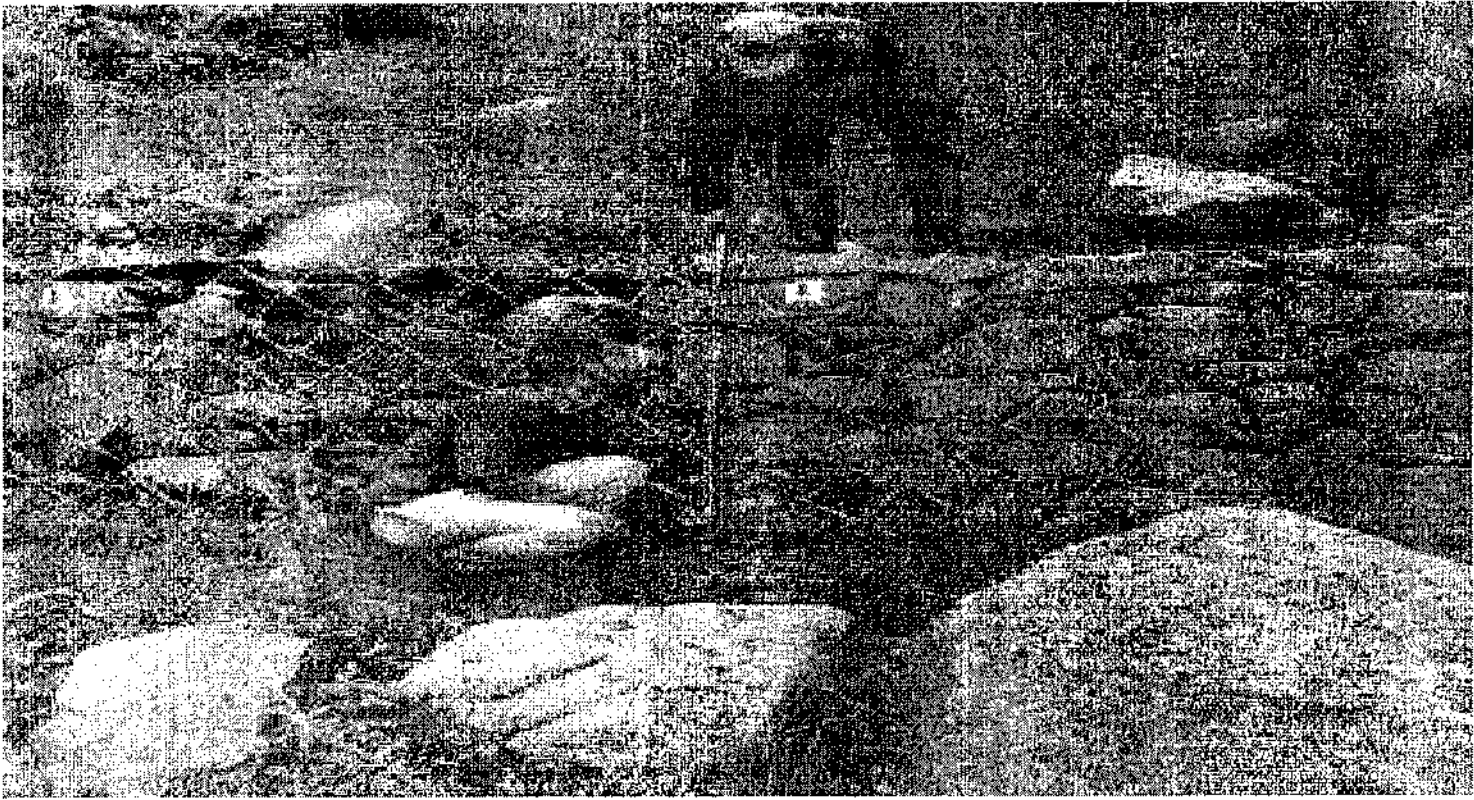
Circle /Division/Range/Block/Beat
18. Rampur/Rampur / Nankhari/Nankhari

1. Soil conservation work register has not been prepared.
2. No plan has been made before treatment of nallah.
3. More Structures at appropriate location needed.
4. Stones used in soil conservation work have been charged on through rate but there is no mention of source of stone and registered mine from where stones have been obtained by the contractor.
5. Numbering has not been done on check walls.

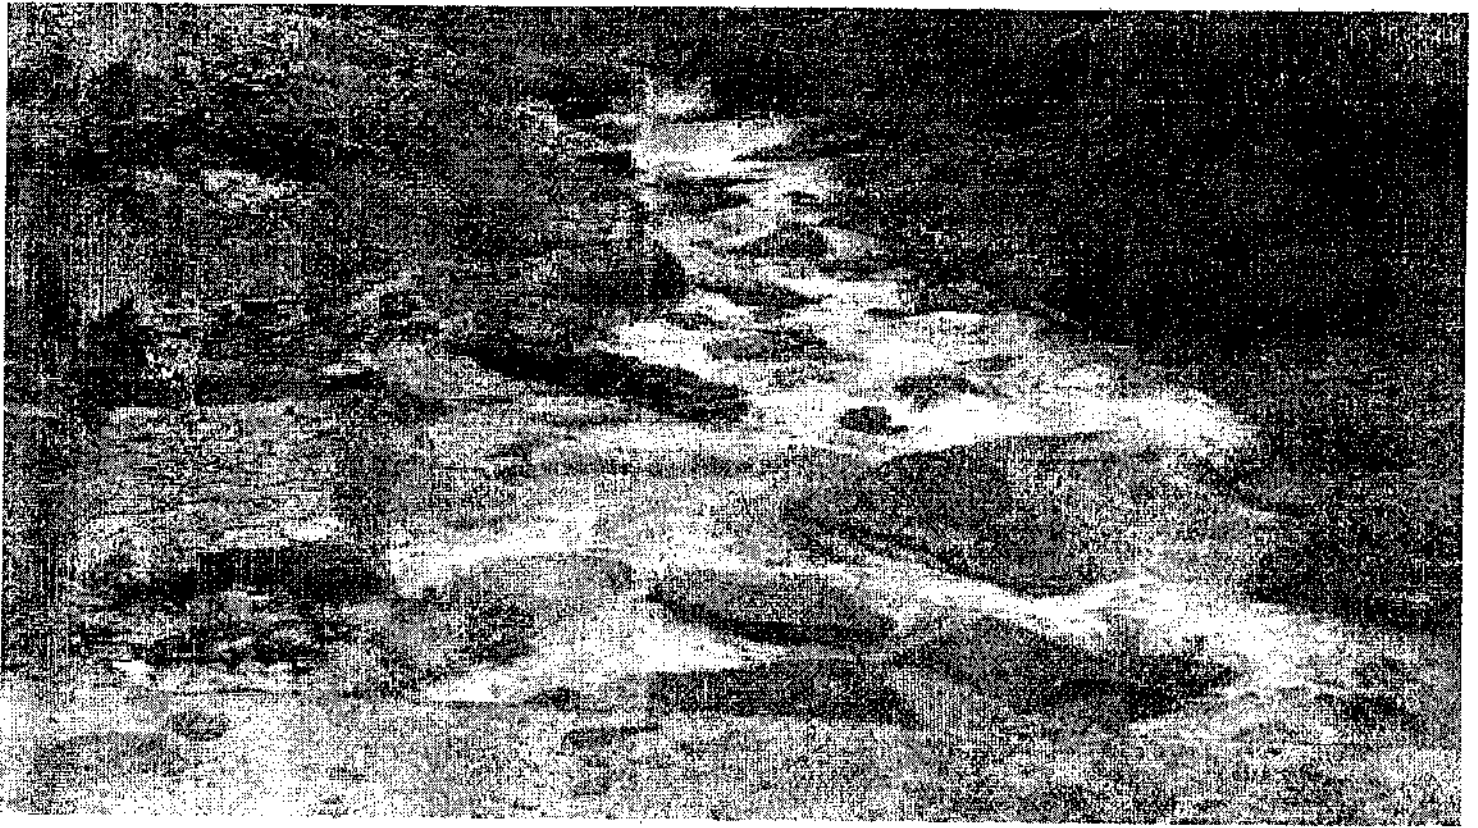
Circle /Division/Range/Block/Beat
19. Rampur/Rampur / Nankhari/Nankhari

Quality of work: - Damaged (5 Nos.)

1. Soil conservation work register has not been prepared.
2. No plan has been made before treatment of nallah.
3. More Structures at appropriate location needed.
4. Site selection for constructing check walls was not proper.
5. Stones used in soil conservation work have been charged on through rate but there is no mention of source of stone and registered mine from where stones have been obtained by the contactor.

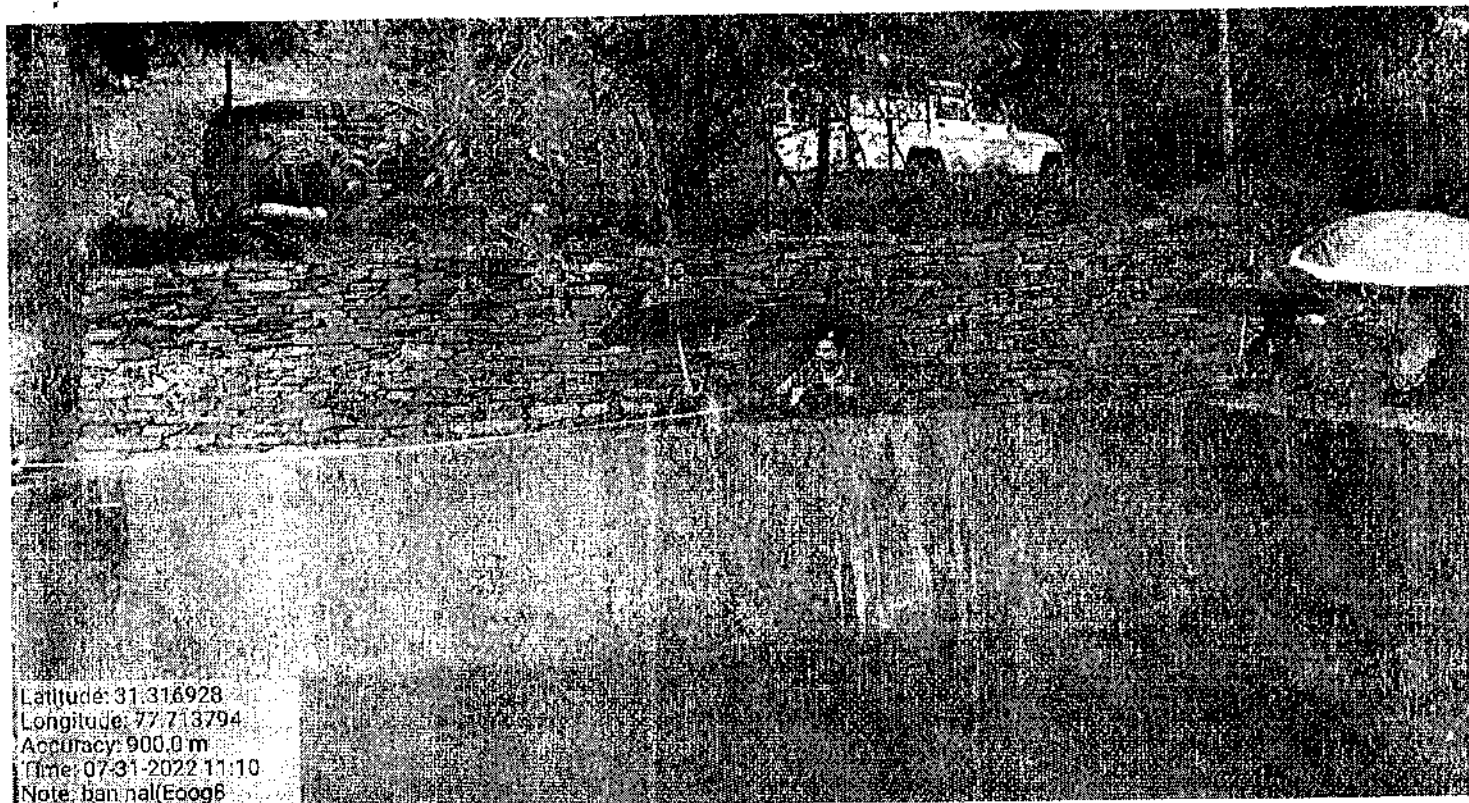
1. Stones used in soil conservation work have been charged on through rate but there is no mention of source of stone and registered mine from where stones have been obtained by the contractor.
2. There was no complete plan at the site.
3. No bio-engineering works carried out
4. Year of execution has not been done on Water Tank.

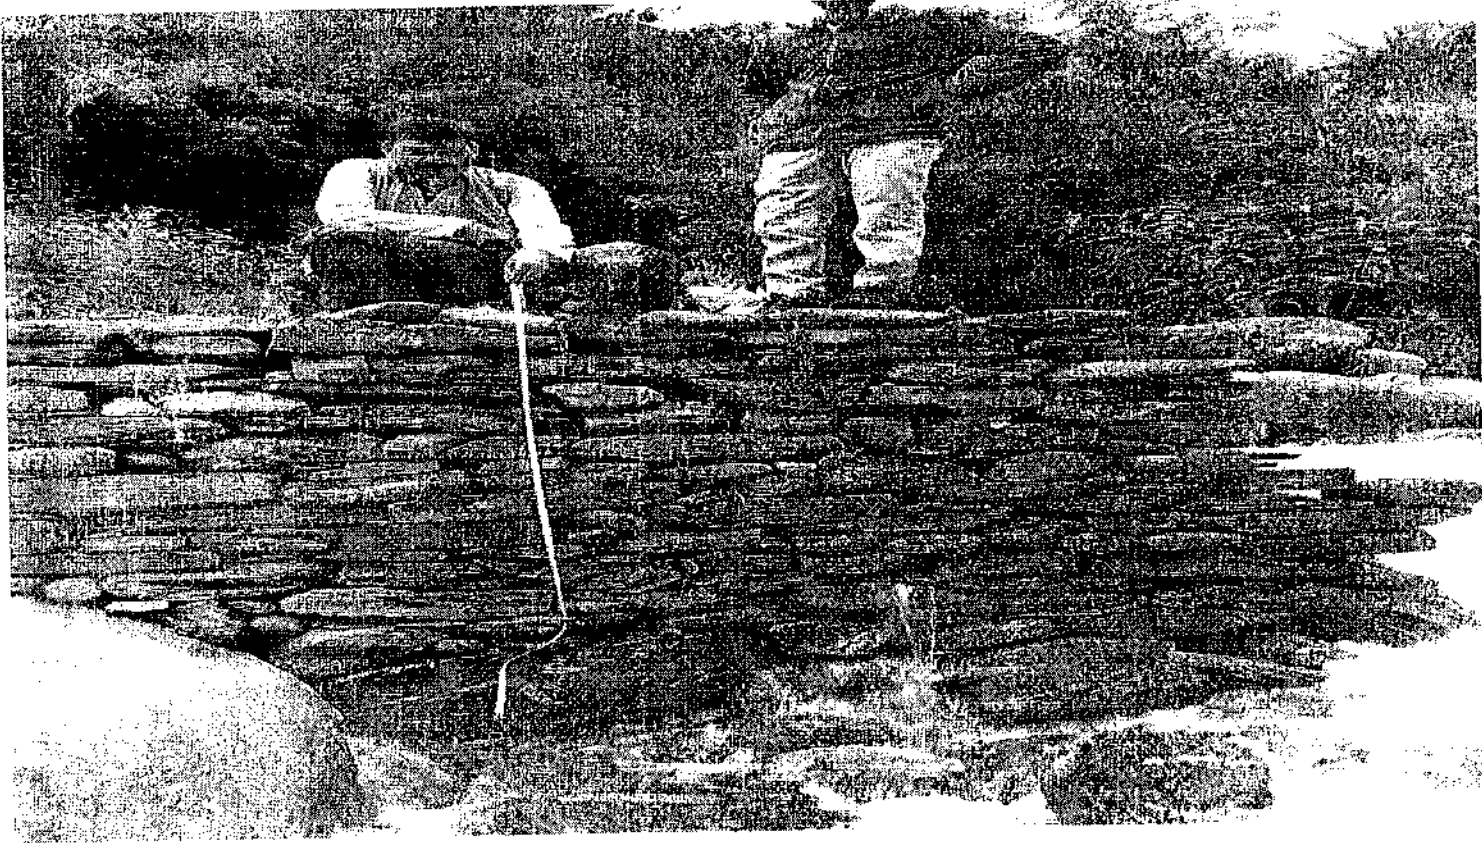
**Circle /Division/Range/Block/Beat
21. Rampur/Rampur / Bahli/Jarashi**

1. There was no complete plan made before treatment the Nallah.
2. Stones used in soil conservation work have been charged on through rate but there is no mention of source of stone and register mine from where stones have been obtained by the contractor.
3. Will walls of Check Dam have not been properly done.
4. Actual measurement of work has not been entered in MB whereas estimate has been copied in the MB.
5. Soil Conservation concept was not followed.
6. No bio-engineering works carried out.

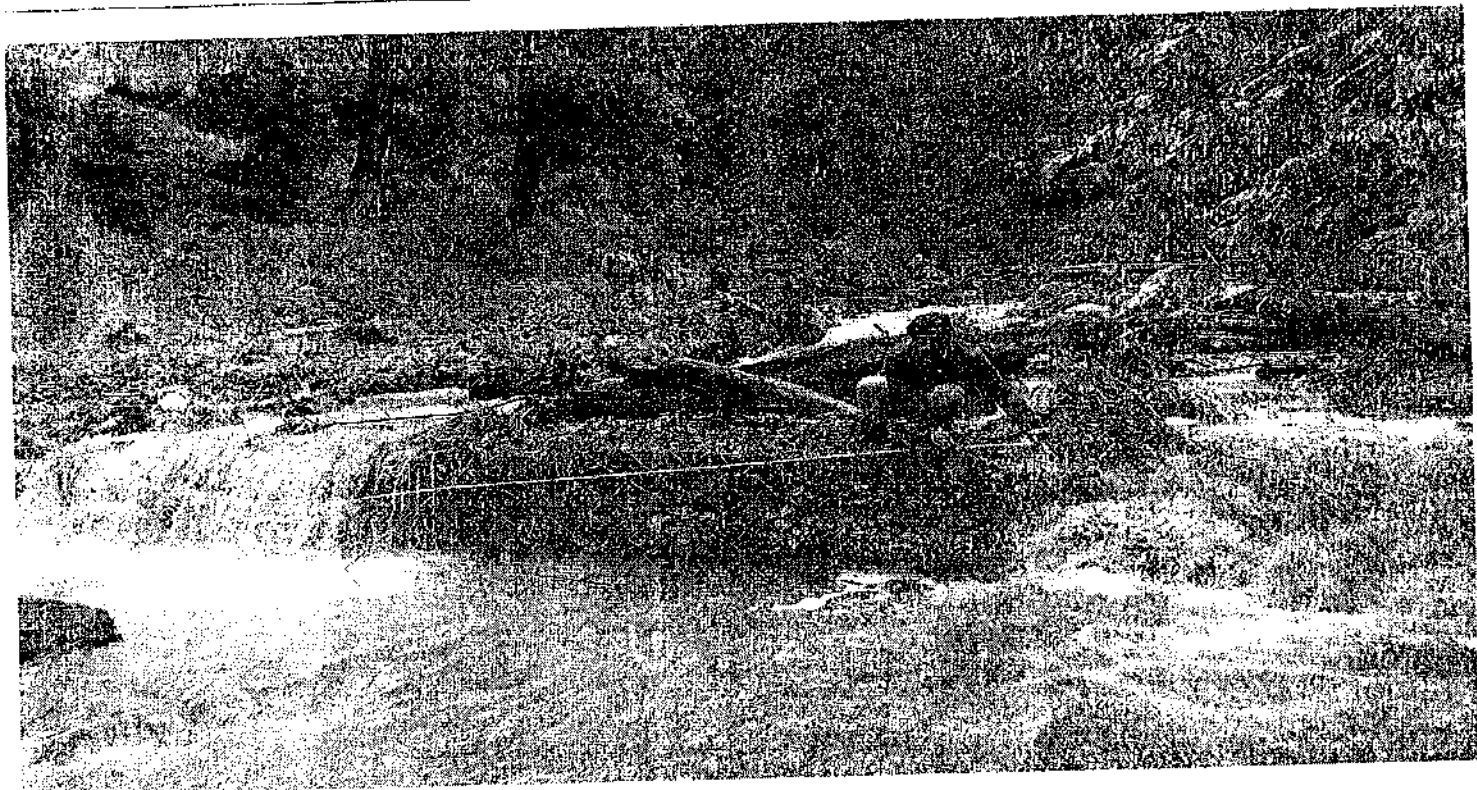
**Circle /Division/Range/Block/Beat
23. Rampur/Rampur / Bahli/Jarashi**

Name of Work/Location: - Crate wire Check Walls = 34Nos. at Jarashi Nallah.
 Total Expenditure:-Rs. 5,94,136/-
 Date of Inspection:- 02.08.2022.
 Quality of work:-Damaged (Appropriate).

1. Damaged wire Crate check walls were reported by RFO Bahli to DFO Rampur, Rampur Forest Division vide letter no. 206/BH, dated 25.07.2022 & photocopy attached.
2. Due to heavy rain and floods in Jarashi Nalla, except one, all wire Crate check walls were found totally damaged on spot.
3. There was no complete plan made before treatment the Nallah.
