# Third Party Monitoring and Evaluation of CAMPA Plantations and Other Activities

for the period  
2018-2019

Submitted to  
Kerala Forests & Wildlife Department (CAMPA)

**ICFRE - INSTITUTE OF FOREST GENETICS AND TREE BREEDING**

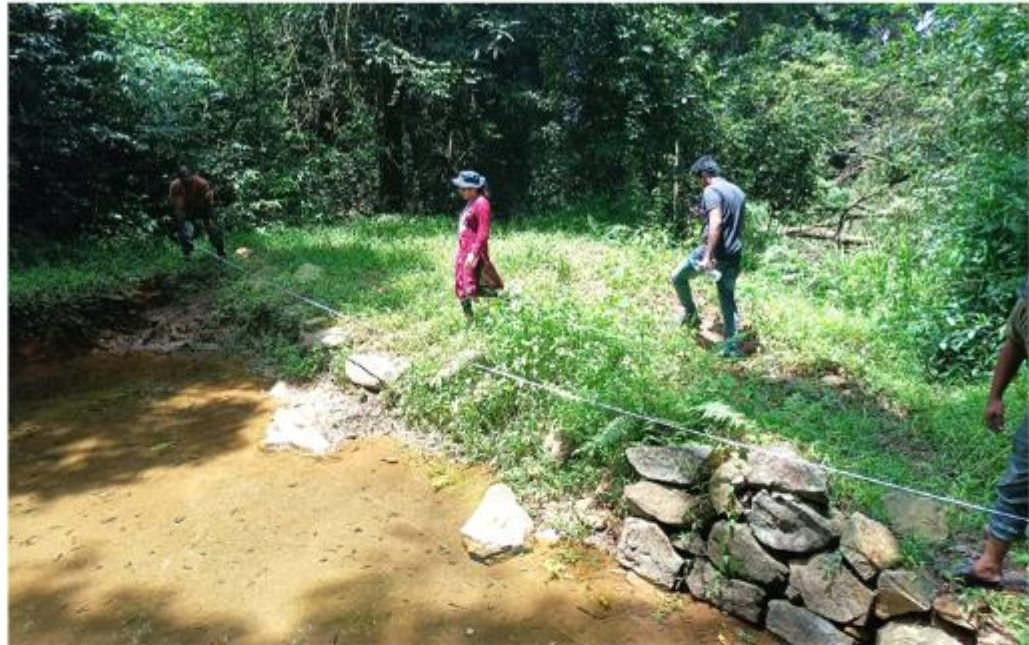
Water pond at Pulpally

The activity carried out during 2018-2019 was physically verified, records perused and found correct. Ponds were able to deliver only 70% of the envisaged impacts. The structure needs periodical desiltation.

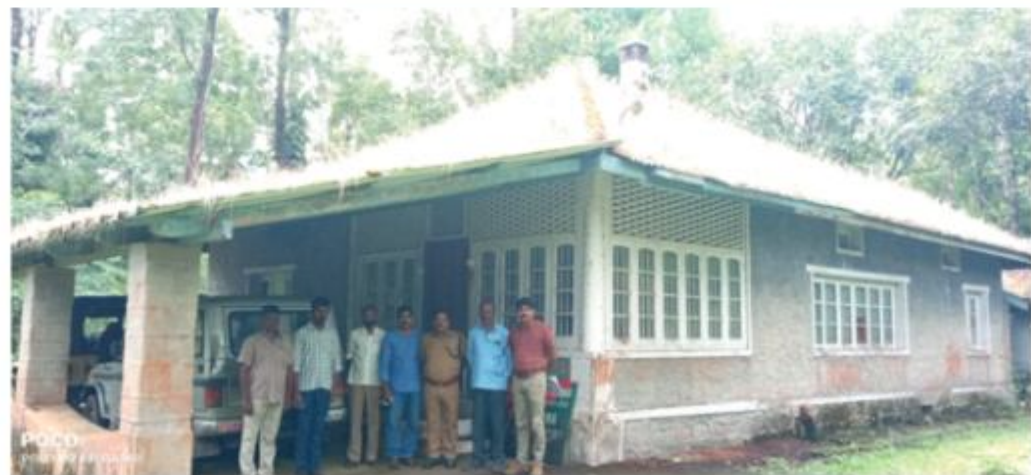
Sooryapara Camp shed at Nelliyampathy

Sites	GPS Location	Year of Construction	Observations of the Evaluation Team
Nelliyampathy, Nemmara	N10°30'14.7" E76°41'27.94"	Constructed during British period	Maintenance of doors/windows/ kitchen utensils/ furnitures are required.

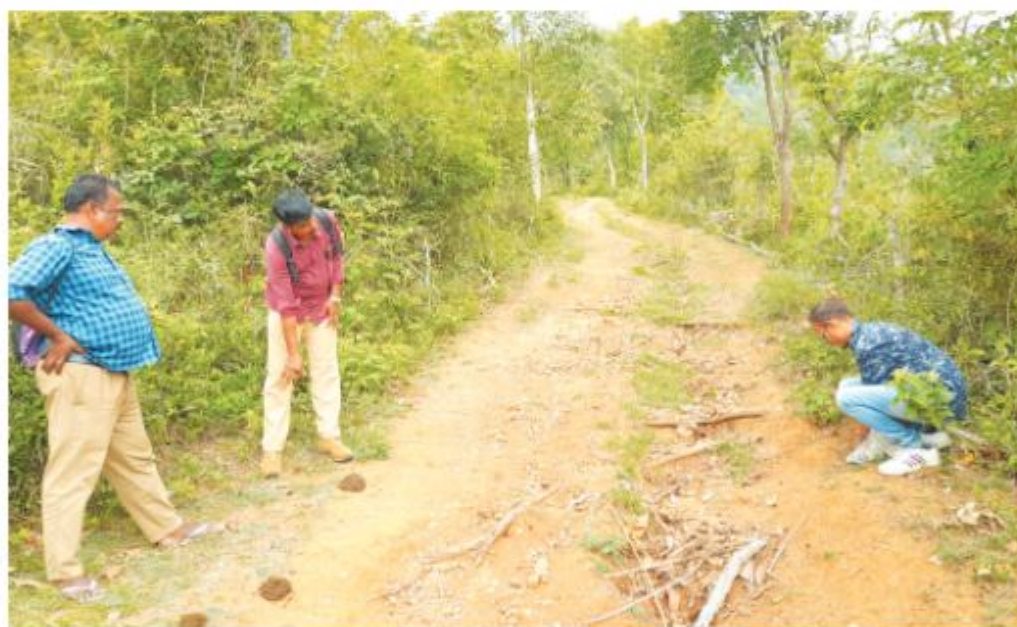
Trek path at Pudur

Sites	GPS Location	Year of Activity	Dimensions	Observations of the Evaluation Team
Pudur, Attappady	N11°09'56.06" E76°37'26.41"	2018-19	Length - 8 km Width - 3.2m	The works were evaluated for physical existence and quality.
Koottupuzha Elival, Olavakkode	N11°25'0.72" E76°13'28.01"	2019-20	Length - 3km	The works were evaluated for the physical existence and for the quality.

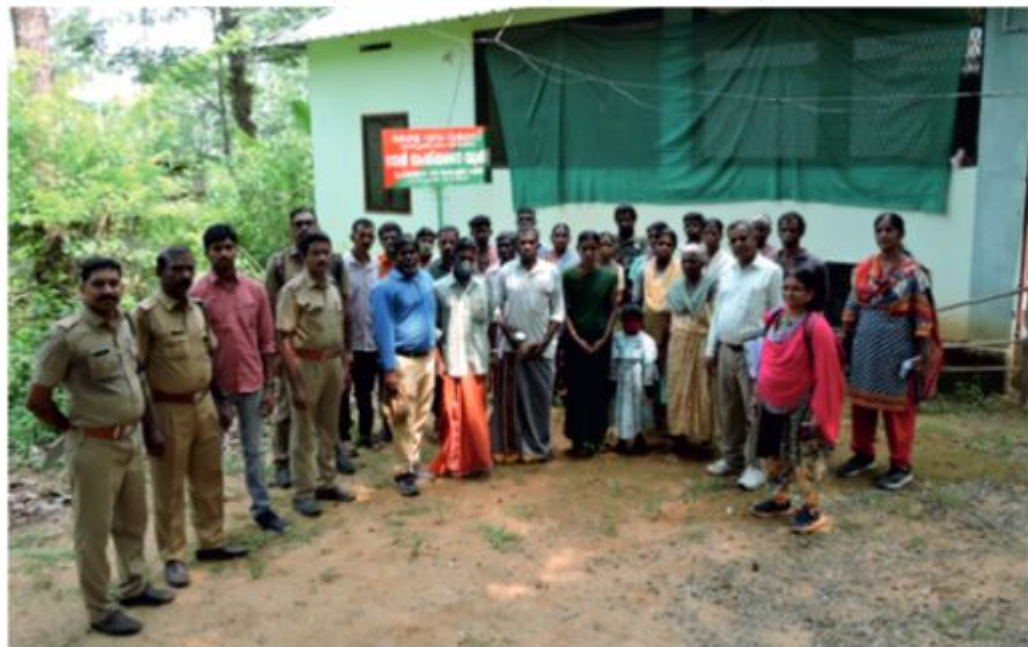
The inspection team with members of VSS at camp shed

Sites	GPS Location	Dimensions (m <sup>2</sup> )	Observations of the Evaluation Team
Vazhachal Division, Poringalkuthu	N10°20'46.82" E76°38'18.76"	95	Maintenance like patch work in the floor of the existing camp shed.
Malayattoor Division Thundathil & Kuttampuzha ranges	N10°11'46.1" E76°48'1.5" N10°09'24.1" E76°50'23.2"72.	16	Maintenance like tress work over the existing camp shed.

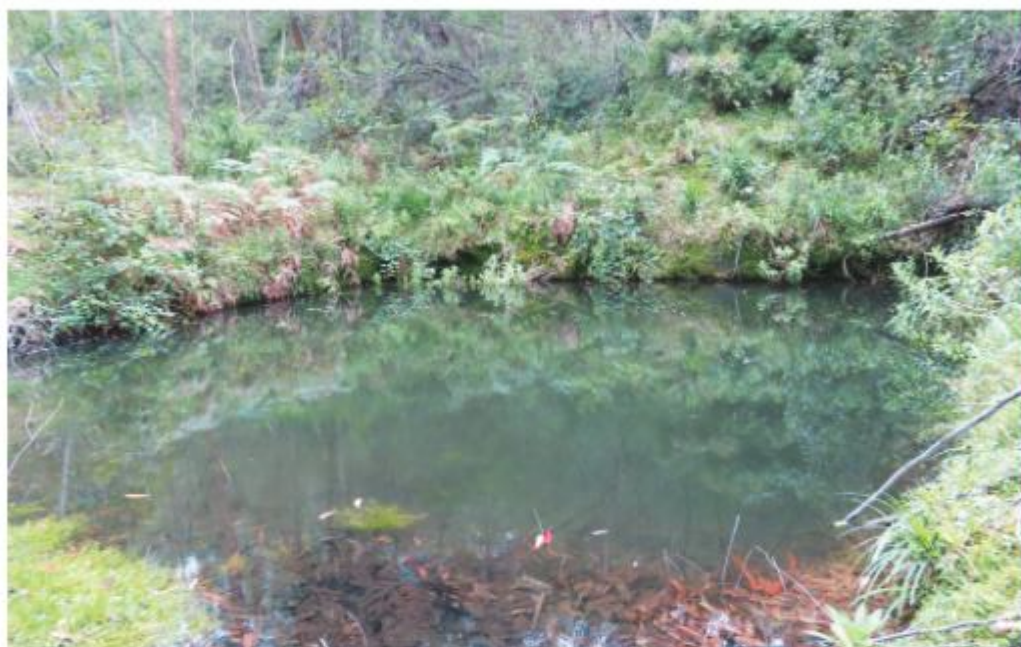
Muthuvanpara Water Hole

4.	Muthuvanpara Water Hole: Munnar, Munnar	Water is stored at full level for the wildlife.	This water hole is mostly used to provide water for animals. Well maintained.	9	High

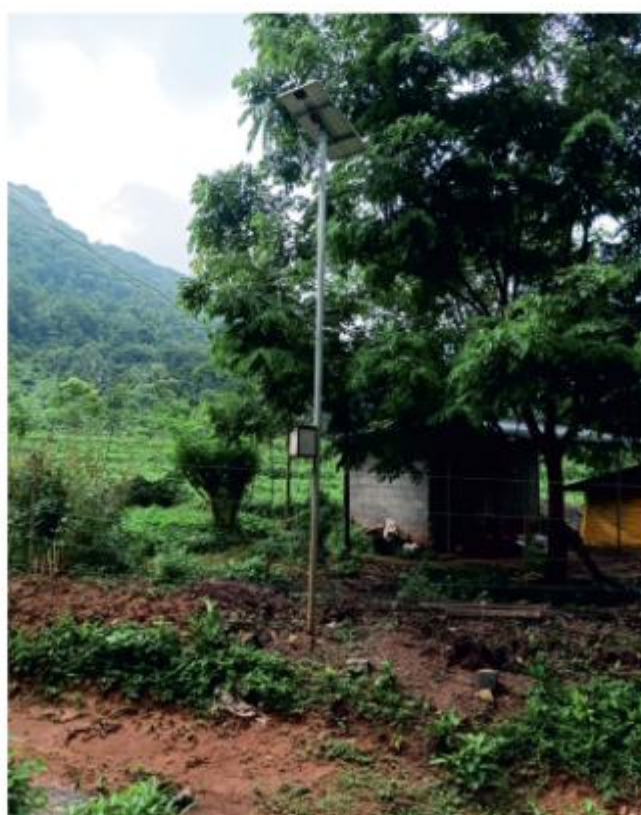
Solar Fencing at Silent Valley

Location	Year	Observations of the Evaluation Team
Chiranada, Sulthan bathery	2018-19	The solar fencing was physically verified. There are minor damages to the fences. Records were verified and found correct.
Podhuvapadam, Silent Valley	2018-19	The solar fencing was physically verified. There are minor damages to the fences. Records were verified and found correct.
Ambalapara, Silent valley	2018-19	The solar fencing was physically verified. There are minor damages to the fences. Records were verified and found correct.

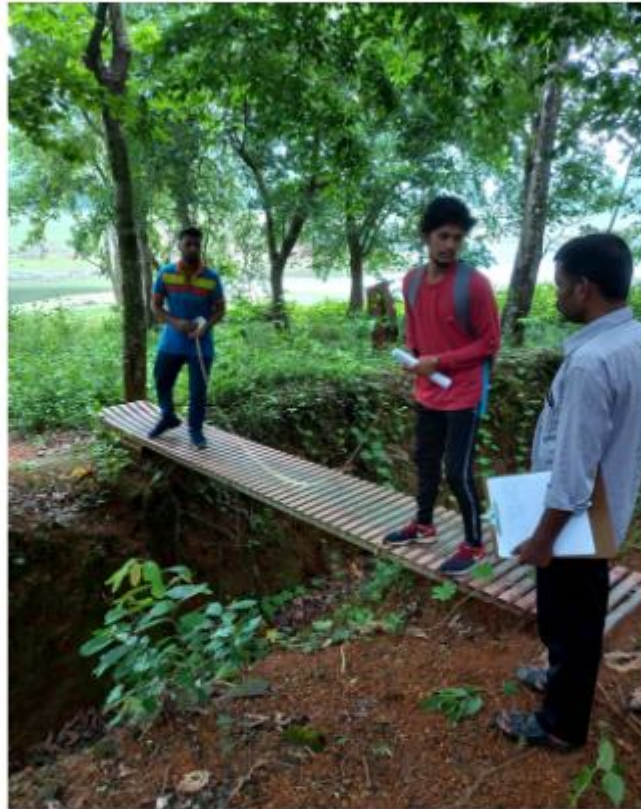
Elephant Proof Trench at Chimmony

Location	Year	Observations of the Evaluation Team
Anaporu, Chimmony (maintenance)	2018-19	The trenches were physically verified for its maintenance

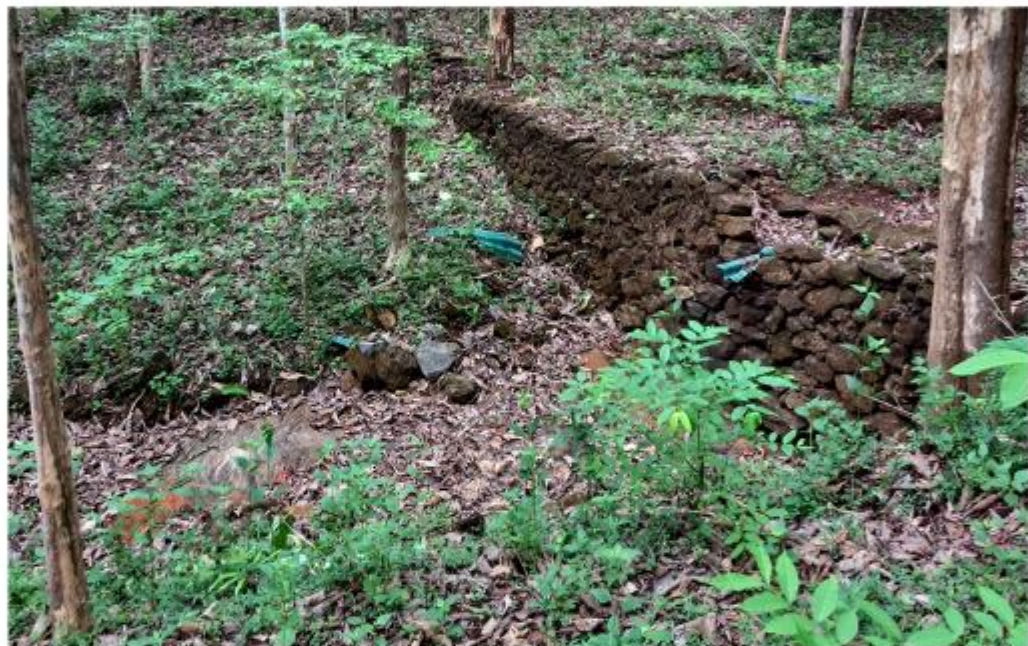
Gully plugging at Chimony

Sites	GPS Location	Dimensions (m)	Observations of the Evaluation Team
Gully Plugging/ Peechi/ Chimony/ Pazhavalachal	N10°26'45.48" E76°27'5.67"	10.2x1x1.7	Inspected gullies. They displayed damages which the staff mentioned was due to washing away in floods.
Gully Plugging/ Peechi/ Chimmony/ Vellani	N10°59'80.43" E76°35'36.7"	2.9x5.5x0.9 1.5x6.3x0.6 1.5x6x2	Inspected gullies. They displayed damages which the staff mentioned was due to washing away in floods.

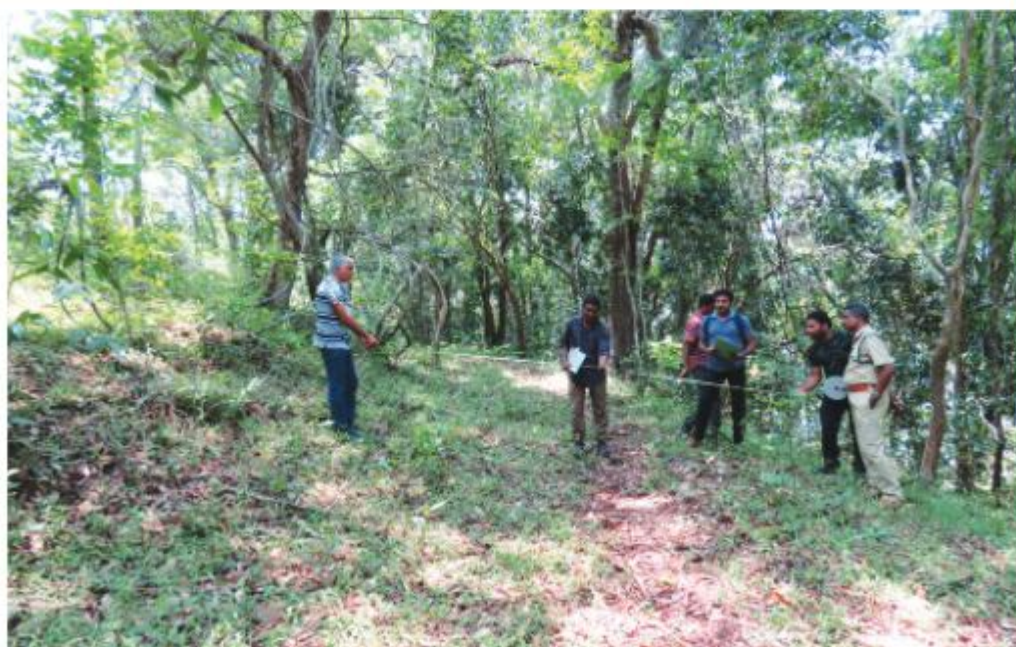
Inspecting the Trek Path at Kanamudiyoram

Type of Assets/ Division / Range	Type of current use/ Observations	Score (Low, $\leq 3$ , Medium $>3$ to $<7$ , High 7 to 10	Assessment on the quality of the asset - Low, Medium or High
Trek Path/ Kanamudiyoram/ Vallakkadavu/ PTR(East)	The trek path needs maintenance	5	Medium

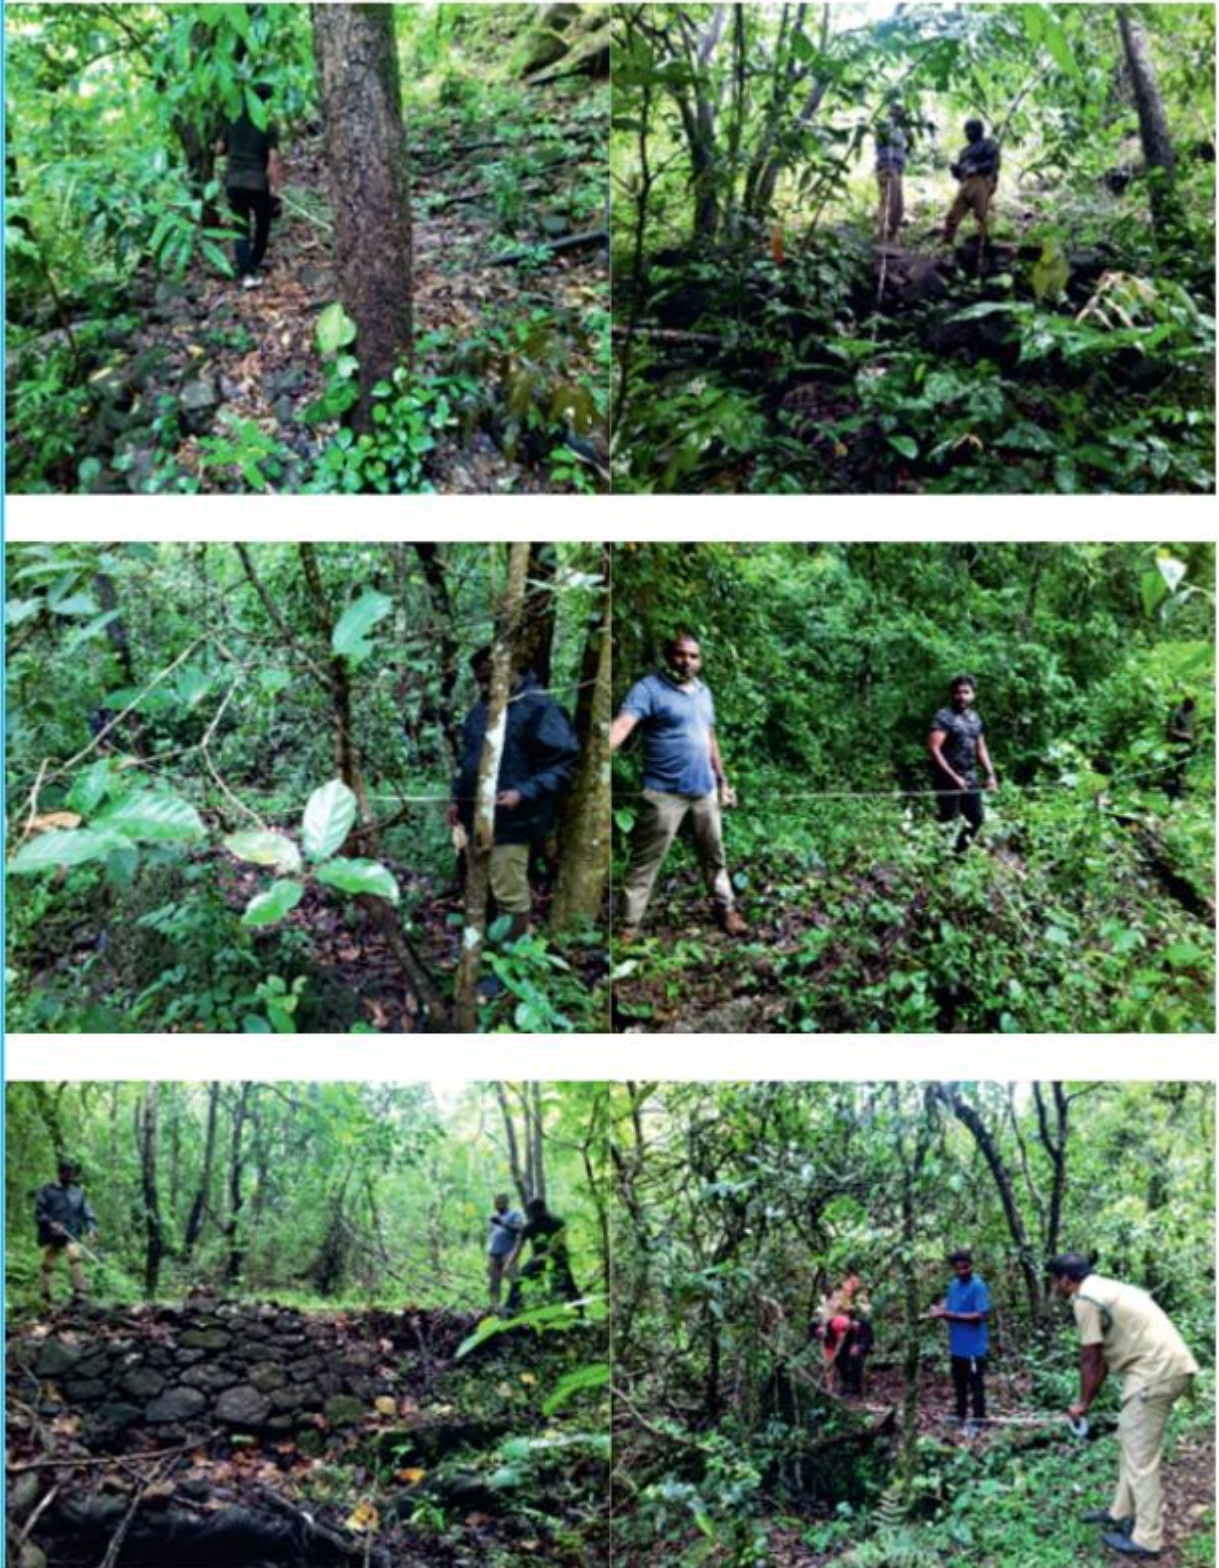
Gullies from different locations in Idukki WLS

Under this activity, 46 gullies were created. These activities were verified physically and dimensions were measured and confirmed with the vouchers/records. Most gullies have been weakened due to floods.

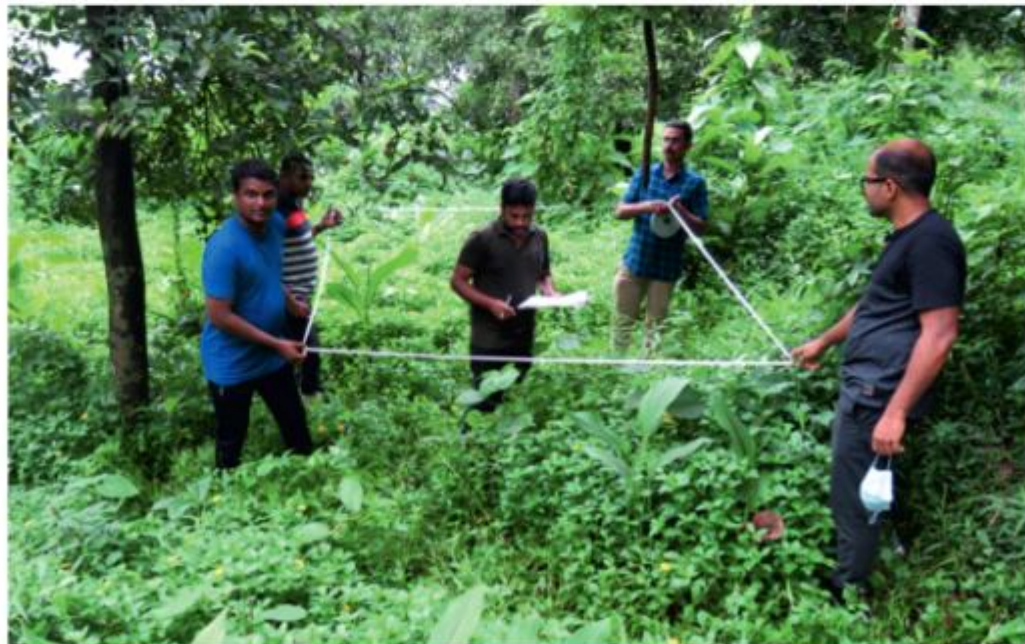
Weed Density Assessment in Vallakkadavu

Id/No.	Size/density of infestation in the worked plot	Size/density of infestation in the unworked plot	% change (+/-)	Observations of the Evaluation Team Present status - Intact/Worn out/effectiveness of work
Aquaticbody-TBS	Infestation- Nil All the exotic aquatic weeds were removed. Recorded only lotus and lilies only.The algal cover is low.	28000/ High level of aquatic exotic weeds occupied in the lake. Algal cover is higher in this plot.	100	The removal of aquatic exotic weeds increased the native species of lotus and lilies and also reduced the floating algal growth. Weed eradication has been very effective in maintaining the aquatic lake.
Vallakkadavu 2 mile	Ecorestoration of Eucalyptus plantation through gridling of bark and removal of <i>Lantana camara</i> and <i>Eupatorium perfoliatum</i> found very effectitve and hardly few lantana was observed.	The plot is heavily infested.	85	same kind of treatment may be implemented in other areas which will help in protecting the grasslands and improve the wildlife habitats. This treatment protects the grassland which is the main food source for wild elephants and buffalos.

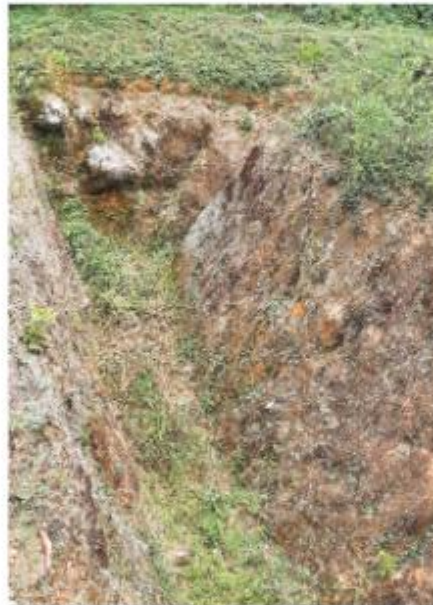
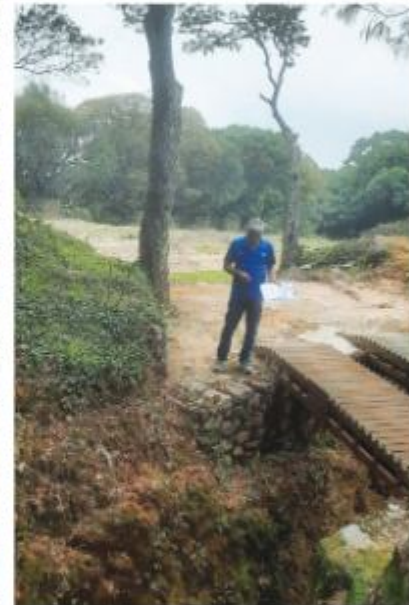
Trenches around campsheds

Sl. No.	Type of Assets / Division / Range	Type of current use/ Observations	Impact	Score (Low, <3, Medium >3 to<7, High 7 to 10)	Assessment on the quality of the asset - Low, Medium or High
			last 5 years, no fire incidence was recorded. Every year the firelines are maintained.		
3	Trench/ Eravangalar/ Periyar/ PTR(East)	Maintained well.	The trench is used to protect the camp shed from wildlife	9	High

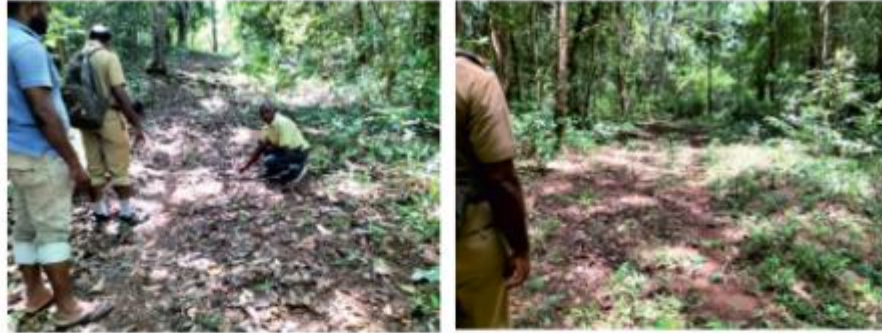
Inspection of trek path

Location / Range / Division	GPS Location	Year of Activity	Dimensions (m)	Remarks
Pallivasal to Dharbhakkulam	N08° 54' 34.1" E77° 10' 58.2	2018-19	8100 x 2 M	book details verified and found correct.
Vattavila to Pazhaunniattinpuram	N08° 35' 23.1" E77° 7' 13.2	2018-19	2000 x 1.5	Mbook details verified and found correct.
Utharamkayam to Pulizhunthalchuna	N08° 32'44" E77° 13'4"	2018-19	2000 x 1.5	Since Mbook details were not provided, the year of work execution could not be verified.
Bhoodhaka – Ayanimoodappu	N08° 33'33" E77° 17'20"	2018-19	4900 x 2.5	Since Mbook details were not provided, the year of work execution could not be verified.

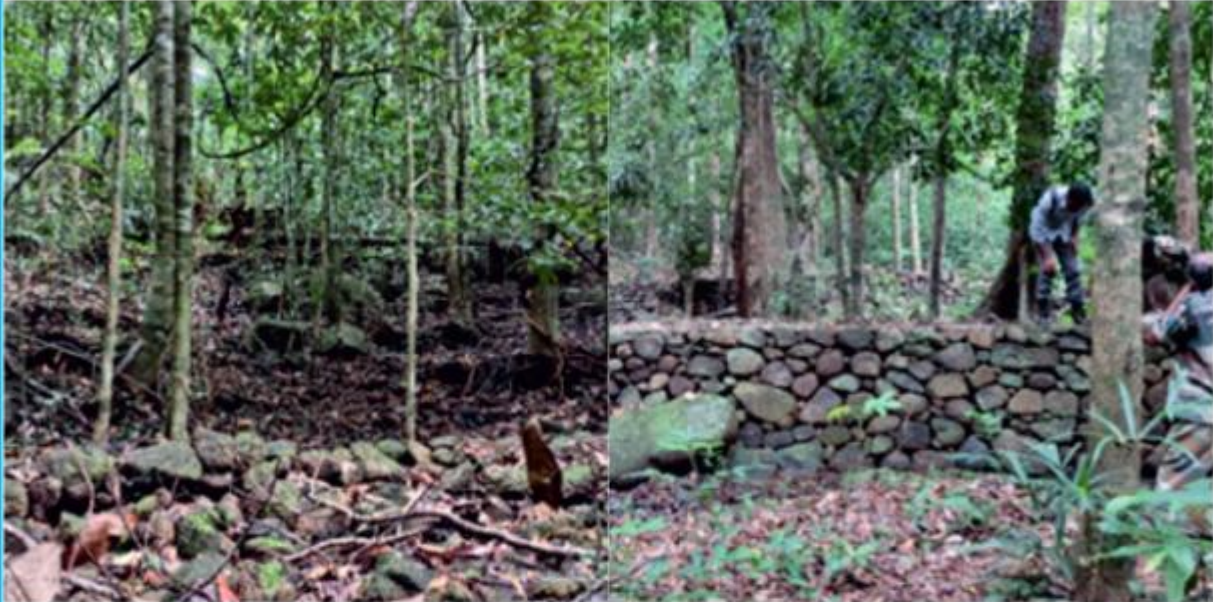
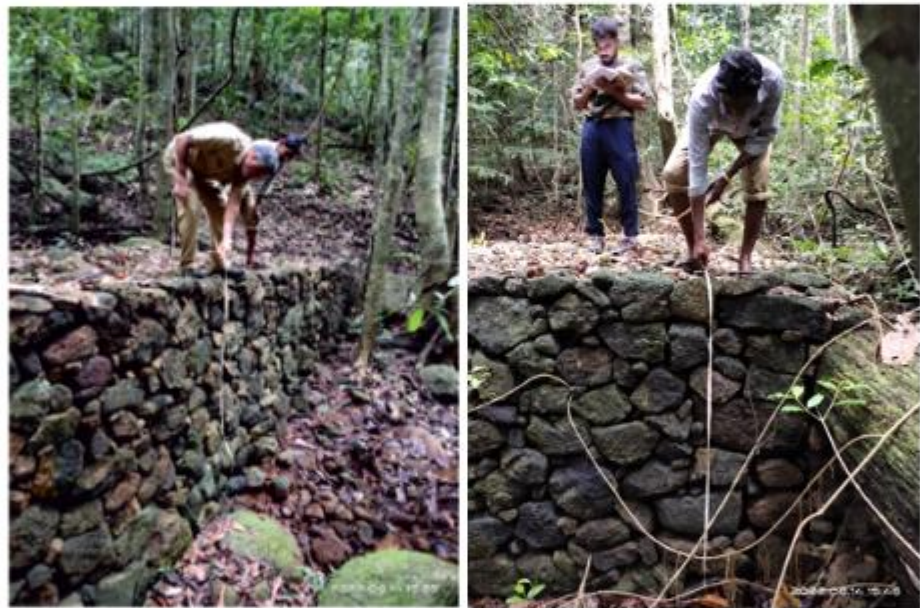
Gully plugging in four different locations

4.	Thumbithode/ Athirumala/ Peppara wildlife sanctuary/ Thiruvanatha puram	There are 8 gullies at three different locations of which three were verified. All the gullies are intact.	The moisture content in surrounding areas is improved as is evident from the vegetation.	9	High
