# **Third Party Monitoring and Evaluation of Compensatory Afforestation Fund Management and Planning Authority (CAMPA) Activities of Andhra Pradesh Forest Department (APFD) During 2017-18**

**INSTITUTE OF WOOD SCIENCE AND TECHNOLOGY**  
**(Indian Council of Forestry Research & Education)**  
18<sup>th</sup> Cross, Malleswaram, Bangalore – 560 003  
October 2025

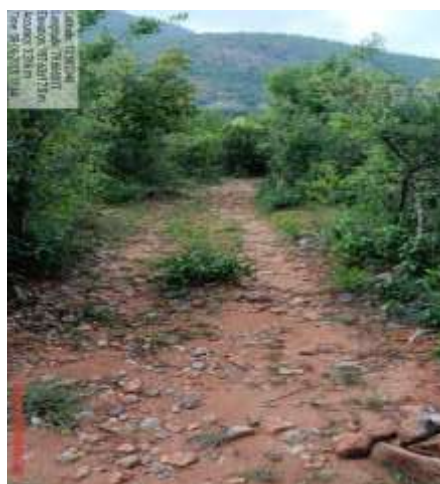
**Creation of fire lines in Anjur beat**

A fire line created and maintained across the natural forest of Anjur beat in Sri Kalahasti range was monitored and evaluated against the specifications recorded in the measurement book and actual field conditions. The fire line measured 6 meters in width and 2,000 running meters in length, with no deviations observed. The fire line was clearly visible along the inspection path, though moderate weed growth was noted, indicating that it has been maintained across the natural forest area. However, regular maintenance is required to ensure continued effectiveness.

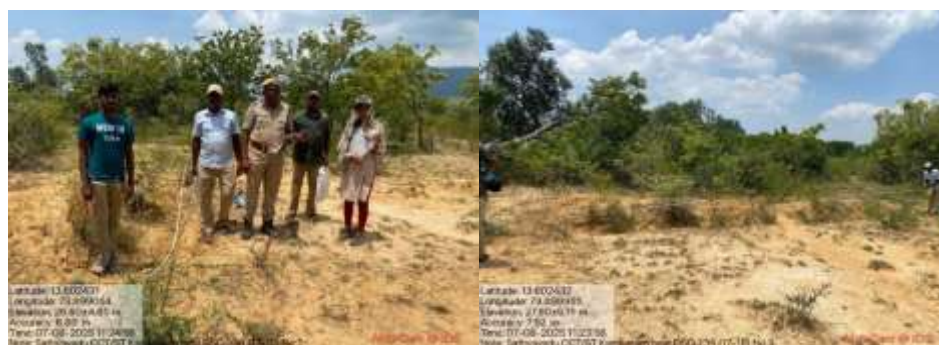
### CCTs Kambakam beat of Sathyvedu range

A total of 347 Continuous Contour Trenches (CCTs) excavated in Kambakam RF of Kambakam beat and section of Sathyvedu range were monitored and evaluated against the specifications recorded in the measurement book and the actual field measurements. The standard dimensions of the trenches are: length: 10 m, Width: 0.50 m, depth: 0.50 m and total volume: 867.5 cum. The field measurements were found to be in full agreement with the recorded specifications, indicating no deviations from the approved design. A minor reduction in depth was observed in some of the lower-lying trenches, primarily due to the accumulation of silt and stony gravels. However, this reduction is negligible and does not significantly impact the overall functionality of the structures.

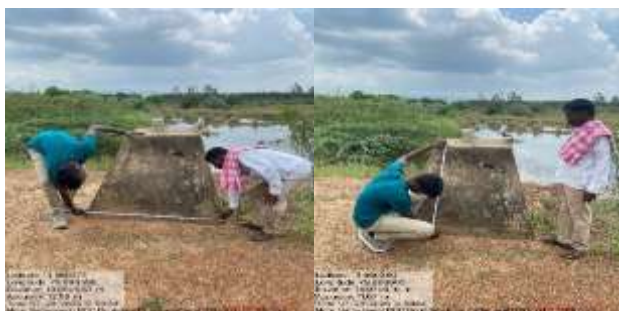
RCC pillars in Kadur &amp; Pandur beat

The boundary pillars were structurally sound and well-maintained, providing clear demarcation of reserve forests from adjoining revenue lands, with only minor maintenance needs noted.

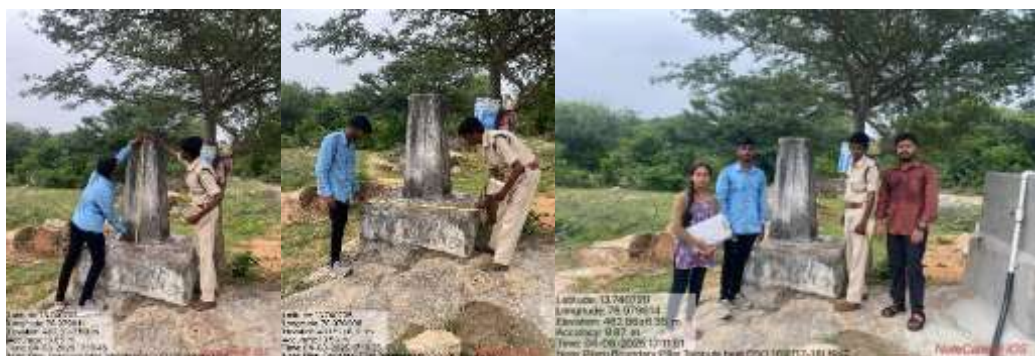
RCC boundary pillars in Talapula beat

Constructed 48 boundary pillars in Talapula beat of Piler section and range were monitored and evaluated against the specifications recorded in the measurement book and the actual field measurements. The above-ground dimensions of the RCC boundary pillars were: height – 1.22 m, top width – 0.33 m, and bottom width – 0.45 m. The field measurements were consistent with the records in the measurement book, with no major deviations observed. Boundary pillars are intact and covering the boundary, demarcating the boundary of reserve forest and revenue land in Talapula beat and were in good condition.

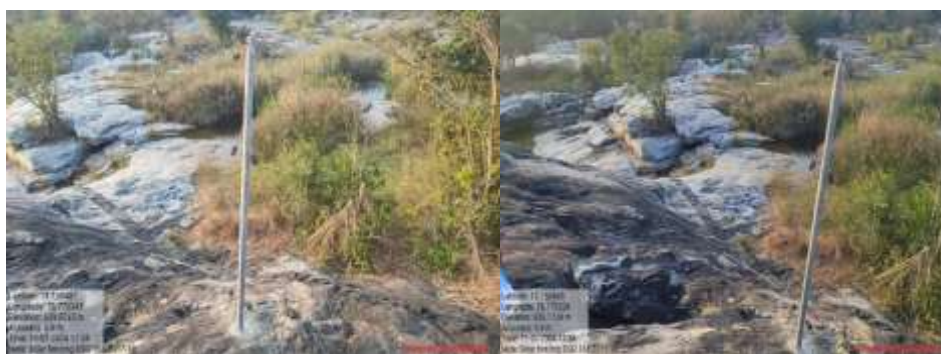
**Solar fence line in Kaluvapalle beat of Palamaner range**

The new solar fence line in Kaluvapalle beat of Palamaner range was monitored and evaluated against the specifications recorded in the measurement book and the actual field conditions. As per the measurement book, the fence was constructed with a width of 2 m and a length of 500 m. However, field measurement could not be carried out as the entire fence was washed away due to increased water discharge from the dam during the monsoon season.

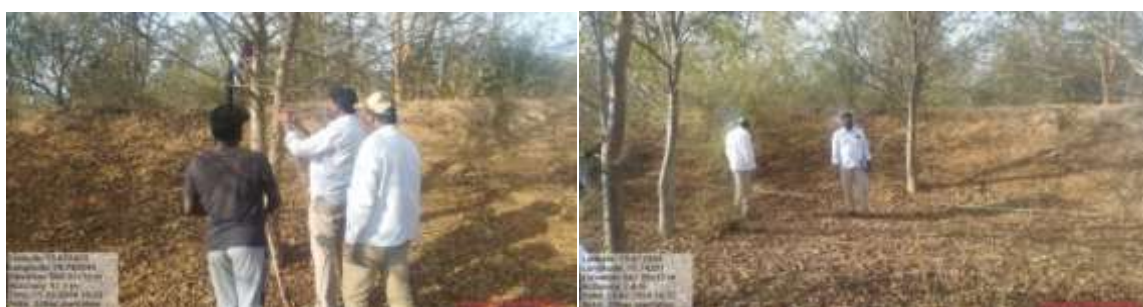
**Earthen bunds in 20 Ha NTSH (SMM) plantation, Guttapalem RF of Madanapalle range**

Earthen bunds in 20 Ha NTSH (SMM) Plantation, compartment no. 48, Guttapalem RF of Kalikiri beat of Valmikipuram section, Madanapalle range was monitored and evaluated against the specifications recorded in the measurement book and the actual field conditions. Earthen bund dimensions as per measurement book are; length: 6 m, width: 1.5 m, depth: 0.2 m and volume: 1575 cum. The field measurements were found to be consistent with the entries in the measurement book, confirming that the construction was carried out as per approved specifications, with no deviations observed. Volume has been reduced because of siltation however, the bunds are well-maintained and have a good water-holding capacity. These structures are designed to retain water, prevent flooding, aid in the collection of surface runoff, increase water infiltration, and prevent soil erosion.

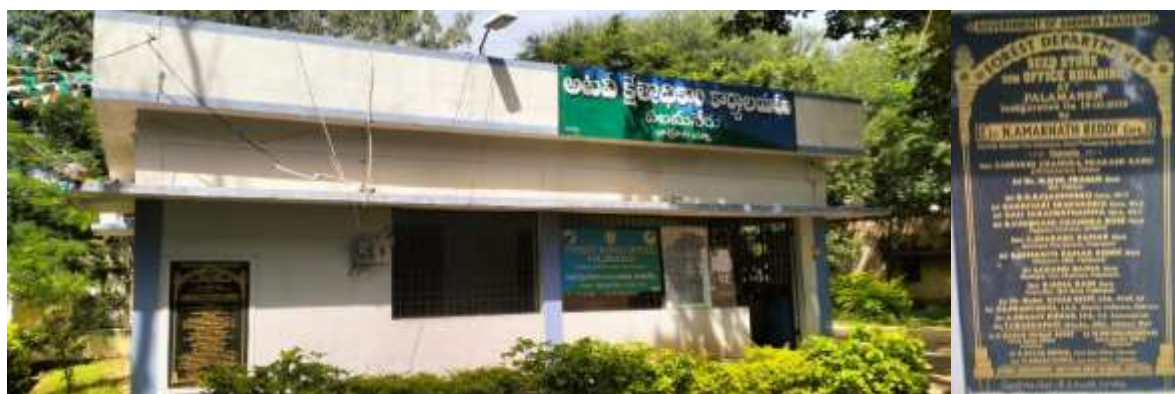
**Seeds & Store Room at Field Nursery in Range Office compound at Palamaner Range**

Construction of Seeds & Store Room at Field Nursery in Range Office compound at Palamaner Range was monitored and evaluated against the specifications recorded in the measurement book and the actual field conditions. Dimensions as per measurement book are; length: 9.30 m, width: 8.45 m, height: 4.5 m. The field measurements were found to be consistent with the entries in the measurement book, confirming that the construction was carried out as per approved specifications, with no deviations observed. Building is in good condition and presently the room is used as range forest office.

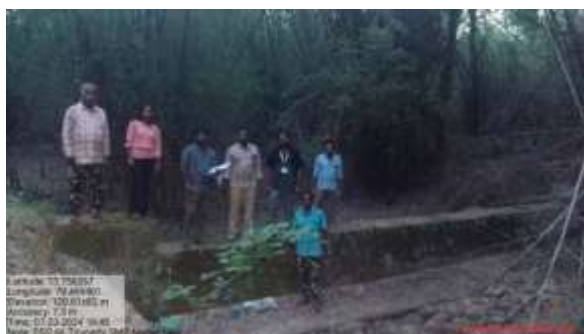
**Napier beat, Tirupati range**

restore and enhance the water storage capacity. Seepage has been observed from both the body wall and the core wall, indicating potential structural concerns. Immediate repair work is recommended for the body wall and apron to prevent further deterioration

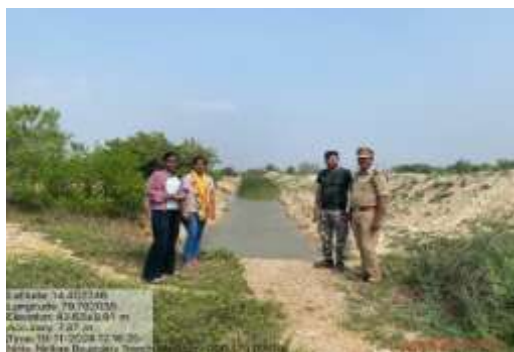
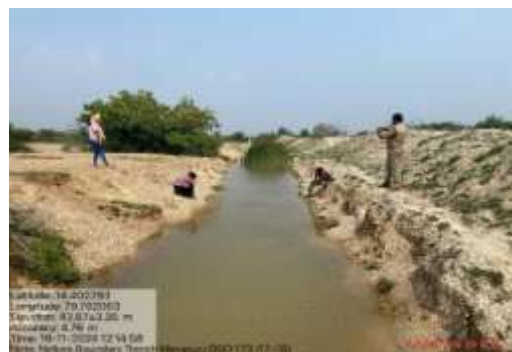
**Boundary trench in Toderu RF of Marupuru beat**

A boundary trench was created at Marupuru beat under the CAMPA-NPV forest fire management scheme and monitored against recorded specifications. While the length (2 km) and depth (2 m) matched the records but width has been reduced by 0.5 m from the specified 1.5 m. The trench is well maintained and effectively serves as a barrier to prevent animal entry, unauthorized access and to control moisture intake in the Toderu Reserve Forest. Regular desiltation is recommended to maintain its effectiveness.

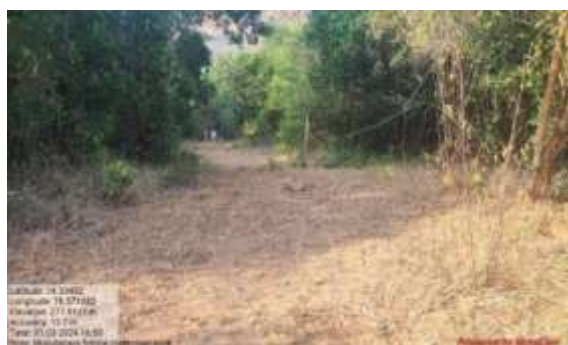
**Idupulapaya beat, Vempalli**

A fire line was created and maintained in Idupulapaya beat and Chintarajupalli section under CAMPA-NPV (forest fire management) scheme was monitored and evaluated against the specifications recorded in the measurement book and the actual field measurements. The dimensions of new fire lines are width – 3 m and length – 2000 rmt. The field measurements matched those in the measurement book, indicating no deviations. Both fire lines is found to be well maintained and clearly visible as it is established along the baseline near the Red Sander Park. No weed growth was observed indicating effective maintenance across the natural forest.

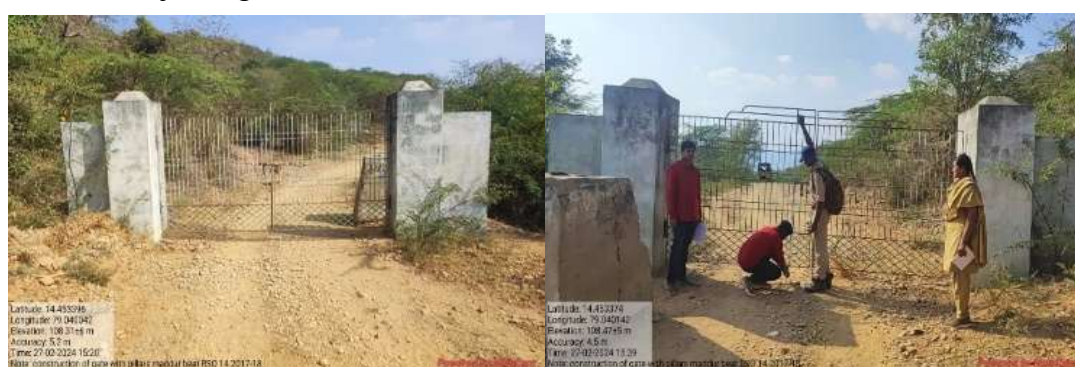
**Gate with pillars at Maddur beat of Sidhout range**

The field verification confirmed that measurements matched those in the measurement book, indicating no deviations. The gate with pillars was found to be well maintained and intact, serving as a clearly defined entry and exit point along the boundary separating the Reserve Forest from the adjoining revenue land.

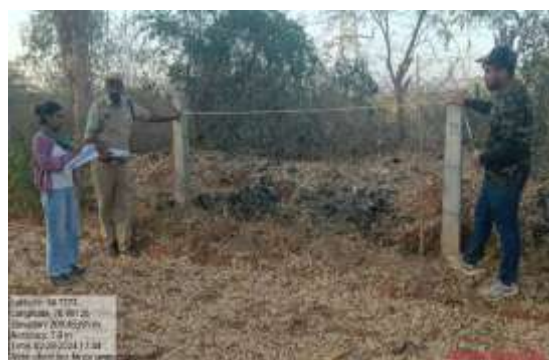
A chain-link fence with 95 RCC poles, constructed under the CAMPA-NPV (Forest Fire Management) scheme at Jangamarajupalli beat was found to match the specifications recorded in the measurement book- 1.2 meters in height and 285 running meters in length. Field inspection confirmed that the structure is well maintained with no damage and all RCC pillars intact. The fence effectively prevents animal entry and protects nursery seedlings. Annual maintenance is recommended to ensure its continued effectiveness.

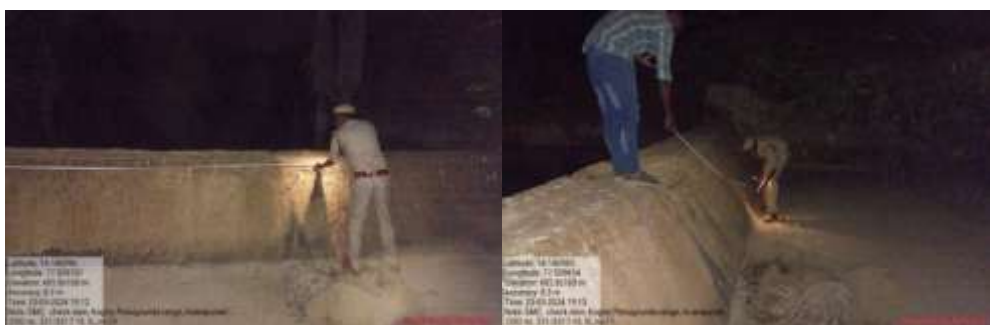
##### Check dam at Sy.no.669 in Kogira Block of Penukonda beat, Penukonda range

A check dam constructed in the Kogira block of Penukonda Beat was monitored and evaluated against the specifications recorded in the measurement book and verified through actual field measurements. The dimensions of the check dam are as follows: length – 10.0 meters, width – 0.5 meters, and depth – 1.5 meters. The field measurements were found to be consistent with the recorded specifications, indicating no deviations. The structure is well maintained and effectively demonstrates good water storage capacity during the monsoon season. However, regular de-siltation is recommended to further enhance its storage capacity, improve water infiltration, and maintain soil moisture levels more effectively.

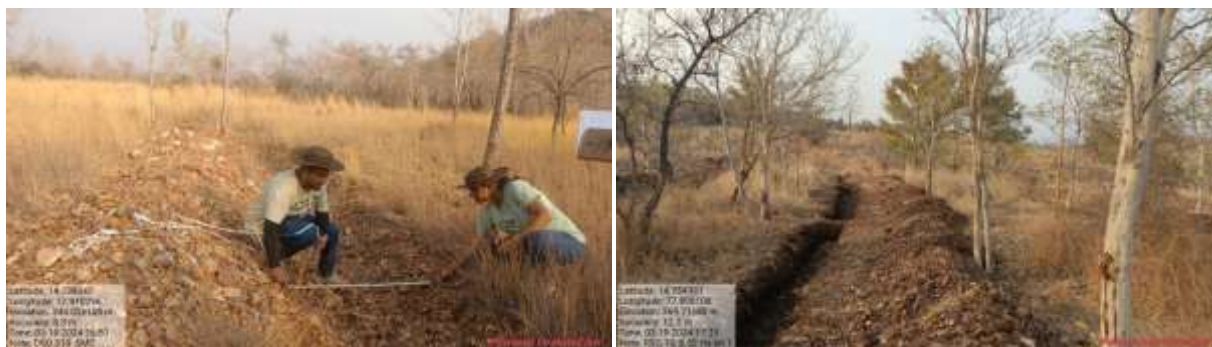
**CCT's in the CA land adjacent to Muchukota RF in Maddipalli beat of Gooty range**

A total of 202 Continuous Contour Trenches (CCTs) excavated in Muchukota Reserve Forest within Maddipalli Beat were monitored and evaluated based on the specifications recorded in the measurement book and compared with actual field measurements. Each trench measured 10 meters in length, 0.50 meters in width, and 0.50 meters in depth, with a total calculated volume of 505 cubic meters. The field measurements were found to be in full agreement with the recorded specifications, indicating no deviations. However, in some of the lower-lying trenches within the reserve forest, a slight reduction in depth was observed due to minor accumulation of silt and stony gravels. This reduction was negligible and does not significantly impact the functionality of the structures.

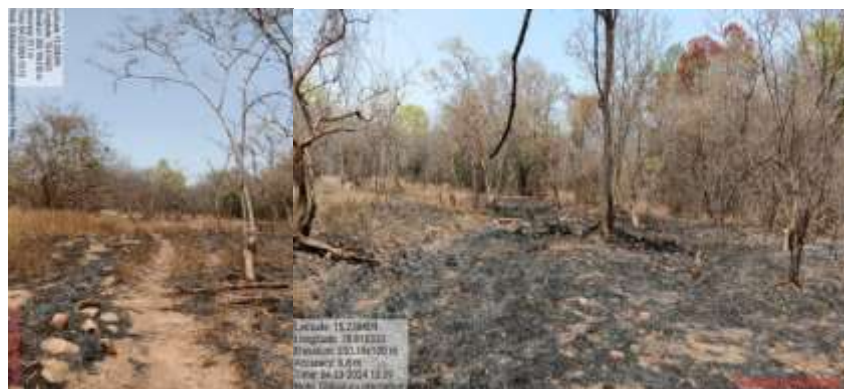
**Fire line at Bodi beat, Giddalur range**

A fire line was created and maintained in Bodi beat under CAMPA-NPV (forest fire management) scheme was monitored and evaluated against the specifications recorded in the measurement book and the actual field measurements. The dimensions of fire line are width - 3 m and length - 8000 rmt. The field measurements matched those in the measurement book, indicating no deviations. The visibility of the fire line was clear with burnt litter and tree stumps. No dense grass or weed growth was observed indicating that the fire line has been well-maintained.

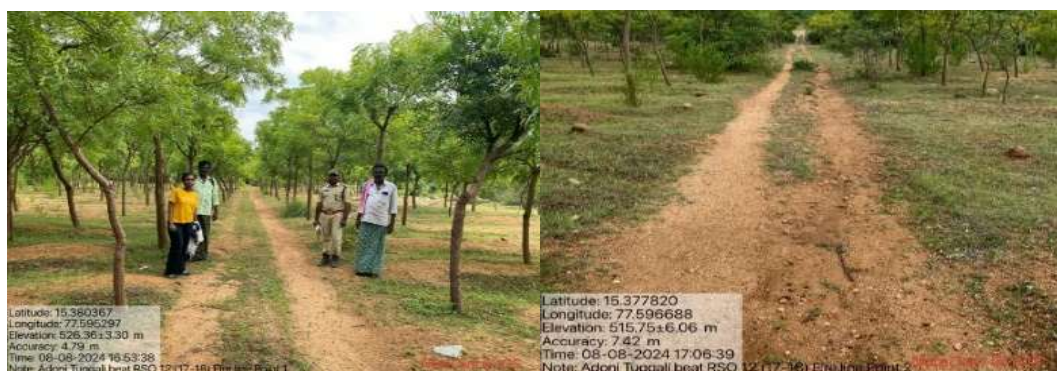
Fire line at Tuggali beat

A fire line created and maintained in Tuggali beat under CAMPA-NPV (forest fire management) scheme was monitored and evaluated against the specifications recorded in the measurement book with the actual field measurements. The dimensions of fire line are width- 3 m and length- 4500 rmt. The field measurements matched those in the measurement book indicating no deviations. The visibility of the fire line was clear as it was established along the inspection path. No dense grass or weed growth was observed indicating that the fire line has been well-maintained.

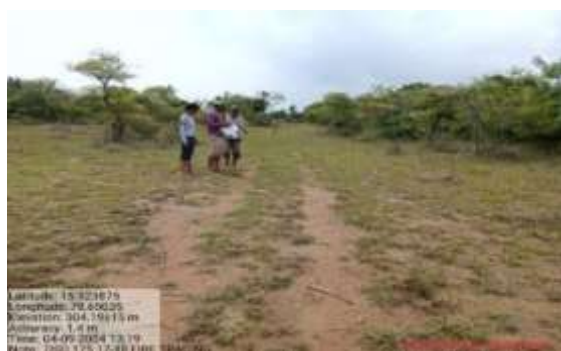
Fire lines in Indireswaram, Nagaluty range

Fire lines were created and maintained under the CAMPA-NPV (Forest Fire Management) scheme at Deccan Cement CA land area in Indireswaram West Beat, Nagaluty Range, and at the GIB Rollapadu Sanctuary in Velgode Range. The fire line dimensions were recorded as 5 m in width and 148,900 rmt in length at Indireswaram West Beat, and 5 m in width and 18,210 rmt in length at Rollapadu Sanctuary. Field verification confirmed that the actual measurements matched those in the measurement book, with no deviations observed. The fire lines were clearly visible and effectively established around the respective sites. However, periodic maintenance is essential to sustain their effectiveness in providing fire protection.

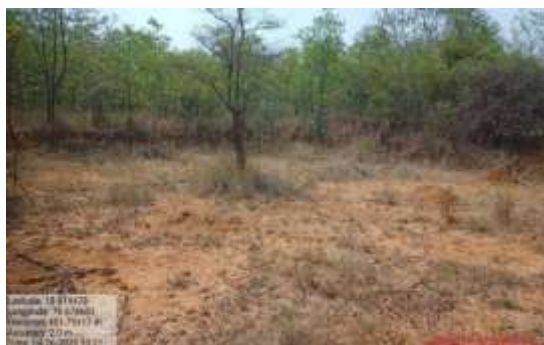
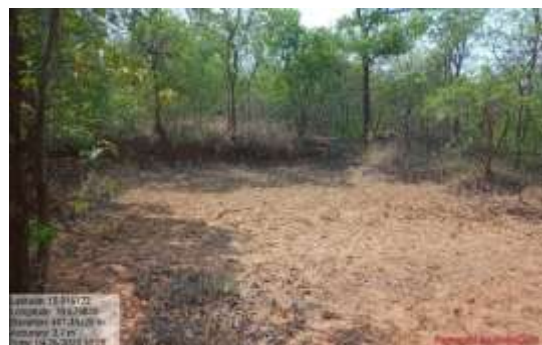
**Mini percolation tanks in CA land area in Indireswaram west beat**

Digging of mini percolation tanks in CA land area in Indireswaram West beat was monitored and evaluated in Nagaluty range. The percolation tanks were found to be well maintained with the dimensions of width - 10 m, length - 10 m and depth of 1 m, and its measurements align with the recorded specifications. It demonstrates good water facility. However, periodic maintenance and de-siltation is recommended to enhance effectiveness.

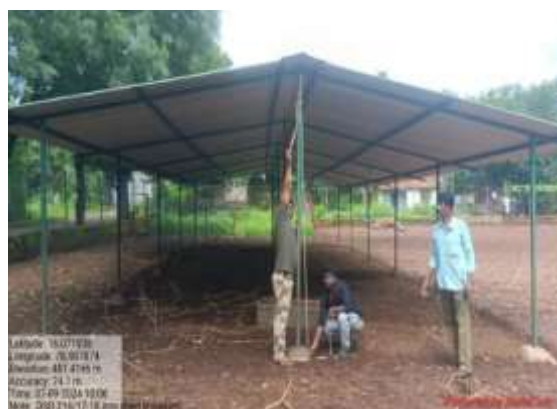
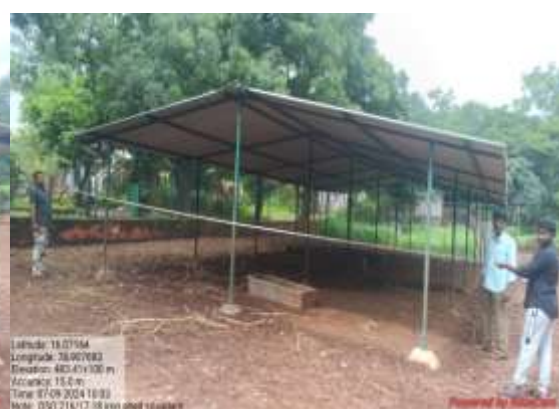
**Iron shed at Sundipenta in Srisailam range**

An iron shed for the Animal Orphanage Centre was constructed within the Forest Range Office complex at Sundipenta in Srisailam Range. As per the measurement book and field verification, Shed-I (15.5 m × 8.5 m × 3 m with 18 iron pillars) and Shed-II (9.5 m × 8.5 m × 3 m with 12 iron pillars) were found to match exactly, with no variation recorded. The shed is in good condition, provided with a roof for protection against sunlight and rain, and enclosed with chain-link fencing to ensure the safety and security of rehabilitated wild spotted deer sheltered within.

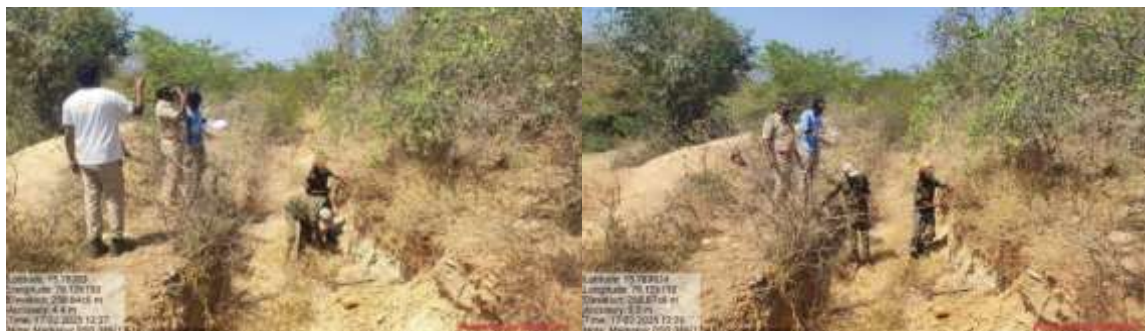
**Peripheral trench around Inamakula CA land bit II in Markapur range**

A total of six peripheral trenches were constructed around Kalanuthala village within and across the Inamakula CA land, with a recorded length of 212 m, breadth 2.5 m, and depth 3 m as per the measurement book (MB). Field verification, however, revealed an actual length of 3300 rmt, breadth 2.5 m, and depth 2.5 m, indicating some variation due to siltation, which has reduced trench depth in certain areas. The trench remains clearly visible but has experienced grass and weed overgrowth, as well as silt accumulation. To maintain its effectiveness, regular de-siltation and maintenance are recommended.

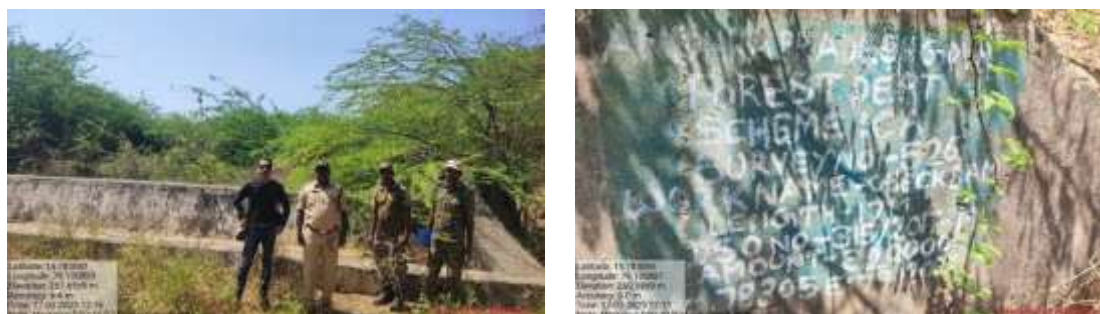
**Check dam across Mekalabonda Vagu in Markapur**

The check dam across Mekalabonda Vagu in Kalanuthala CA block of Gottipadita beat consists of a main dam (17 m × 0.70 m × 1.00 m), upstream and downstream side walls (2 m × 0.45 m × 1.60–1.71 m), and two aprons (17 m × 2.00 m × 0.45 m), with a total measured quantity of 48.025 cum, which matches field measurements. During inspection, seepage was observed from both the main dam and side walls, and the side walls require significant repairs. Additionally, de-silting is necessary to enhance storage capacity.

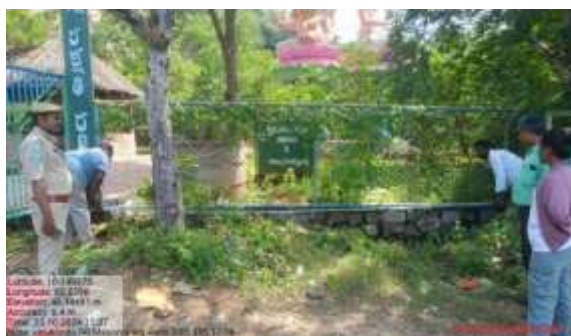
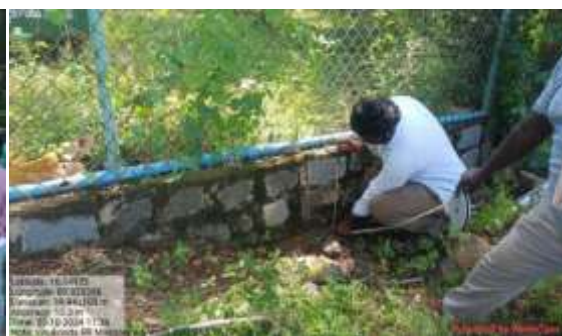
R.R. Masonry walls at Kotappakonda Saraswathi, Lakshmi and Parvathi statues

The R.R. masonry adjacent walls constructed near the Kotappakonda Saraswathi, Lakshmi, and Parvathi statues area through Guravayapalem VSS in Thangedumalli beat of Vinukonda range were monitored and evaluated in the field. The recorded field dimensions were 0.45 m in width and 250 rmt in length. However, since the dimensions were not entered in the measurement book, verification against official records was not possible, and potential deviations could not be assessed. These masonry walls function as a sturdy basement foundation supporting the chain-link mesh enclosure surrounding the statues. During inspection, weed regrowth was noted around the base of the walls, highlighting the need for regular weeding and routine maintenance to preserve both the structure and its immediate surroundings.

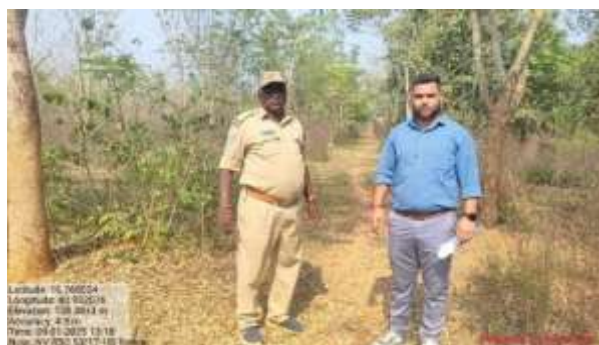
**Katrenipadu beat Nuzvid range**

A fire line was created Katrenipadu beat under CAMPA-NPV (forest fire management) scheme was monitored and evaluated against the specifications recorded in the measurement book and the actual field measurements. The dimensions of new fire line are width – 3 m, and length – 2000rmt. The field measurements matched those in the measurement book, indicating no deviations. The visibility of the fire line was clear, although moderate weed and grass growth was observed along the strip. This indicates that while the fire line has been effectively established, regular maintenance is recommended to control vegetative growth and ensure its continued effectiveness in preventing and containing forest fires.

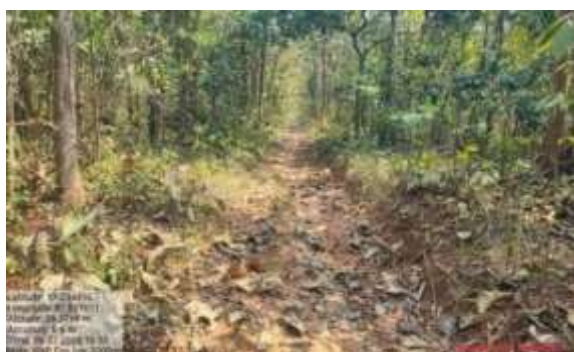
**LND Peta beat, Kannapuram range**

measurements were found to be consistent with the entries in the measurement book, indicating no deviations. The fire lines were clearly visible and well-defined, reflecting proper implementation.
