# **Third Party Monitoring and Evaluation of Compensatory Afforestation Fund Management and Planning Authority (CAMPA) Activities of Andhra Pradesh Forest Department (APFD) During 2018-19**

**INSTITUTE OF WOOD SCIENCE AND TECHNOLOGY**  
**(Indian Council of Forestry Research & Education)**  
18<sup>th</sup> Cross, Malleswaram, Bangalore – 560 003  
October 2025

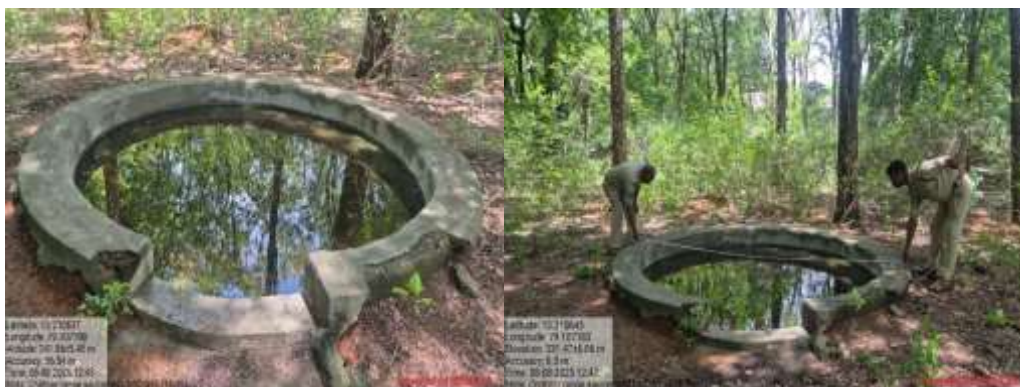
**Saucer pits in Chittoor beat**

Twelve saucer pits constructed in Chittoor beat of Chittoor East range were monitored and evaluated against the specifications recorded in the measurement book. The field measurements matched the documented dimensions, confirming no deviations. Each saucer pit measured 2 meters in diameter and 0.5 meters in depth. All 12 saucer pits were found to be in good condition and well maintained. However, to further enhance their storage capacity, removal of accumulated dirt and re-plastering with cement are recommended.

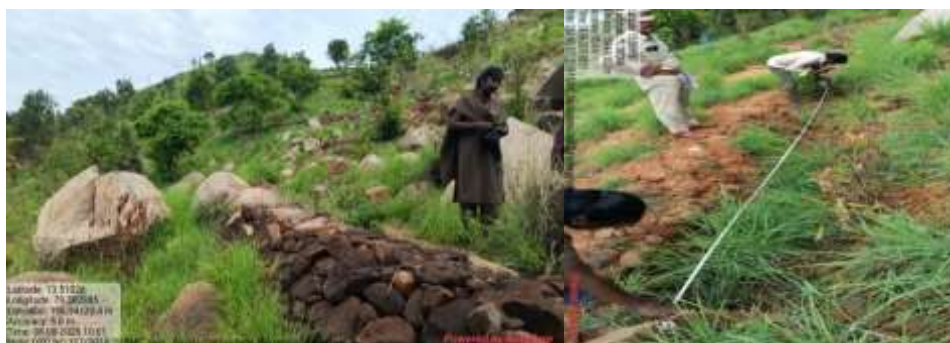
#### **Soil Moisture Conservation works (CCT and RFD) in 50.64 Ha CA, Rayalacheruvu beat**

- **Continuous Contour Trenches (CCTs):** Each trench measured 10 m in length, 0.5 m in width, and 0.5 m in depth, with a volume of 2.5 cu. m. The CCTs were found to be generally well maintained. However, in some of the lower trenches, depth had been reduced due to siltation. Regular de-siltation is recommended to restore their full capacity and ensure effective soil moisture conservation.
- **Rock-filled Dams (RFDs):** Each structure measured 8 m in length, 1 m in width, and 0.3 m in depth, with a volume of 2.4 cu. m. The gully check structures were in good condition and well maintained. Regular de-siltation is advised to enhance their storage capacity, improve water infiltration, and maintain soil moisture levels. These structures have contributed positively to biomass growth, particularly of boda grass and associated vegetation.

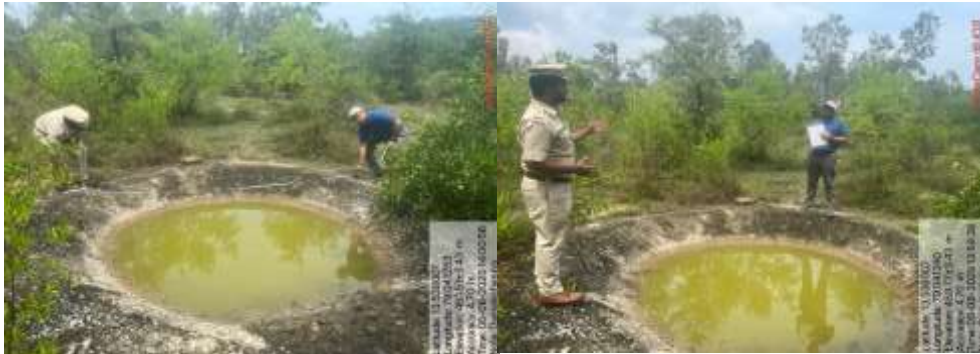
**Saucer pits in Piler range**

Twenty-three saucer pits constructed in Piler range were monitored and evaluated against the specifications recorded in the measurement book. The field measurements matched the documented dimensions, confirming no deviations. Each saucer pit measured 2 meters in diameter and 0.5 meters in depth. All 23 saucer pits were found to be in good condition and well maintained. However, to further enhance their storage capacity, removal of accumulated dirt and re-plastering with cement are recommended.

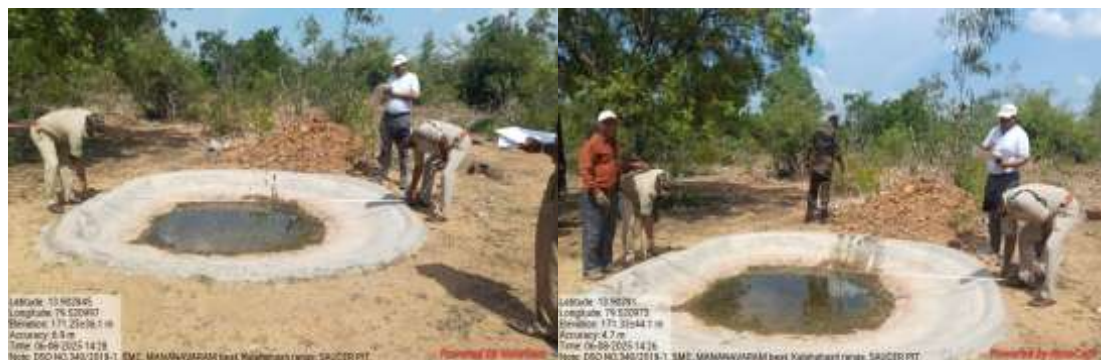
**Saucer pits in Sri Kalahasthi range**

Seven saucer pits constructed in Mannavaram beat, Pallam section of Sri Kalahasthi range were monitored and evaluated against the specifications recorded in the measurement book. The field measurements matched the documented dimensions, confirming no deviations. Each saucer pit measured 4 meters in diameter and 0.5 meters in depth. All seven saucer pits were found to be in good condition and well maintained. However, to further enhance their storage capacity, removal of accumulated dirt is recommended.

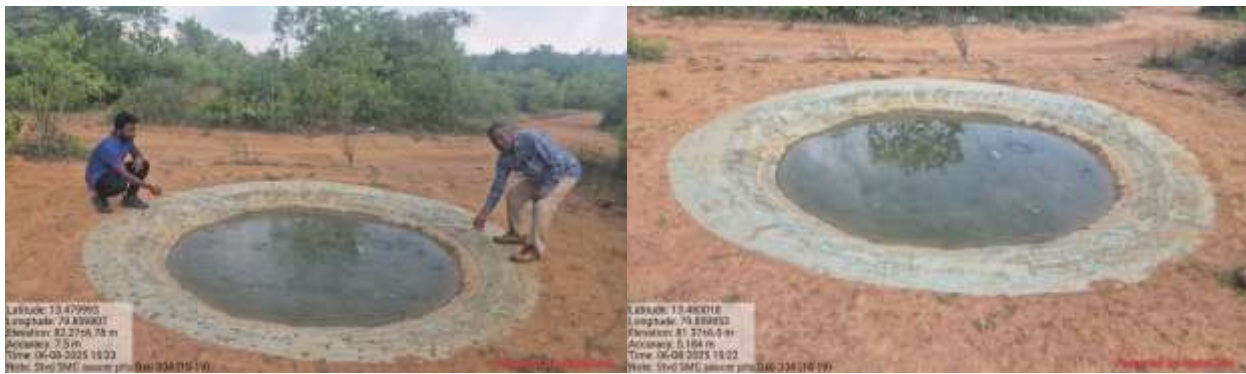
### Saucer pits in SK Madugu beat

Four saucer pits constructed in Piler range were monitored and evaluated against the specifications recorded in the measurement book. The field measurements matched the documented dimensions, confirming no deviations. Each saucer pit measured 3 meters in diameter and 0.5 meters in depth. All four saucer pits were found to be in good condition and well maintained. However, to further enhance their storage capacity, removal of accumulated dirt and re-plastering with cement are recommended.

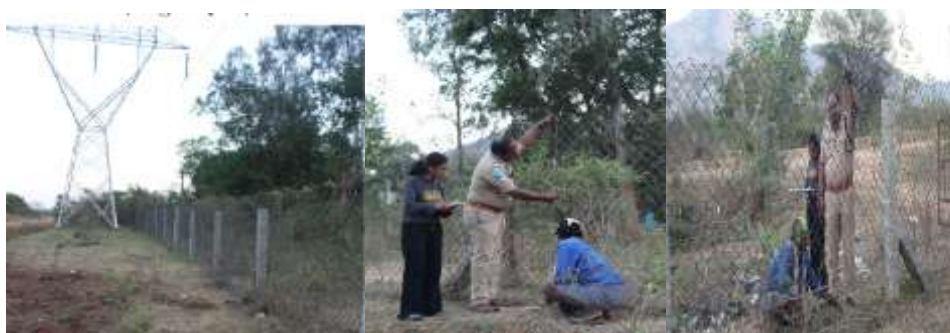
**Chain-link mesh fencing around the Irala CN of Chittoor West range**

Chain link mesh fencing around the Irala CN of Chittoor West range was monitored and evaluated against the specifications recorded in the measurement book and the actual field measurements. The dimensions of new fire line are width – 3 m, and length – 850 m. The field measurements matched those in the measurement book, indicating no deviations. The chain-link mesh fence was well-maintained, with intact pillars and no observed damage along its entire length. It was installed with the primary objective of preventing animal entry and protecting seedlings from grazing damage.

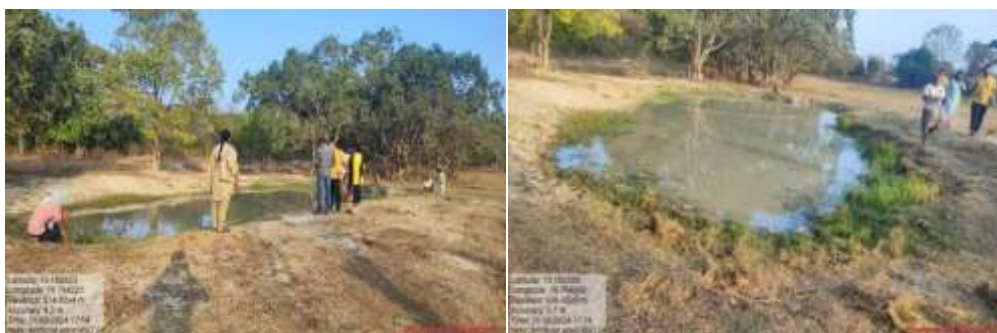
**Artificial pond in Musalimadugu RF of Kaluvapalle beat**

Excavated artificial pond at Dommarapapamma Kunta locality in Kaluvapalle beat, Musalimadugu RF, compartment No. 298 of Palamaner range was monitored and evaluated with reference to the specifications recorded in the measurement book and actual field measurements. The recorded dimensions of the structure are: Length: 8 m, Width: 8 m and Depth: 1.3 m. Field measurements accurately matched the specifications noted in the measurement book, indicating no deviations. The artificial pond is experiencing significant silt deposition due to erosion, leading to a reduction in its depth and a narrowing of its sides from accumulated silt along the edges.

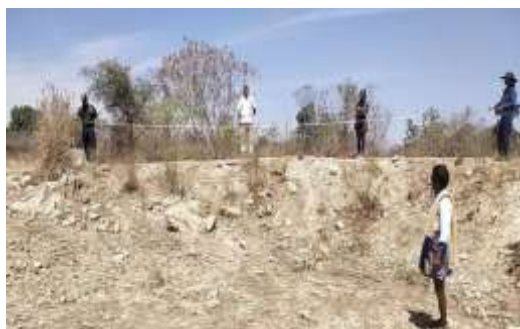
Neredikonda beat of Madanapalle range

Percolation tanks located at Neredikonda beat of Burakayalakota section in Madanapalle range and Ramiganipalle beat of Burakayalakota section, Madanapalle range was inspected and evaluated against the specifications recorded in the measurement book. Tank dimensions as per measurement book are; length: 50 m, width: 2 m, depth: 1 m and volume: 100 cum in Neredikonda beat and length: 30 m, width: 10 m, depth: 1.17 m and volume: 350 cum in Ramiganipalle beat. The field measurements were found to be consistent with the entries in the measurement book, confirming that the construction was carried out as per approved specifications, with no deviations observed. The percolation tank is well maintained and located in a catchment area, allowing all the rainfall water to accumulate. However, along with the water, there is a significant accumulation of silt, which reduces the tank's volume and storage capacity over time.

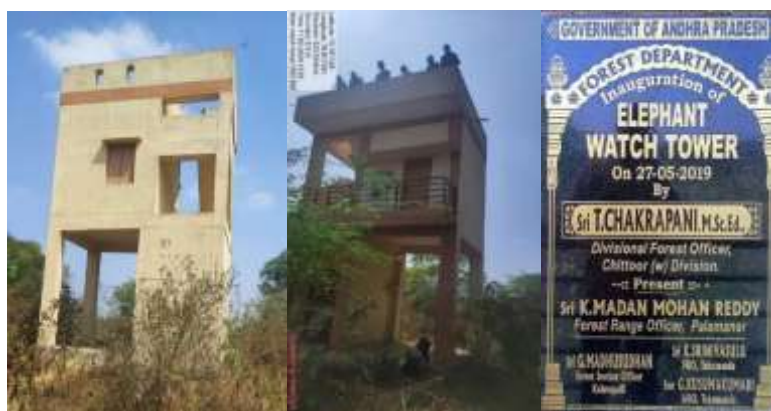
Watch tower at Gounicheruvu in Tekumanda beat of Palamaner range

Watch tower at Gounicheruvu Tekumanda beat of Palamaner range was inspected and evaluated against the specifications recorded in the measurement book. Tank dimensions as per measurement book are; Height 8.5 m, Side width 4.15 m, Front width 5.4 m with tower pillars 6 no. The field measurements were found to be consistent with the entries in the measurement book, confirming that the construction was carried out as per approved specifications, with no deviations observed. The watch tower is well-maintained and strategically located adjacent to a water body, offering an ideal vantage point for monitoring elephant movement and recording any fire incidents within the forest. However, the surrounding weed growth needs to be cleared to maintain visibility and ensure easy access to the structure.

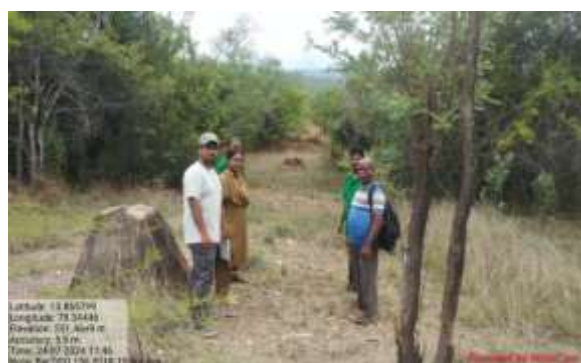
**Gunjana South beat of Balapalli range**

A fire line was created and maintained in Gunjana south beat under CAMPA-NPV (forest fire management) scheme was monitored and evaluated against the specifications recorded in the measurement book and the actual field measurements. The dimensions of new fire line are width – 10 m, and length – 5000rmt. The field measurements matched those in the measurement book, indicating no deviations. The fire line is well maintained with clear visibility throughout the plantation. Only minimal grass and weed growth is observed reflecting effective upkeep.

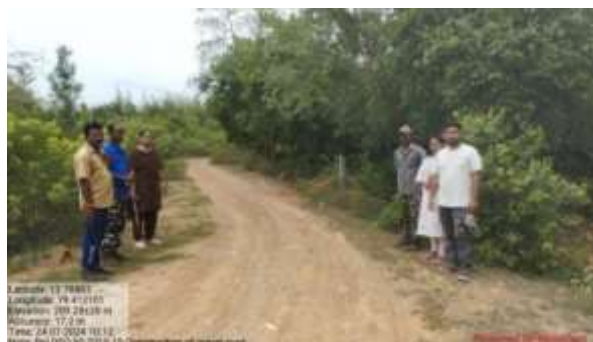
Balapalli west beat, Balapalli range

Construction of gravel road at Dunnapothula Marrimanu in Balapalli West beatsection was monitored and evaluated against the specifications recorded in the measurement book and the actual field measurements. The dimensions of the gravel road are as follows; Length -3000 m, width- 3m, the field measurements matched those in the measurement book, indicating no deviations. The road constructed along the boundary of Sheshachalam reserve forest in the Balapalli West beat is currently in good condition. However, seasonal maintenance during the monsoon is essential to ensure smooth and uninterrupted transportation.

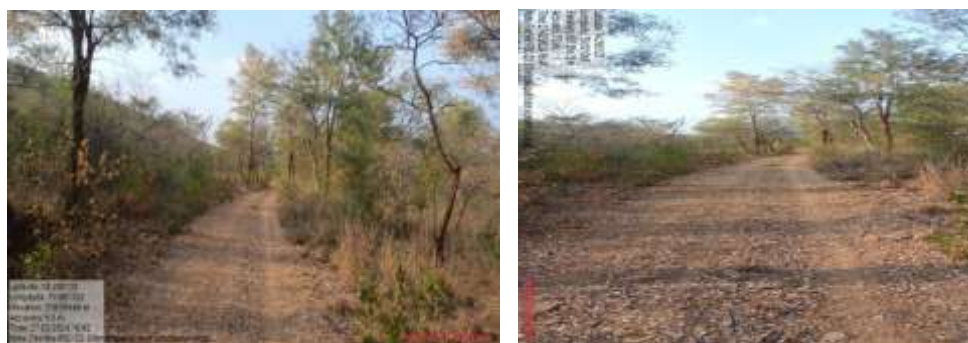
**Fire lines in natural forests at Chintarajupalli**

A fire line was created and maintained in Chintarajupalli section under CAMPA-NPV (forest fire management) scheme was monitored and evaluated against the specifications recorded in the measurement book and the actual field measurements. The dimensions of new fire line are width - 3 m and length - 2000 rmt. The field measurements matched those in the measurement book, indicating no deviations. The fire line was found to be well maintained with clear visibility throughout as it has been effectively aligned along the inspection path. No grass or weed growth was observed reflecting regular upkeep, while the adjoining natural forest areas were also found to be well protected thereby enhancing the functionality of the fire line in preventing fire hazards.

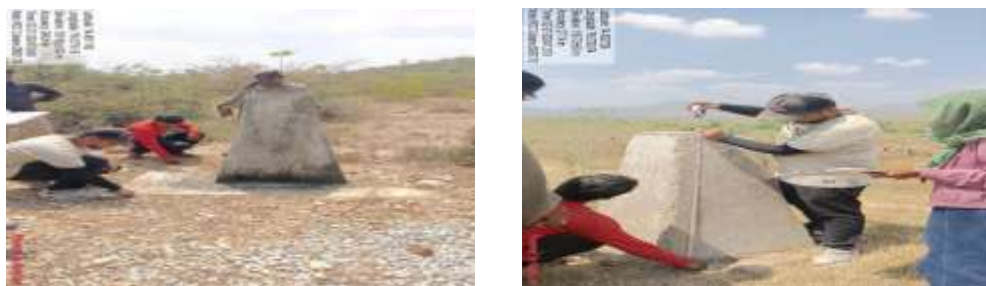
**R.C.C. cairns in PNWLS area of Vontimitta section**

between the PN wildlife Sanctuary and adjoining revenue land. A total of 25 cairns has been installed at 100 m intervals ensuring consistent and visible boundary marking for effective forest protection and management. However, it was observed that the base of the cairns is partially covered with soil and the cement plastering has weathered over time.

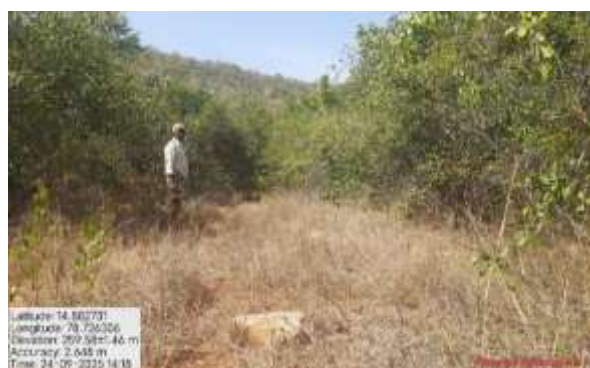
Fire lines at Ganjikutta beat

A fire line measuring 3 m in width and 500 rmt in length was created in Ganjikutta beat under the CAMPA-NPV (Forest Fire Management) scheme. Field measurements matched the specifications in the measurement book with no deviations. However, moderate grass and weed growth has reduced its visibility. Regular clearing is recommended to ensure its effectiveness in fire prevention.

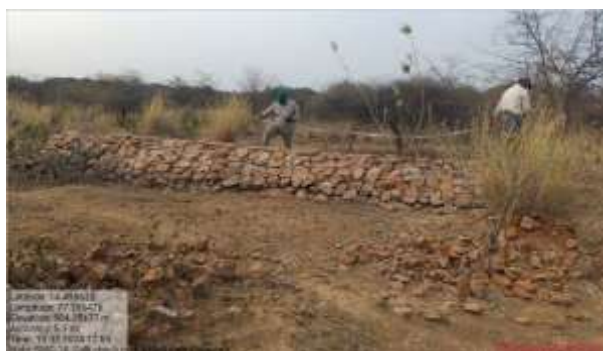
**Gully checks (rock fill dams) in the CA land of Kondapalli beat**

Three Gully Checks (Rock Fill Dams) in Kondapalli Additional Block was monitored and evaluated against the specifications recorded in the measurement book and the actual field measurements. The dimensions of the rock filled dams were: length – 9 m, width – 2.05 m, and depth – 1.00 m with volume of 55.35 m<sup>3</sup>. Total number of Rock Fill Dams and their cumulative volume exceed the figures recorded in official records. The field measurements matched those in the measurement book, indicating no deviations. The gully check structure (rock-fill dam) is well maintained, and its measurements align with the recorded specifications. It demonstrates good water storage capacity during the monsoon season. However, regular de-siltation is recommended to enhance its storage capacity, improve water infiltration, and maintain soil moisture levels effectively.

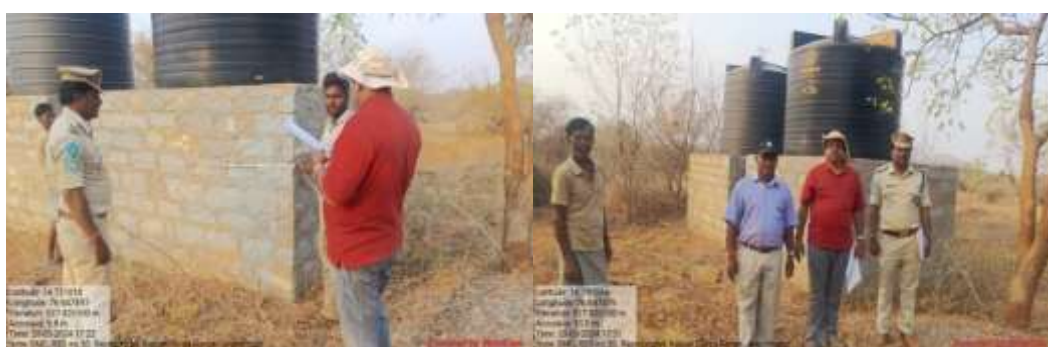
**Platform for tank in Bondanakal field nursery of Rayadurg beat of Kalyandurg range**

A single platform constructed for the nursery water tanks in Rayadurga Beat, Kalyandurg Range was inspected and found to be well-maintained. Platform for tank was constructed using cement R.R masonry with a dimension; length: 8 m, breadth: 0.6 m and depth: 1.6 m (All-round above ground level); Length: 8 m, Breadth: 0.6 m and Depth: 0.3 m (All-round below ground level); Overall concrete structure dimension Length: 2.6 m, Breadth: 1.8 m. The structure is functioning as intended, supporting the irrigation infrastructure of the nursery by maintaining water pressure and distribution efficiency. No structural defects or deviations were observed at the time of inspection.

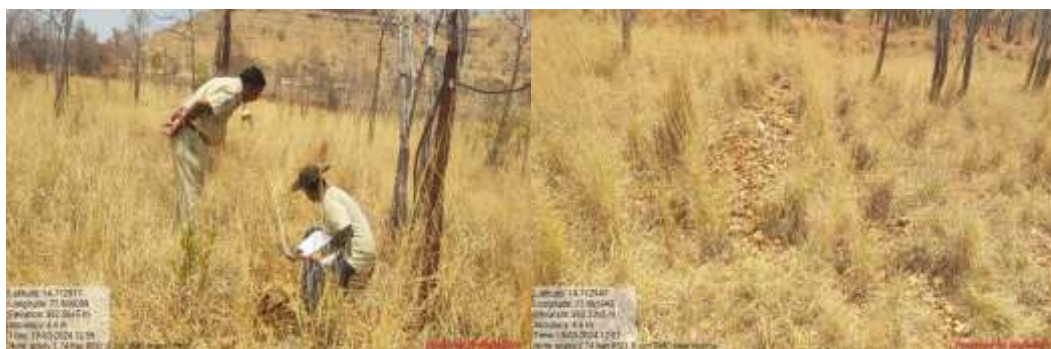
**Continuous contour trenches in the CA land adjacent in Muchukota RF**

A total of 513 Continuous Contour Trenches (CCTs) excavated in Muchukota Reserve Forest were monitored and evaluated against the specifications recorded in the measurement book and the actual field measurements. The standard dimensions of the trenches are: length: 10 m, Width: 0.50 m, depth: 0.50 m and total volume: 1,283 cum. The field measurements were found to be in full agreement with the recorded specifications, indicating no deviations from the approved design. A minor reduction in depth was observed in some of the lower-lying trenches, primarily due to the accumulation of silt and stony gravels. However, this reduction is negligible and does not significantly impact the overall functionality of the structures.

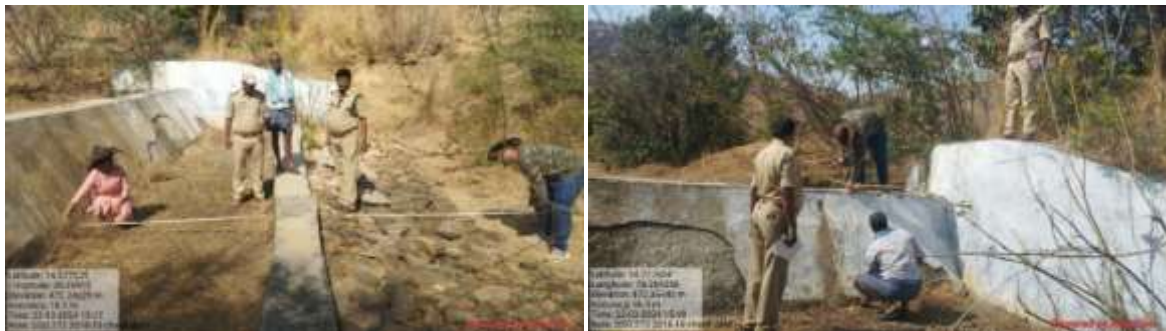
**New cement check dam at Gorivikanuma RF in Talupula beat of Kurli section, Kadiri**

Seepage of water was also noted from both the body wall and the core wall, suggesting the need for structural repairs to these components to prevent further deterioration.

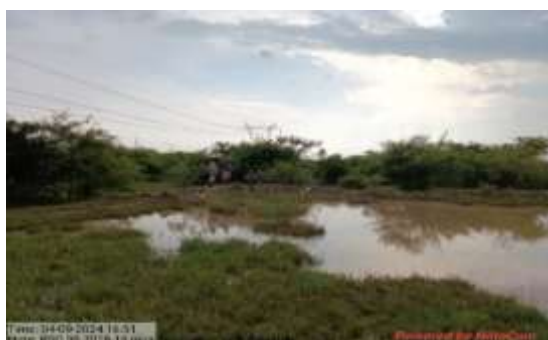
Mini percolation of Indireswaram West beat

A mini percolation tank was constructed in Indireswaram West Beat of Nagaluty Range with dimensions of 10 m × 10 m × 1 m, and a basement-cum-water pit was constructed in Velgode West Beat of Velgode Range with dimensions of 2.6 m × 2.6 m × 0.2 m. Field verification confirmed that both structures matched the measurement book with no variation recorded. The mini percolation tank was found to be functional; however, regular de-siltation is necessary to maintain and enhance its water retention efficiency, as silt accumulation and vegetative growth in and around the tank reduce its storage potential over time. The concrete water pit was observed to be well maintained and in good condition, effectively storing rainwater during the summer and serving as a vital water source for wildlife. To ensure the long-term functionality of both structures, annual maintenance is essential, particularly de-siltation of the percolation tank and upkeep of the water pit, thereby strengthening their role in water conservation and wildlife support.

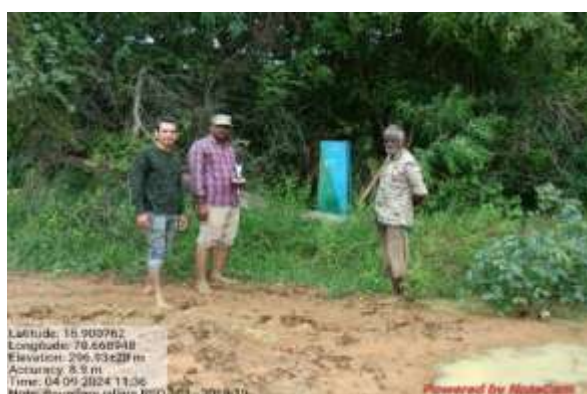
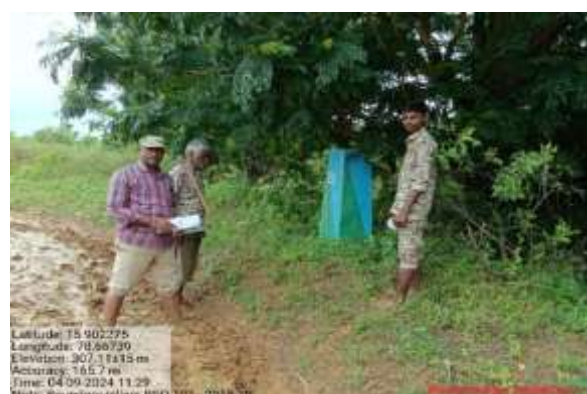
##### RCC boundary pillars in CA land area near current line location of Indireswaram West beat in Nagaluty range

A total of two RCC boundary pillars were constructed in the CA land area near the current line location of Indireswaram West Beat in Nagaluty Range, with dimensions as per the measurement book - below ground: 1.20 m × 1.20 m; above ground: height 1.20 m, top width 0.30 m, bottom width 0.45 m. Field verification confirmed that the structures matched the specifications with no variation recorded. The pillars, placed at intervals of 100 m, serve the purpose of clearly demarcating forest land from revenue land to prevent encroachment and illegal entry. However, it was observed that the basal part of these pillars has been submerged under the soil, potentially reducing their visibility and effectiveness. Regular maintenance and clearing around the pillars are therefore necessary to ensure that they remain visible and fully functional for boundary demarcation.
