Proposal for Rehabilitation and Retrofitting of FRI Heritage Building

Submitted to : CAMPA, MoEF&CC, GoI
Proposed Budget : Rs.10.35 Cr.
Duration : 1 Year
Project Director : Dr. Renu Singh, IFS, Director, FRI
Coordinator : Er. Rajendra Singh Topwal, Scientist F, Head Engineering Cell, FRI

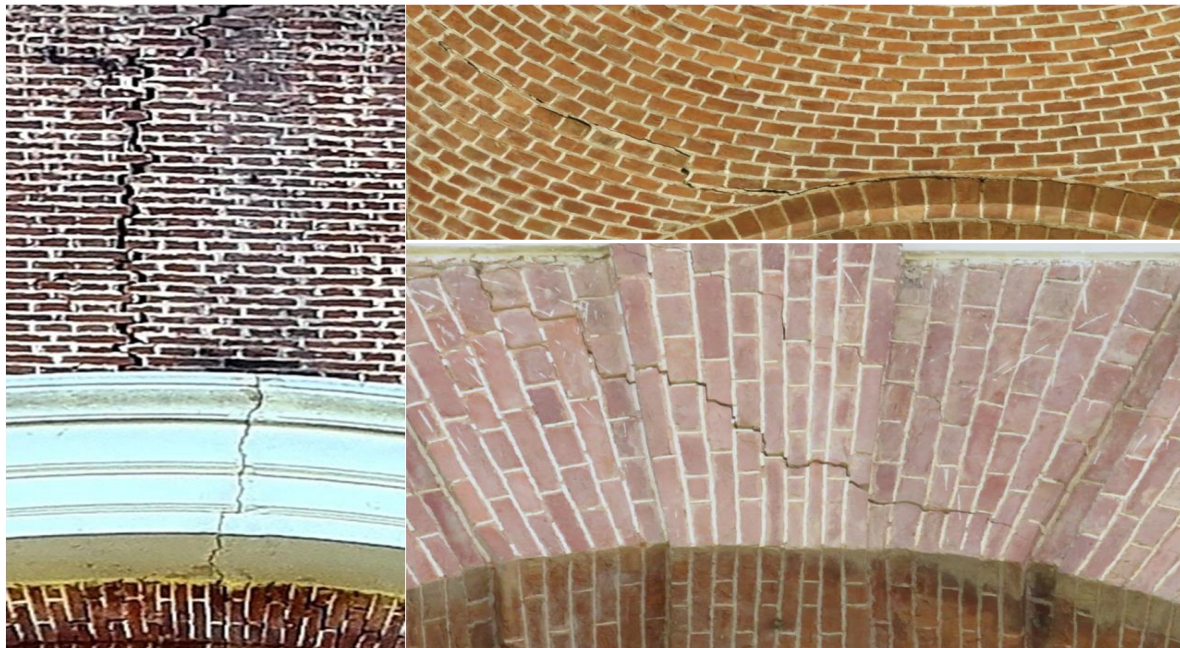
(a) Earthquake Cracks: An earthquake of Richter Magnitude 6.8 rocked the Garhwal Region of Western Himalayas on March 29, 1999 at 00:36:13.4 hours IST with epicenter at 30.408°N, 79.416°E near Chamoli/Gopeshwar. Due to this earthquake, numerous vertical cracks were developed at various places in FRI Building. Few of such cracks are presented hereunder through photographic representation,

- Steam cleaning and sterilizing treatment to exposed brick and stone work
- Construction of shed above canteen area, reconstruction of damaged and sunk terrazzo flooring
- Retrofitment of walls affected adversely
- Lime concrete work below flooring for base preparation
- Repair and renewal of wooden roofing shingles with framework (About 5% has been competed).

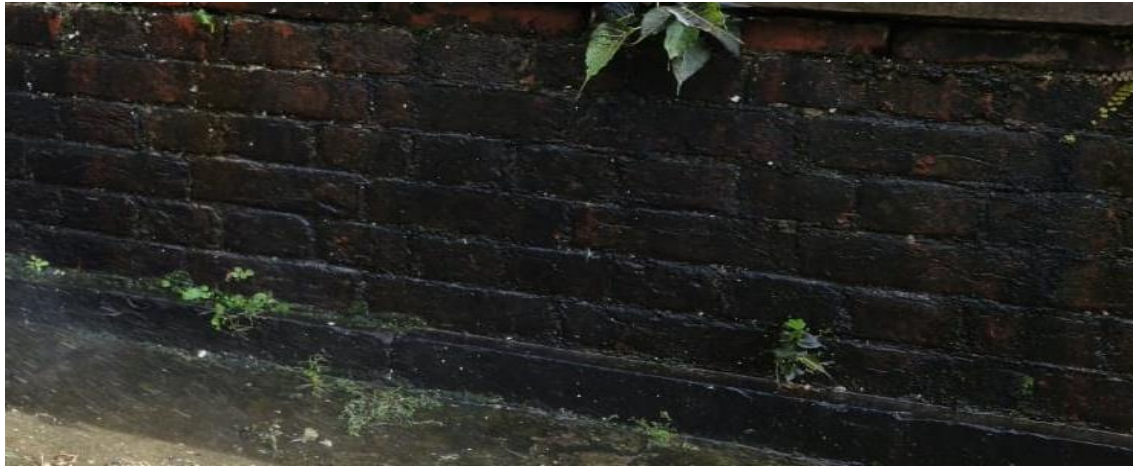
(b) Contaminants Exposed Wall Surface: In addition to cracks due to earthquake, FRI Building made-up of exposed bricks opened on all sides with vegetation in close proximity of plinth by itself invites various type of algal contaminants, surfaces with dust, soot and other airborne pollutants etc.

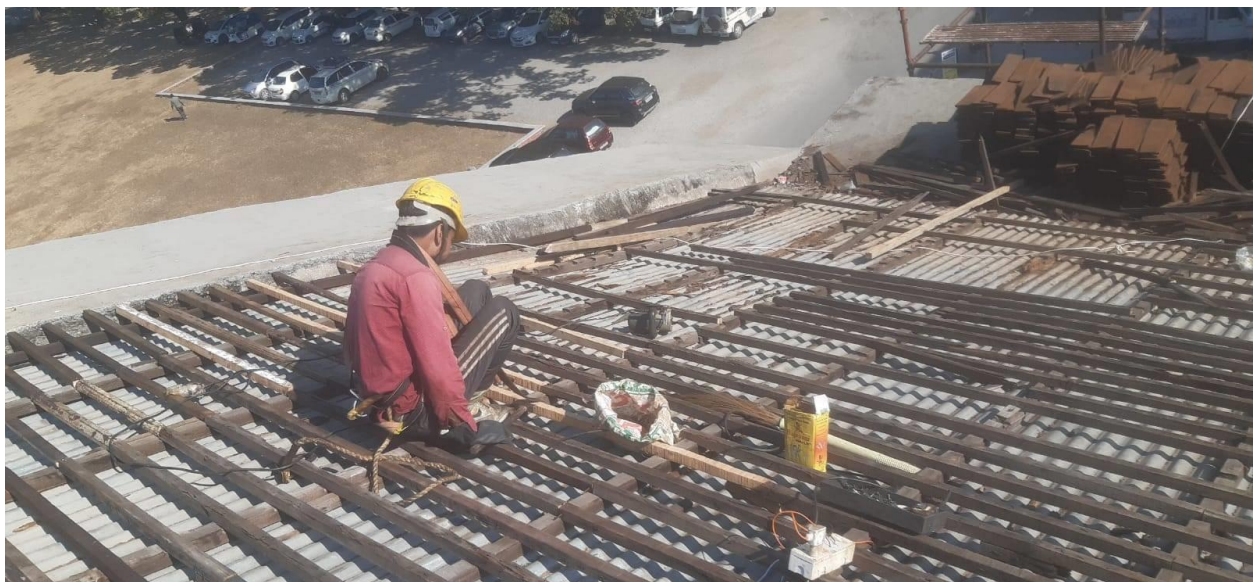
(c) Old Roof Wooden Shingle Replacement:

Wooden shingle on the roof have been decayed and damaged, which need to be replaced urgently.

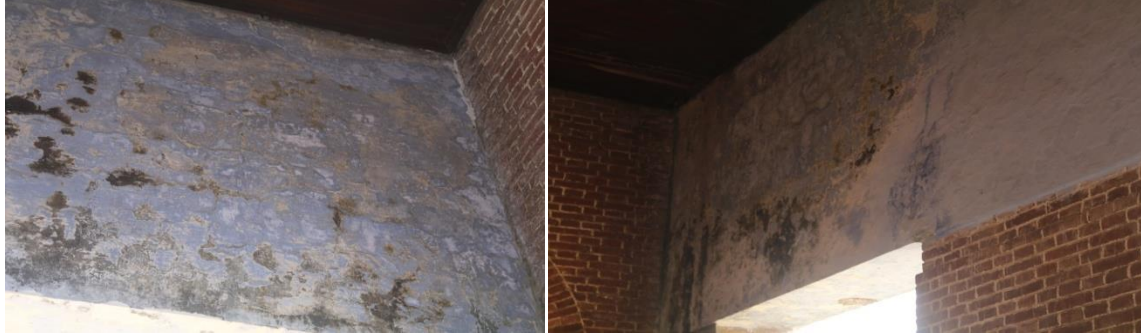
(d) Seepage Problem:

There is a serious seepage issue has been existing which is damaging the FRI main building. Factually, existing seepage at many places needs immediate treatment to protect the main building from further deterioration.

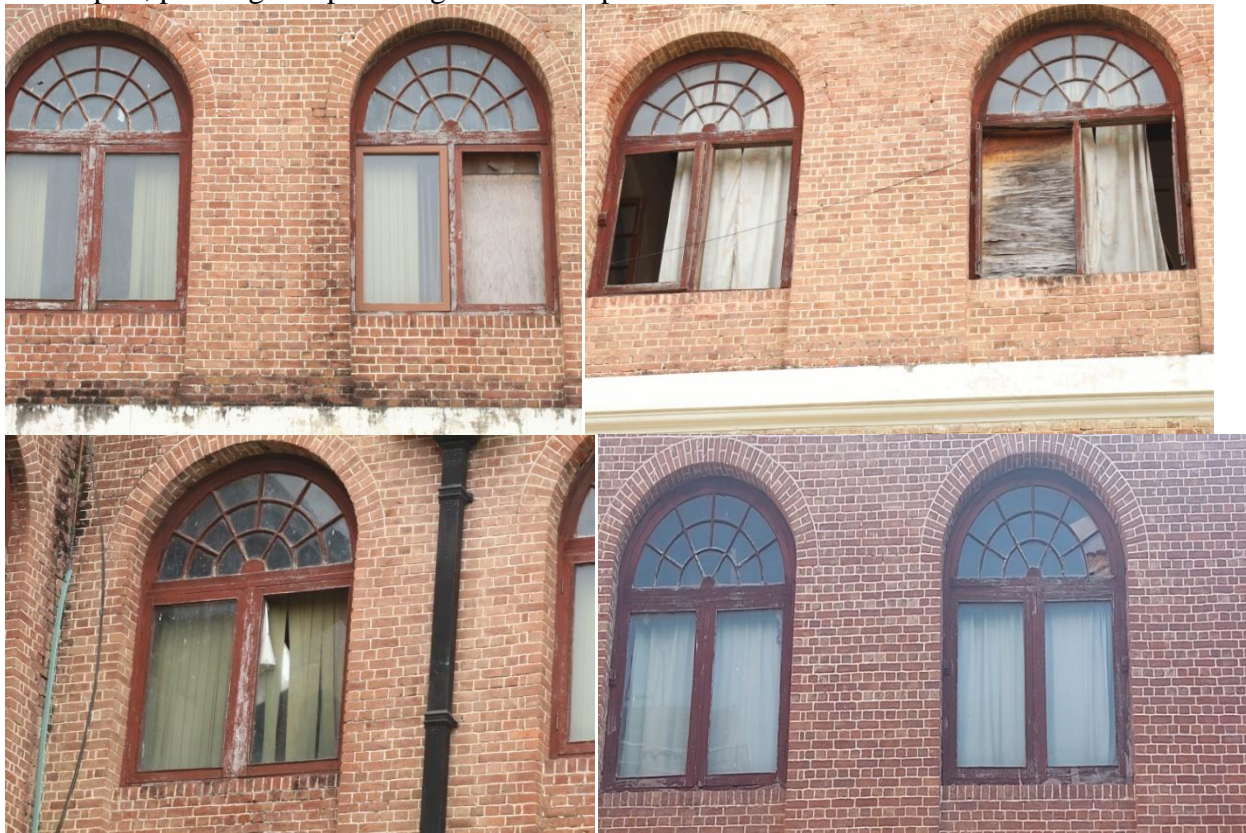
(e) Decayed window Frames:

The FRI Building has been witnessing classical carpentry in its windows and doors. However, doors and windows exposed to outside conditions are decaying sharply, which need immediately to be restored and replaced. All windows and doors of the building, whether outdoor or indoor, need repair, painting and polishing and even replacement for certain areas.

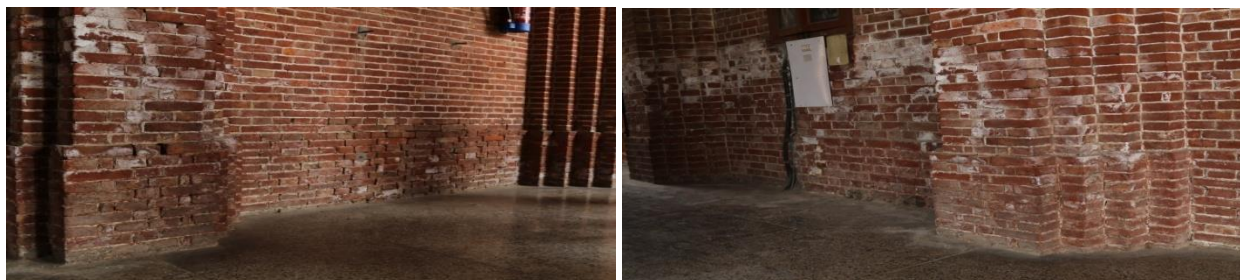
(f) Wall deterioration:

The exposed walls of FRI Building, at certain points, have weathered seriously and need urgent restoration through pointing and transparent silicone painting using modern tools so that original looks could be restored.
