H.P. FOREST DEPARTMENT

***Report of Monitoring of 10%
CAMPA Works 2022-23***

**MONITORING OF CAMPA WORKS
(2ND TIER MONITORING)
DURING 2022-23**

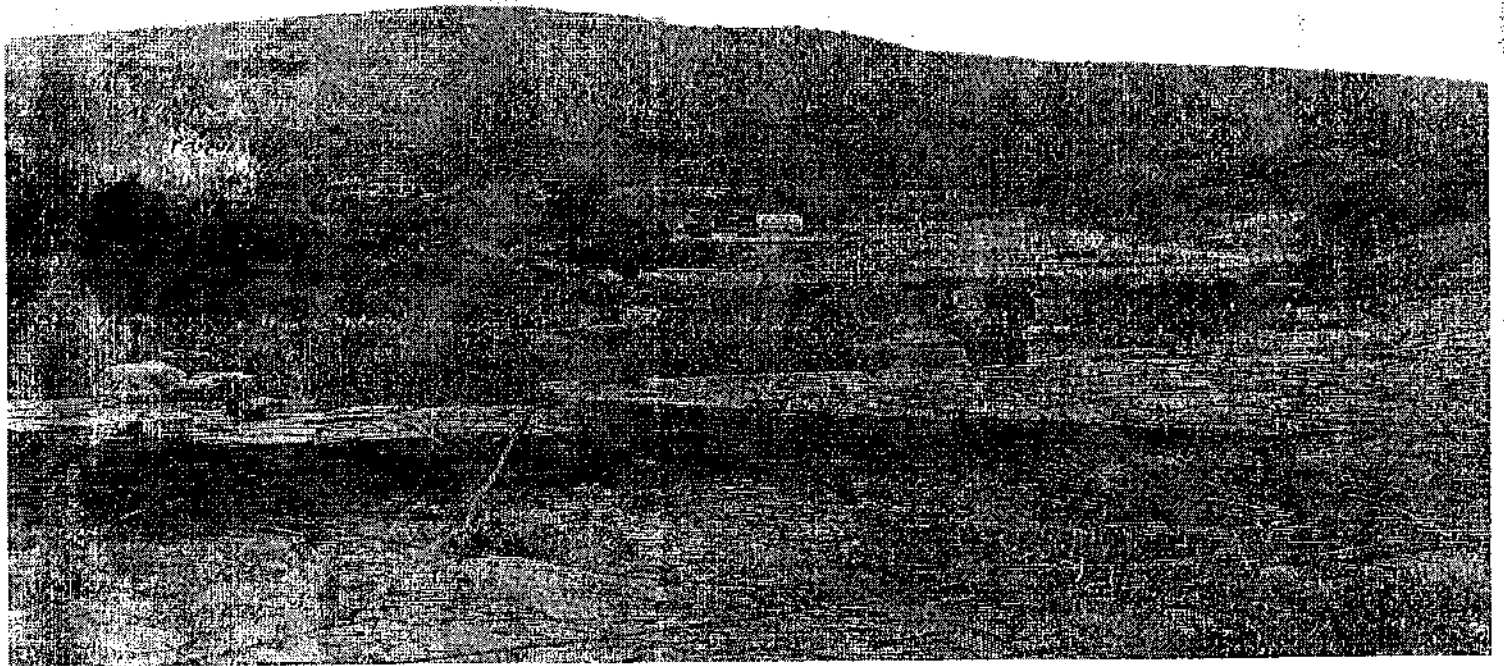
Circle/Division/Block/Beat
24. Shimla/Theog/ Theog/ Kaleri

1. Complete treatment of Nallah has not been prepared for the soil conservation work.
2. Masonry work required quite improvement.
3. Actual measurement of work has not been entered in MB whereas estimate has been copied in the MB.
4. Bio-engineering works was not carried out.
5. The Soil conservation work register has not been maintained.

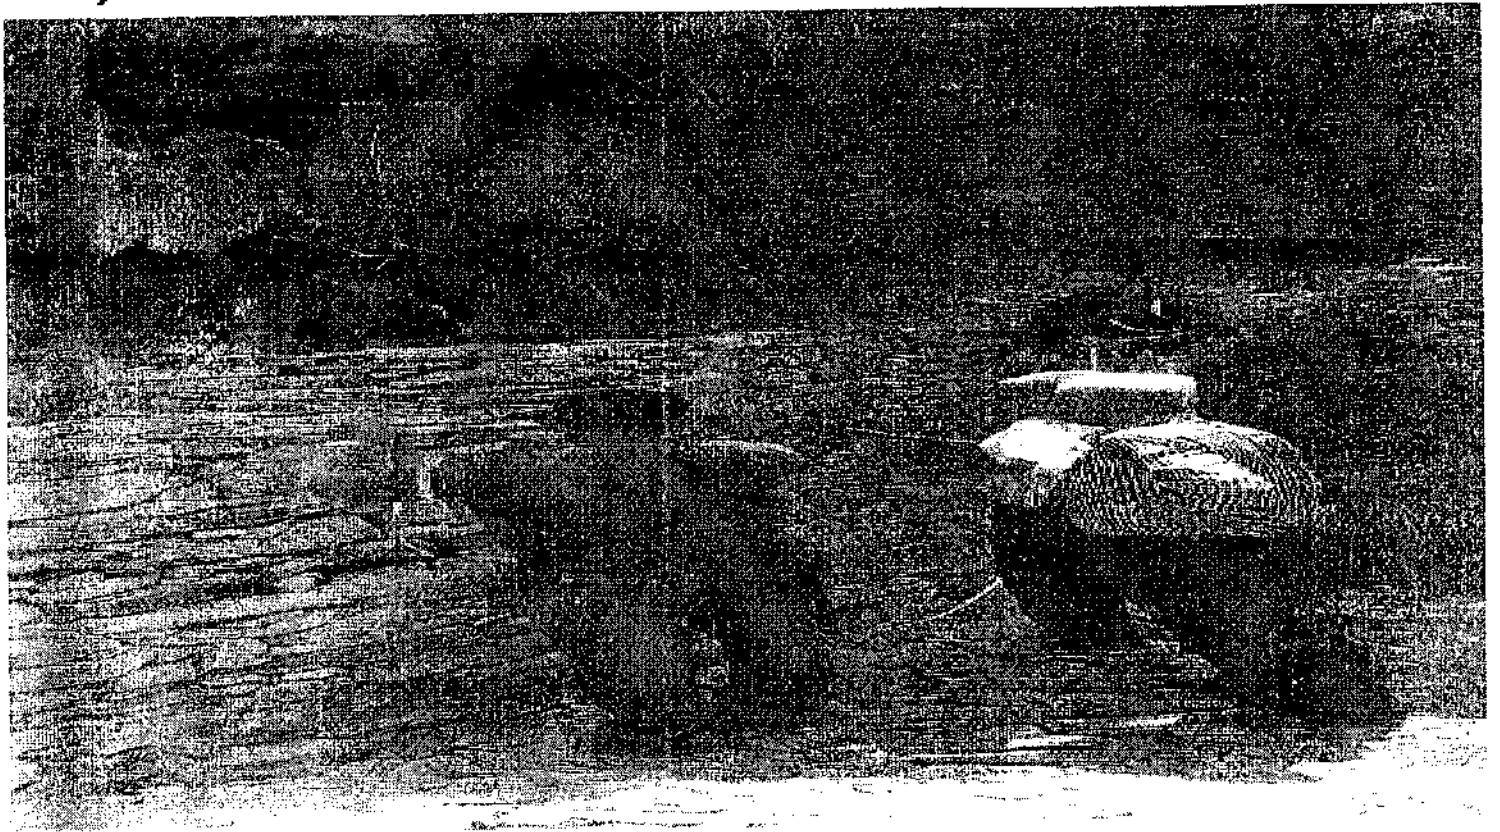
Circle/Division/Block/Beat
25. Shimla/Theog/ Theog/ Kaleri

1. Complete treatment of Nallah has not been prepared for the soil conservation work.
2. Masonry work required quite improvement.
3. Actual measurement of work has not been entered in MB whereas estimate has been copied in the MB.
4. Bio-engineering works was not carried out.
5. The Soil conservation work register has not been maintained.

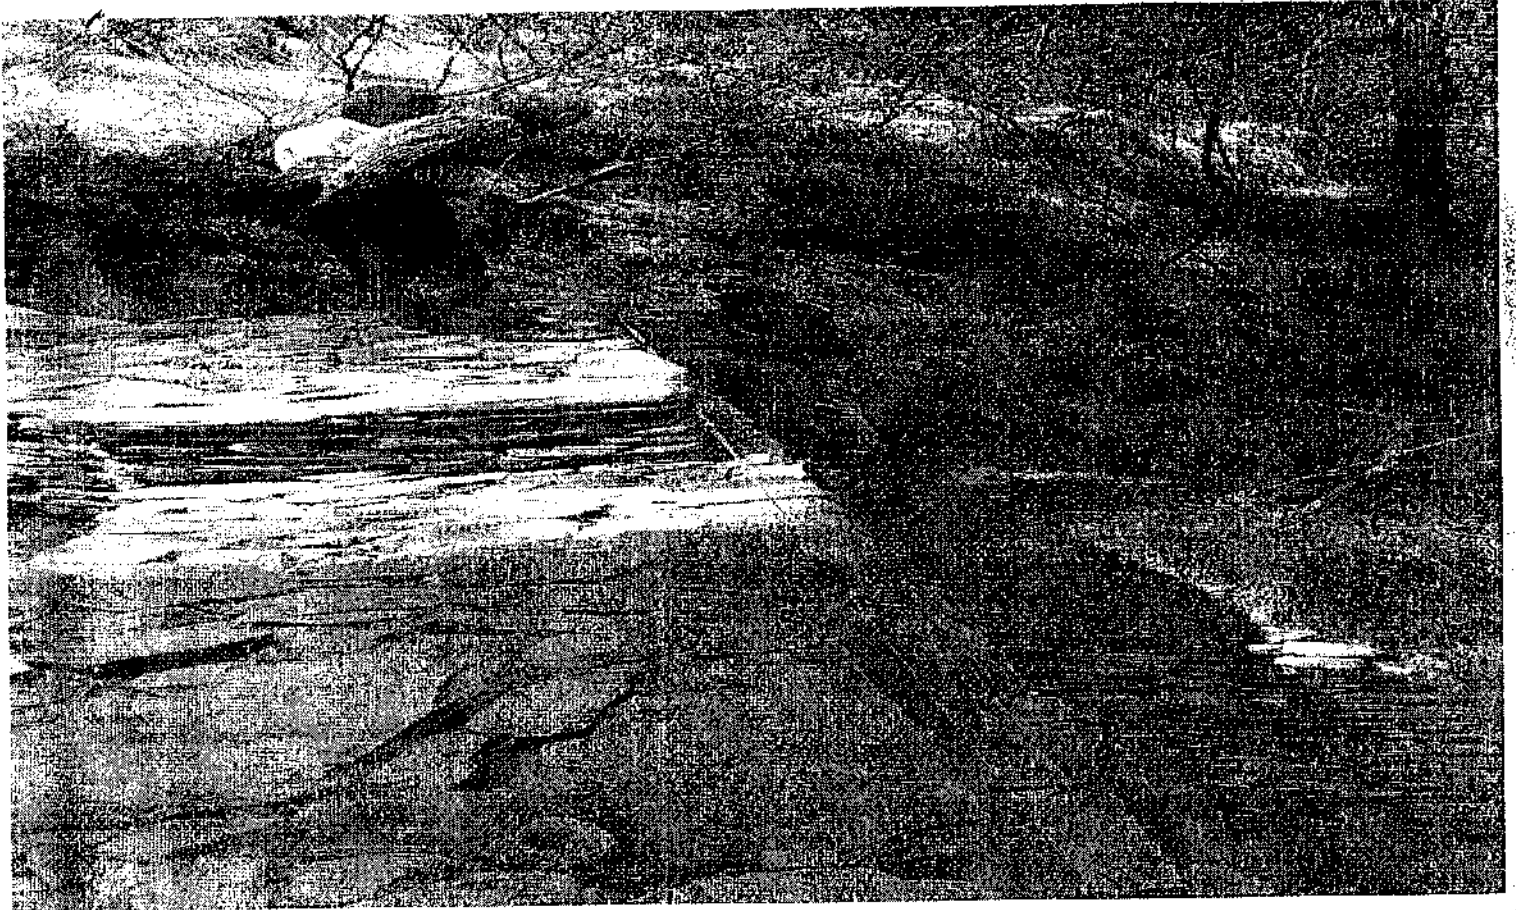
Circle/Division/Block/Beat
26.Shimla/ Theog/ Theog/ Kiari

1. Complete treatment of Nallah has not been prepared for the soil conservation work.
2. Masonry work required quite improvement.
3. Actual measurement of work has not been entered in MB whereas estimate has been copied in the MB.
4. Bio-engineering works was not carried out.
5. The Soil conservation work register has not been maintained.
6. Except RFO Theog, no Senior officers has done the 1st TIER monitoring till the time of 2nd TIER monitoring as per the statement of concerned field staff.

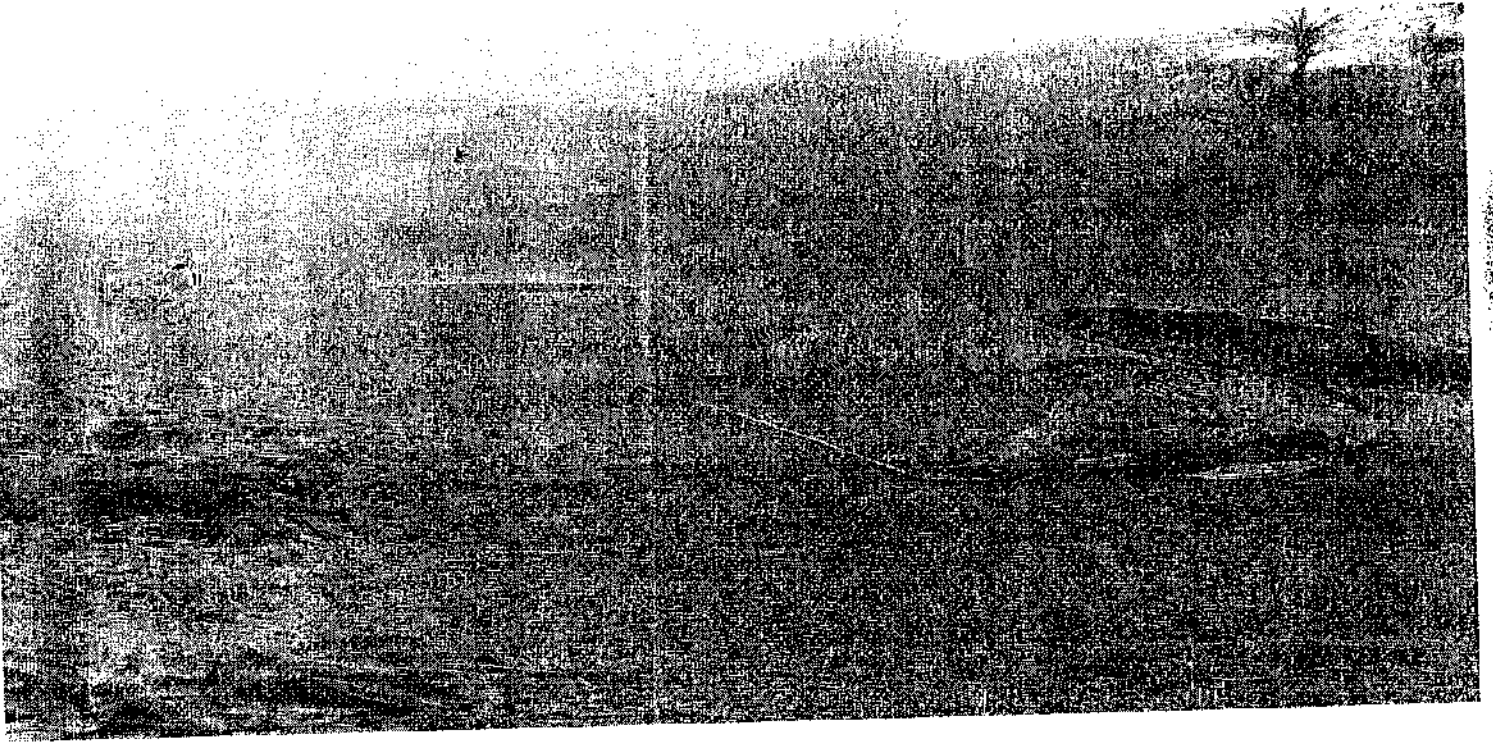
**Division/Block/Beat****27. WL (Shimla)/ WL Kashlog/ WL Kangri**

1. Work register was not prepared.
2. Except RFO Chandi WL, no senior officer has done 1st TIER monitoring till the time of 2nd tier monitoring.

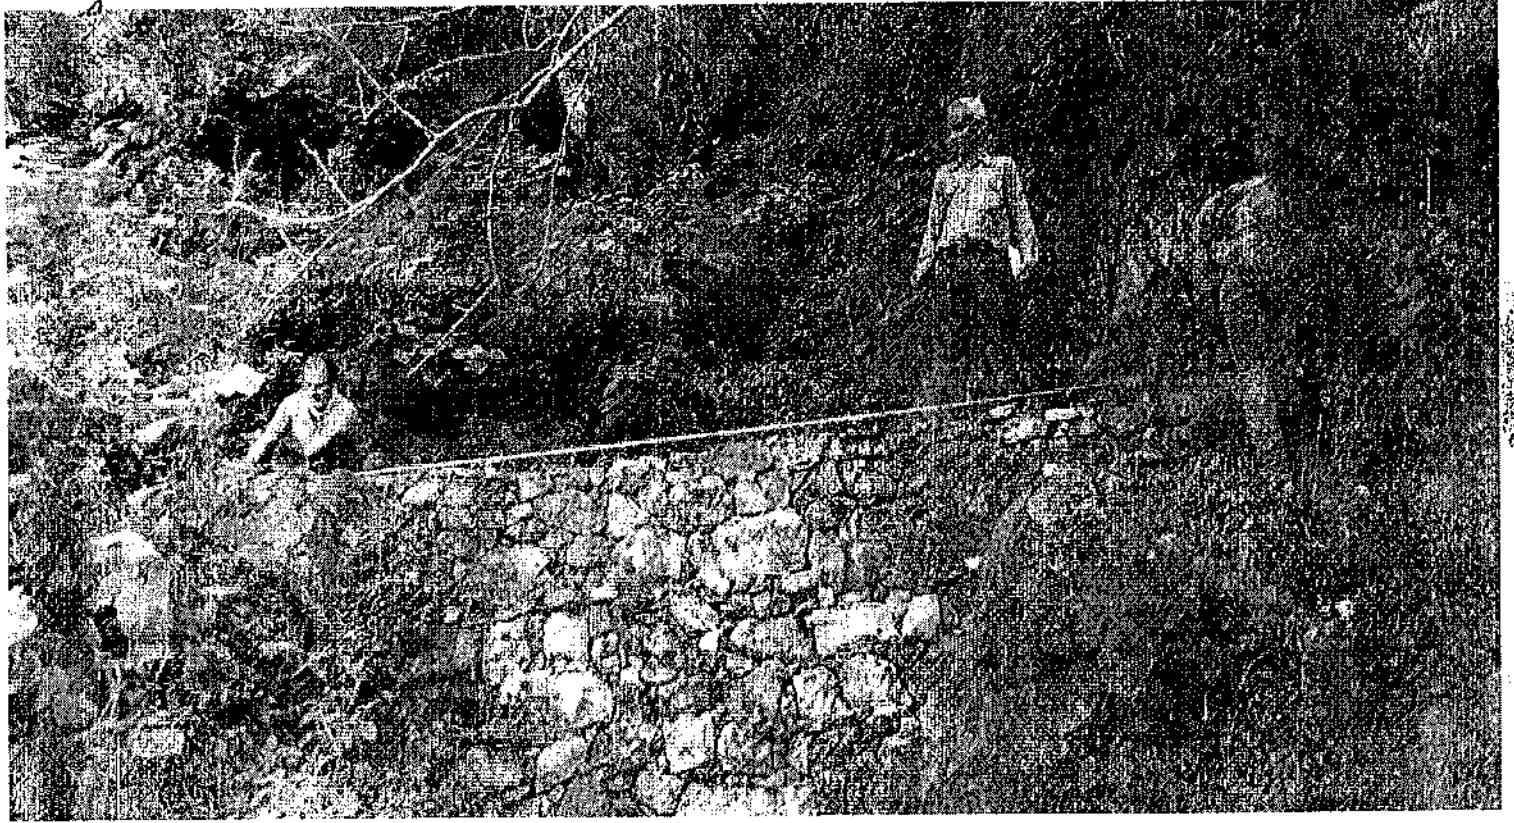
28. WL(Shimla)/ WL Kashlog/ WL Matrech

1. Soil conservation work register has not been maintained.
2. Numbering, year of execution of work and funding & execution agency on check walls has not been marked.
3. Actual measurement of work has not been entered in MB whereas estimate has been copied in the MB.
4. Except RFO Chandi WL, no senior officer has done 1st TIER monitoring till the time of 2nd tier monitoring.

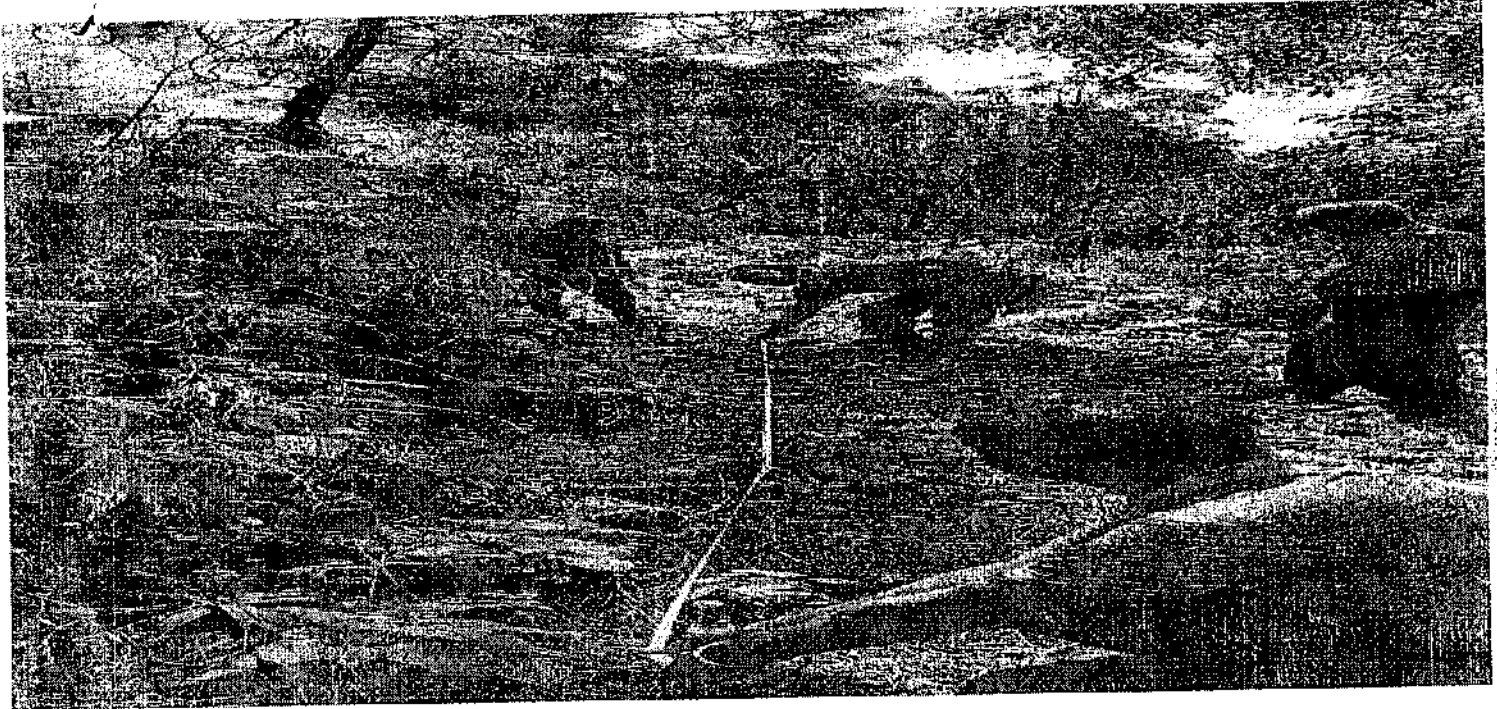
29. WL/Shimla/ WL Kashlog/ WL Matrech

1. Work register was not prepared.
2. Except RFO Chandī WL, no senior officer has done 1st TIER monitoring till the time of 2nd tier monitoring.
