# Third Party Monitoring and Evaluation of CAMPA Plantations and Other Activities

for the period  
2018-2019

Submitted to  
Kerala Forests & Wildlife Department (CAMPA)

**ICFRE - INSTITUTE OF FOREST GENETICS AND TREE BREEDING**

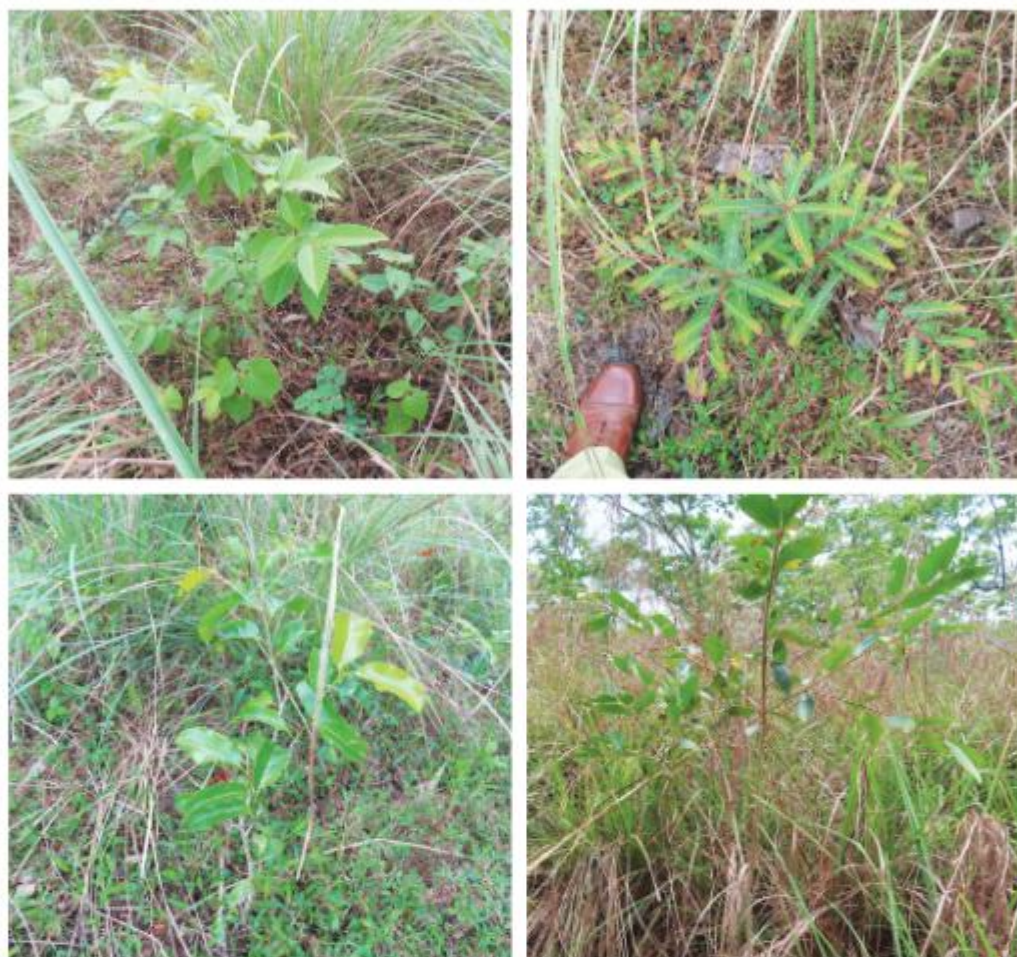
Survival of different species at Makkumchal plantation

This activity was carried out in Munnar Division. Of the 12 species planted only *Pongamia pinnata*, *Syzygium cumini* and *Terminalia paniculata* recorded more than 40 % survival.

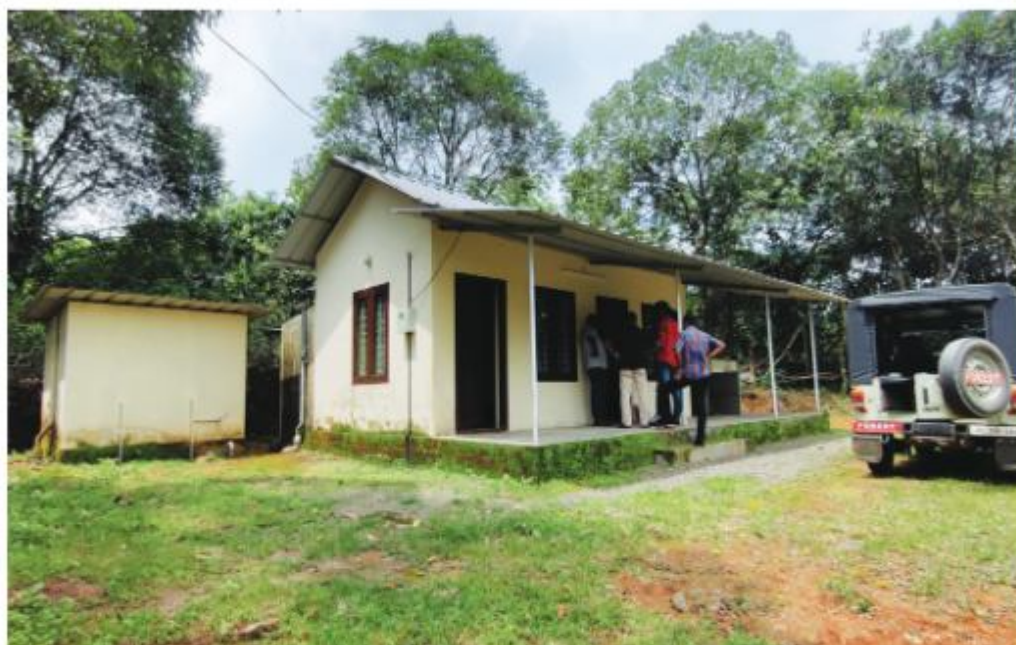
Campshed at Erumely

The works were evaluated for physical existence and quality. The specifications of the camp sheds were checked with measurement books and vouchers and verified the expenditure.

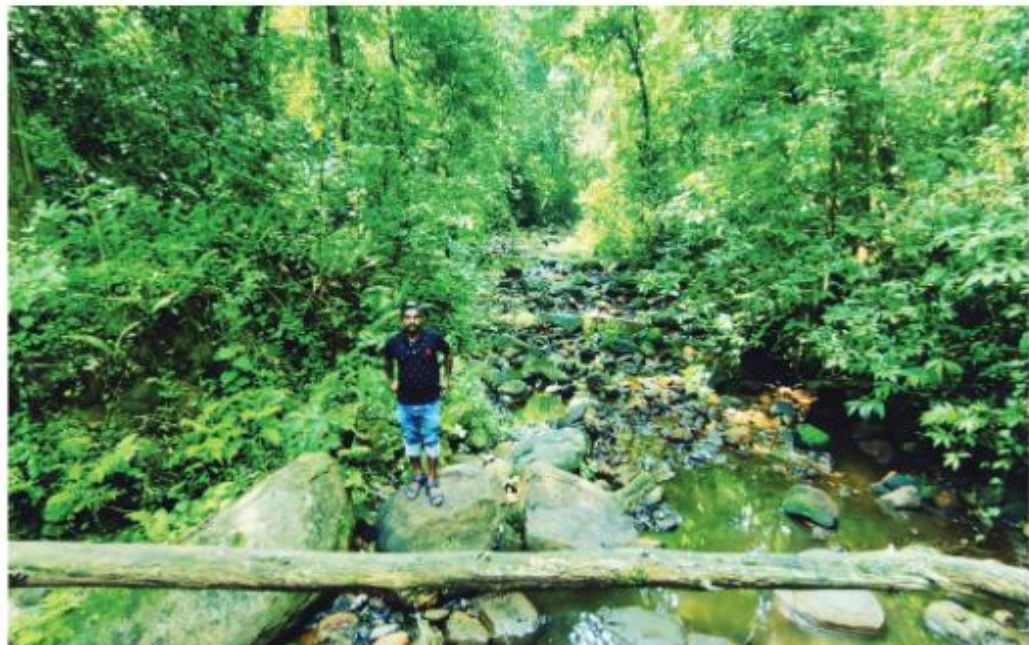
Gully at Bluvady

Under the soil water conservations the gullies and water holes made were inspected for their physical appearance and quality and found good wildlife. The records are verified and found correct.

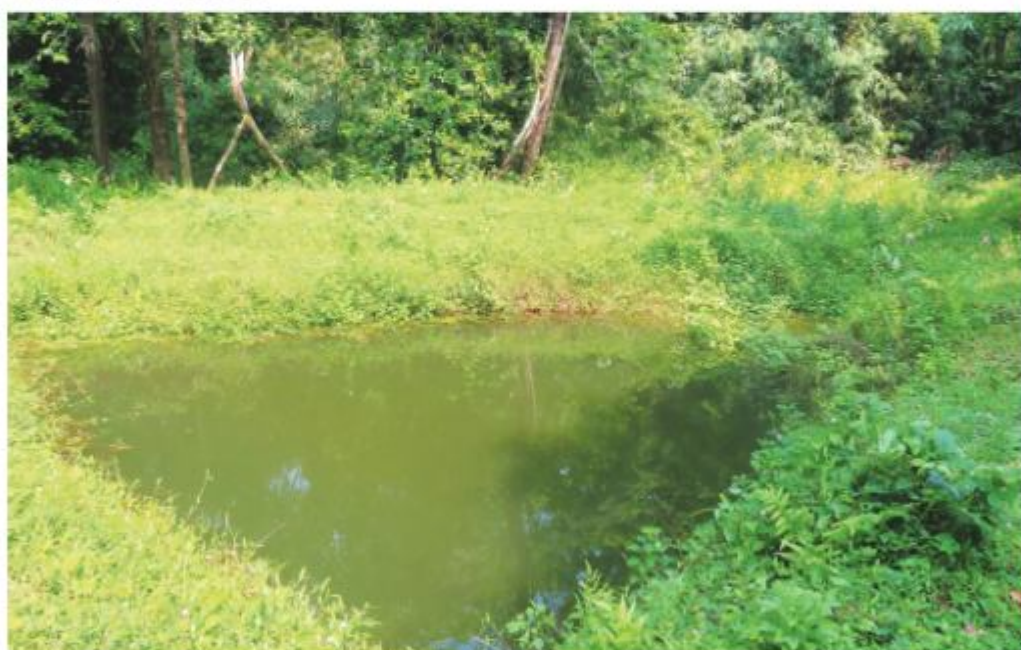
Munnam Mile Water Hole

3.	Munnam Mile Water Hole/ Munnar, Neriamangalam	Water is stored at full level for the wildlife.	This water hole is mostly used to provide water for animals. Well maintained.	9	High

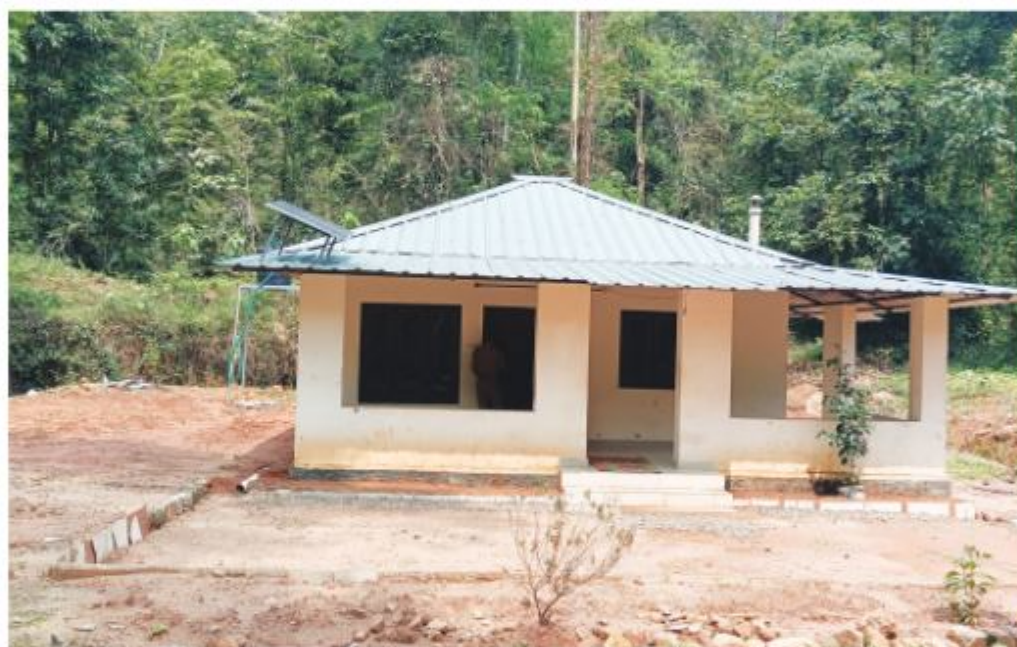
Camp shed at Chittar

Sl. No.	Type of Assets / Division / Range	Type of current use/ Observations	Impact	Score (Low, ≤ 3, Medium >3 to <7, High 7 to 10)	Assessment on the quality of the asset - Low, Medium or High
1.	Camp Shed at Chittar, Achenkovil division	The shed is maintained well.	The shed is useful for the frontline staff.	7	High

The camp shed was evaluated for its physical existence and quality. The specifications of the camp shed was checked by physical measurements and verifying the vouchers and estimates. The camp shed is well maintained which is useful for the frontline staff.

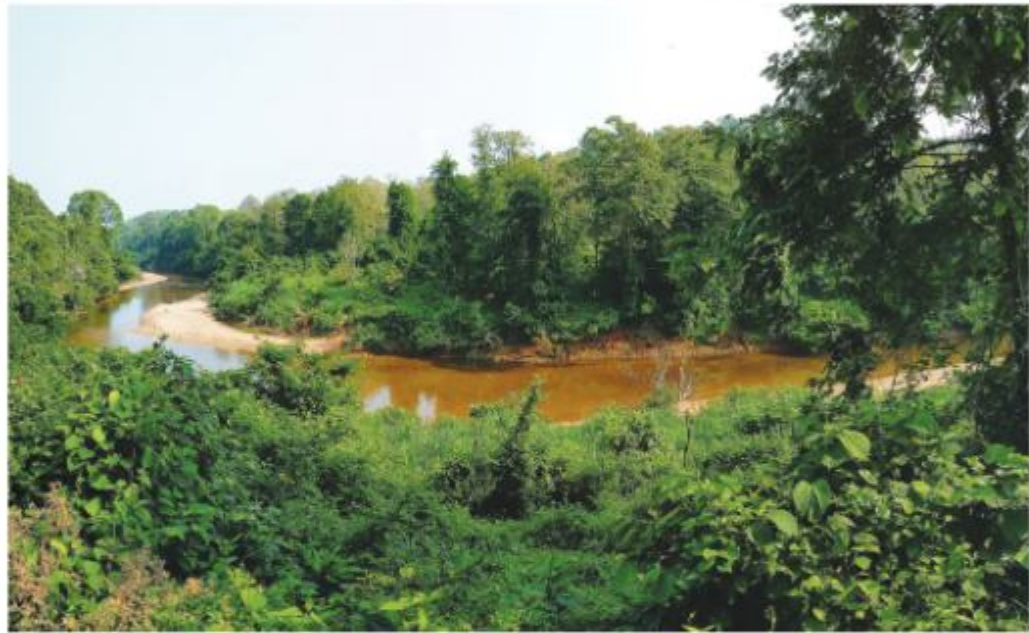
Divisions	Area of Planting	Species	Survival (%)	Observations of the Evaluation Team
				<p>The weeds <i>Glycosmis pentaphylla</i>, <i>Jatropha curcas</i>, <i>Scoparia dulcis</i>, <i>Rorippa indica</i> and <i>Acacia initia</i> were observed</p> <p>River width increased by 5m in both sides. The field was highly infested with weeds and the saplings were damaged due to elephant and wild boar grazing.</p>

River Bank Stabilisation along Achenkovil river in Konni Division

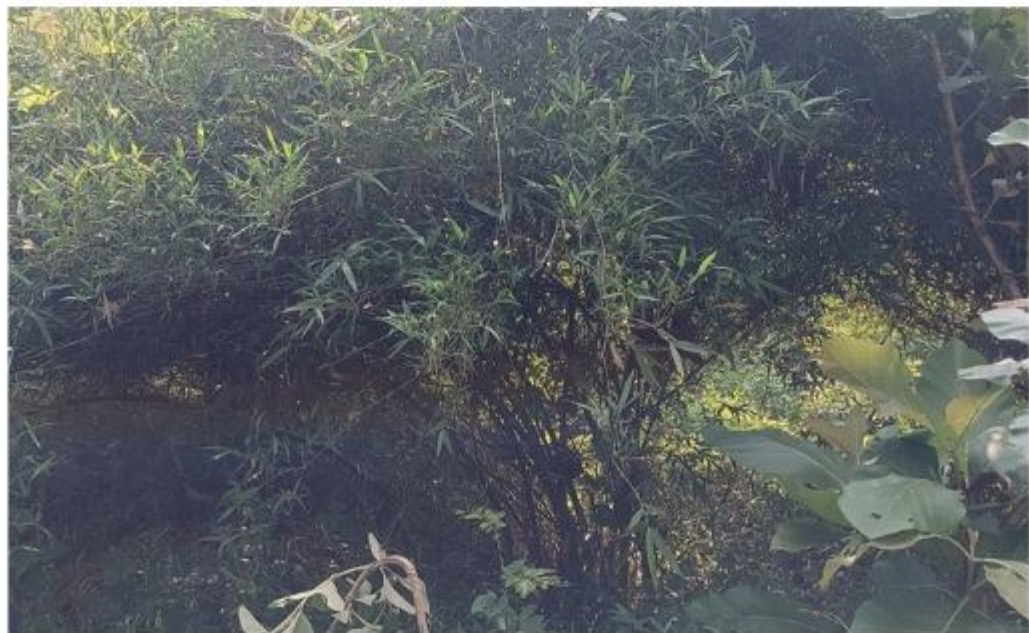
Successful establishment of bamboos in river bank stabilisation

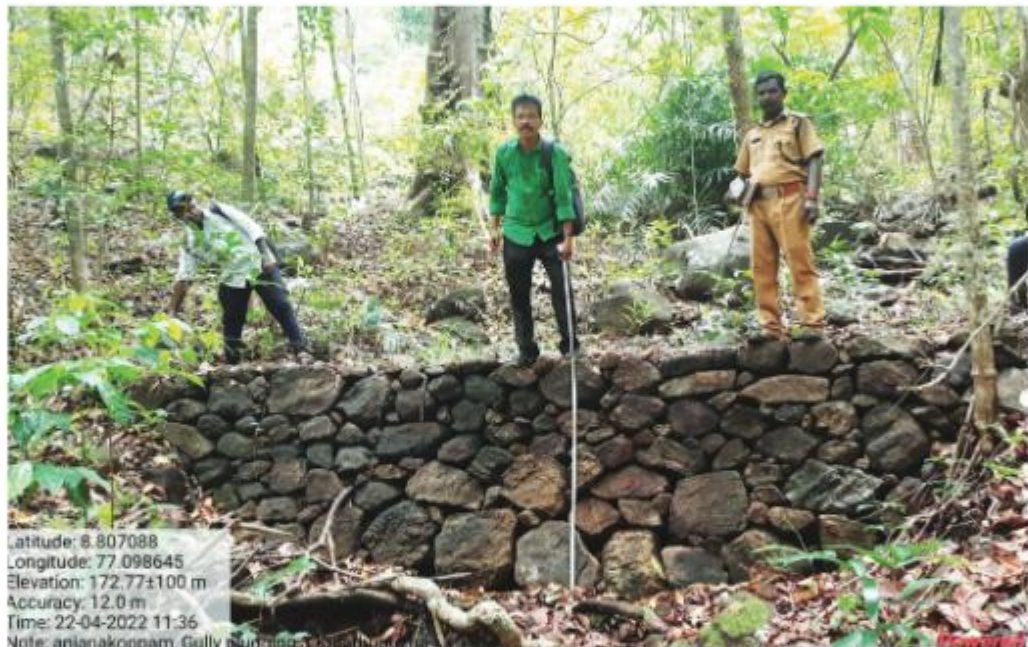
Gully plugging at Anchanakkoppam

Sites	GPS Location	Dimensions (m)	Observations of the Evaluation Team
Anchanakkoppam Reach II, Sankily, Kulathupuzha	N08°48'25.6" E77°05'54.6"	1.9 x 1.5 x 5.1	Sketch and dimensions mentioned in the Measurement (M) book found to be same. Bills and records were maintained well. Gully plugs are found to be intact and good.
Kocharappinchola, Vithura, Paruthipally	N08°46'26.3" E77°02'36.7"	1.8 x 1.4 x 8.5	Sketch and dimensions mentioned in the Measurement (M) book found to be same. Bills and records were maintained well. Gully plugs are found to be intact and good.
Dally, Mylamood, Kulathupuzha	N08°51'11.18" E77°03'57.82"	11.50 x 0.75 x 20	Sketch and dimensions mentioned in the Measurement (M) book found to be same. Bills and records were maintained well. Gully plugs are found to be intact and good.

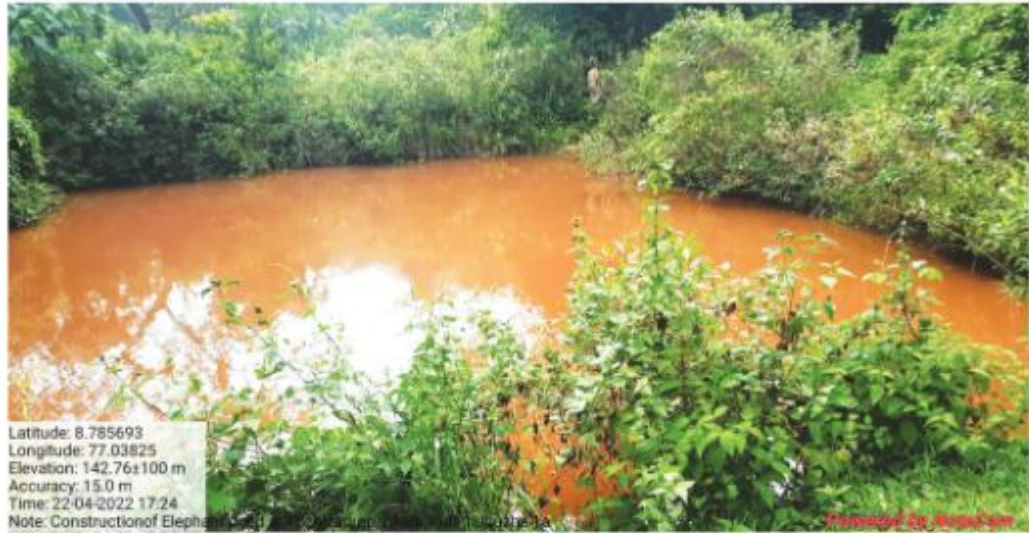
Elephant Pond at Kozhiyappankala

Sites	GPS Location	Year of Construction	Dimensions (m)	Observations of the Evaluation Team
Poovathinmoodu, Mylamood, Kulathupuzha	N08°50'11.90" E77°05'26.60"	2018-19	12 x 0.80 x 15	Sketch and dimensions mentioned in the Measurement (M) book found to be same. Bills and records were maintained well. Elephant ponds are found to be intact and good.
Kozhiyaruppankala, Chittar North	N08°47'07.94" E77°02'17.84"	2018-19	10 x 1.5 x 15	Sketch and dimensions mentioned in the Measurement (M) book found to be same. Bills and records were maintained well. Elephant ponds are found to be intact and good.
Oduchuttapadukka, Chittar South, Kulathupuzha	N08°46'24.9" E77°02'35.9"	2018-19	10 x 1.5 x 15	Sketch and dimensions mentioned in the Measurement (M) book found to be same. Bills and records were maintained well. Elephant ponds are found to be intact and good.
Nallumarudia -moodu, Vithura, Paruthipally	N08°46'26.3" E77°02'36.7"	2018-19	10 x 1 x 15	Sketch and dimensions mentioned in the Measurement (M) book found to be same. Bills and records were maintained well. Elephant ponds are found to be intact and good.

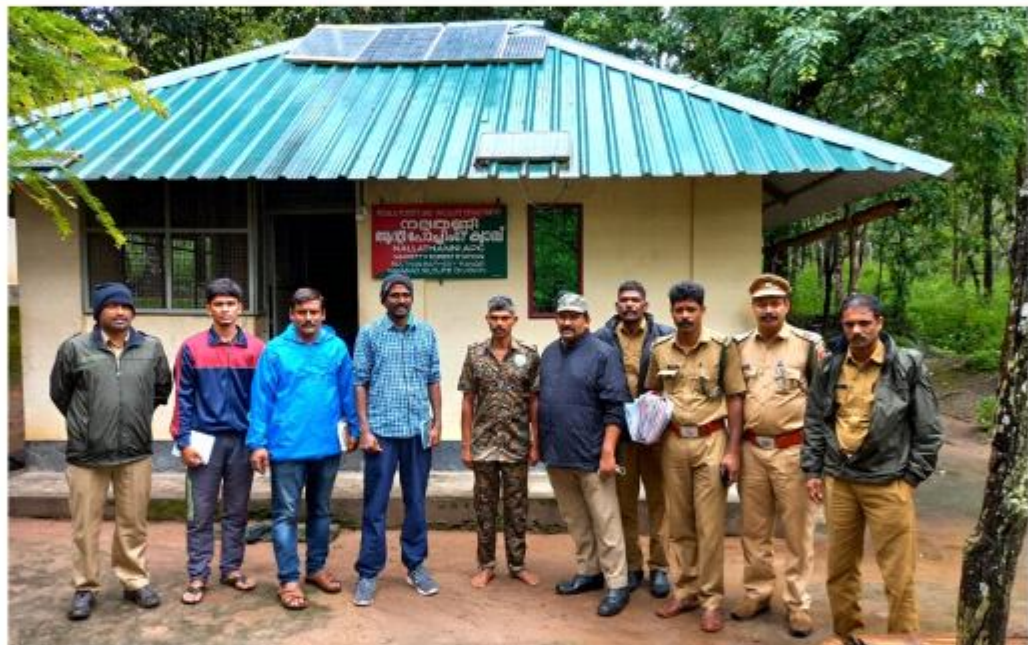
Camp Shed at Naiketty Section

Sl. No.	Type of Assets / Division / Range	Type of current use/ Observations	Impact	Score (Low, ≤3, Medium >3 to<7, High 7 to 10)	Assessment on the quality of the asset - Low, Medium or High
1.	Campshed/ Wayanad division/ Sulthanbatory	The shed is maintained well.	The shed is useful for the frontline staff.	7	High
2.	Camp shed/ Parambikulam division/ Karimala range	The shed is maintained well.	The shed is useful for the frontline staff.	7	High

The camp sheds were evaluated for physical existence and quality. The specifications of the camp sheds were checked by physical measurements and verifying the vouchers and estimates. The camp sheds are well maintained and is useful for the frontline staff.

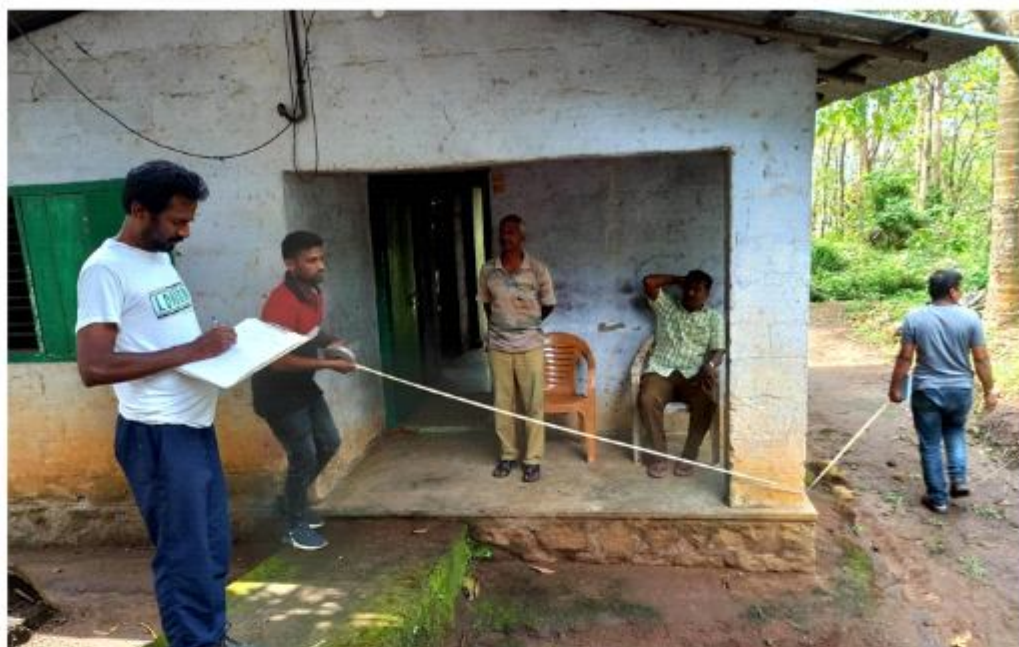
Campshed at Parambikulam

Sites	GPS Location	Dimensions (m)	Observations of the Evaluation Team
Camp shed / Chavachi/ Aralam	N11°55'43.85" E76°26'31.92"	4x3.5	The maintenance of the structure is in good condition
Camp shed/ Keeripara/ Bhavani/ Silent Valley	N11°55'41.5" E76°54'10.5"	4.5x1.5x4	The maintenance of the structure is in good condition.
Camp shed/ Pooparai/ Karimala/ Parambikulam	N10°35'73.11" E76°81'36.35"	5.5x5.5	The maintenance of the structure is in good condition.

The works were evaluated for the physical existence and for the quality. The specifications of both camp sheds were checked by verifying the old vouchers and the estimates.

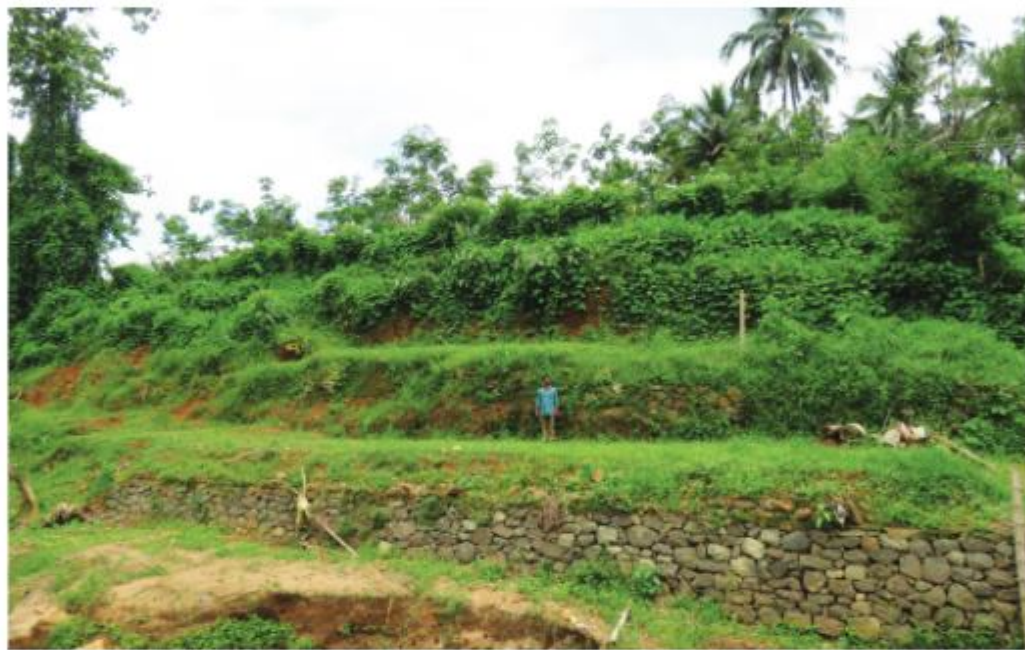
Kayyala in Periyar (West) Division

GPS Location	Dimensions (m)	Observations of the Evaluation Team
N09°27'33.05" E76°58'.03.9"	Foundation: 1 x 26 x 0.3 Super structure: 36 x 1.3 x 1.50	Construction of stone kayyalas for forest boundary

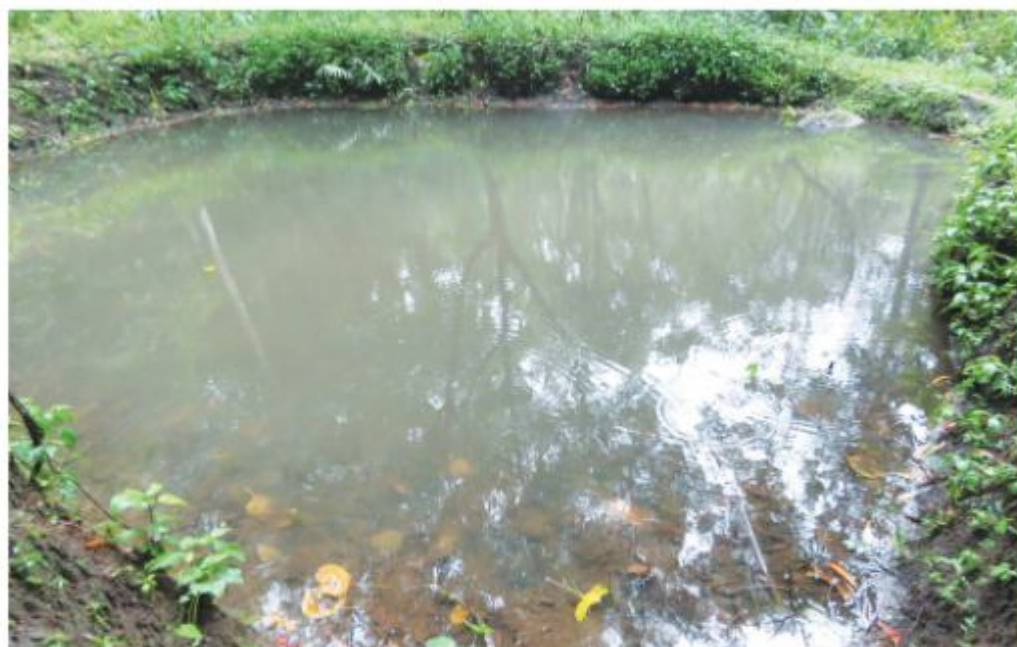
The ponds were created at Kaduvethanam, Thalikanam, 4<sup>th</sup> mile, and Jollymala (7). There was an increase (14.5 %) in expenditure as the activity had to be undertaken in difficult, rigid and rock like conditions.

Pond hole at Thalikanam

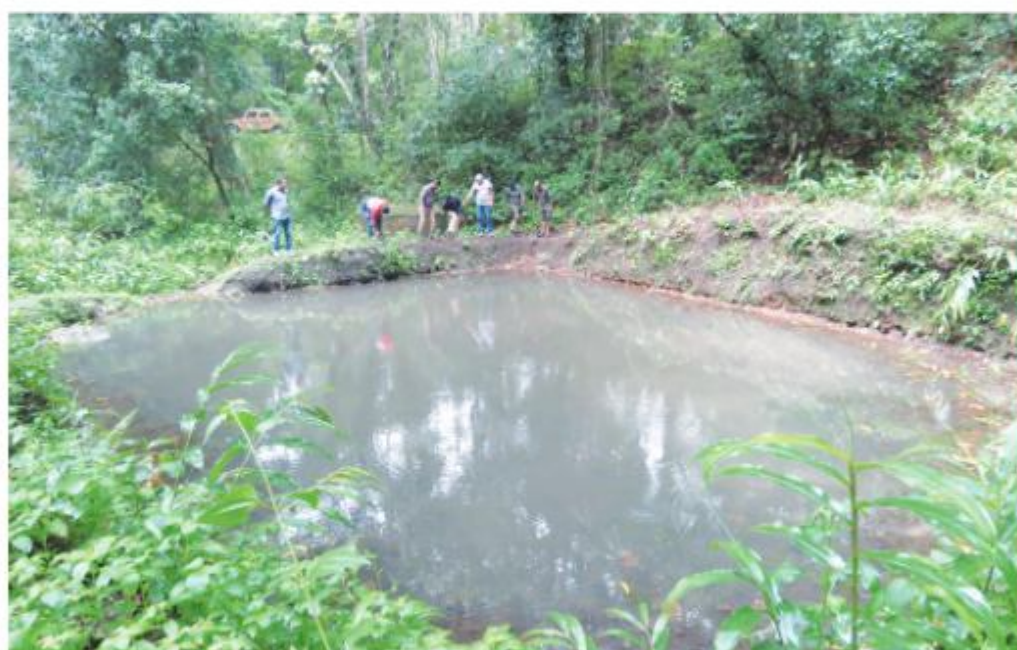
Pond hole at Jollymala

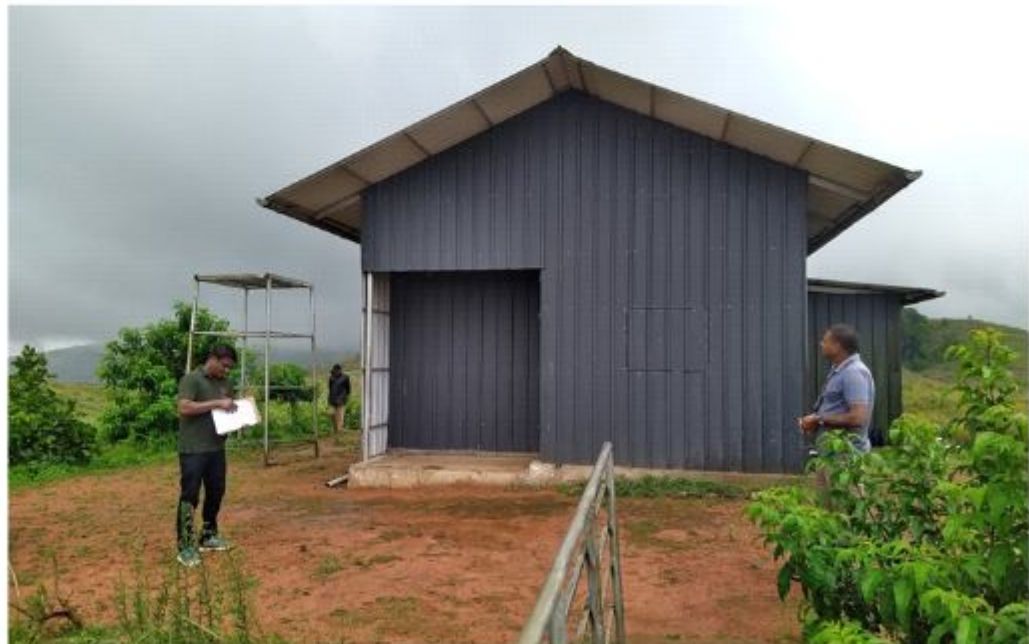
Campshed in Idukki Range

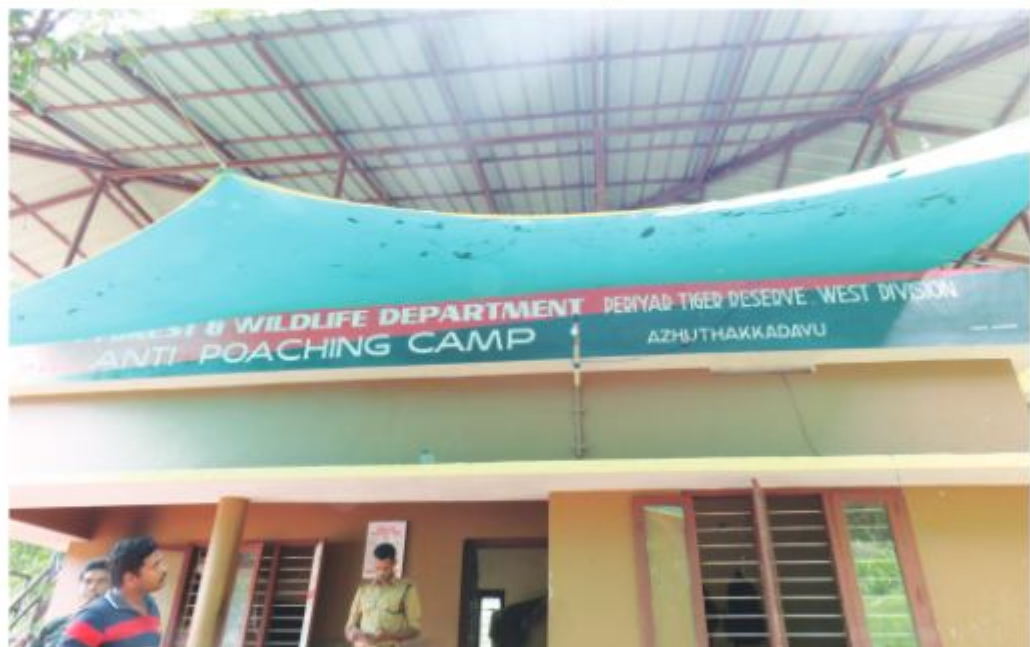
Anti Poaching Camp at Azhuthakadavu

The camp shed constructed at 12 locations were evaluated for their physical existence and the quality of the asset. The specifications of the camp shed was checked by physical measurements and verifying the vouchers and estimates. The camp sheds are well maintained and useful to the frontline staff.

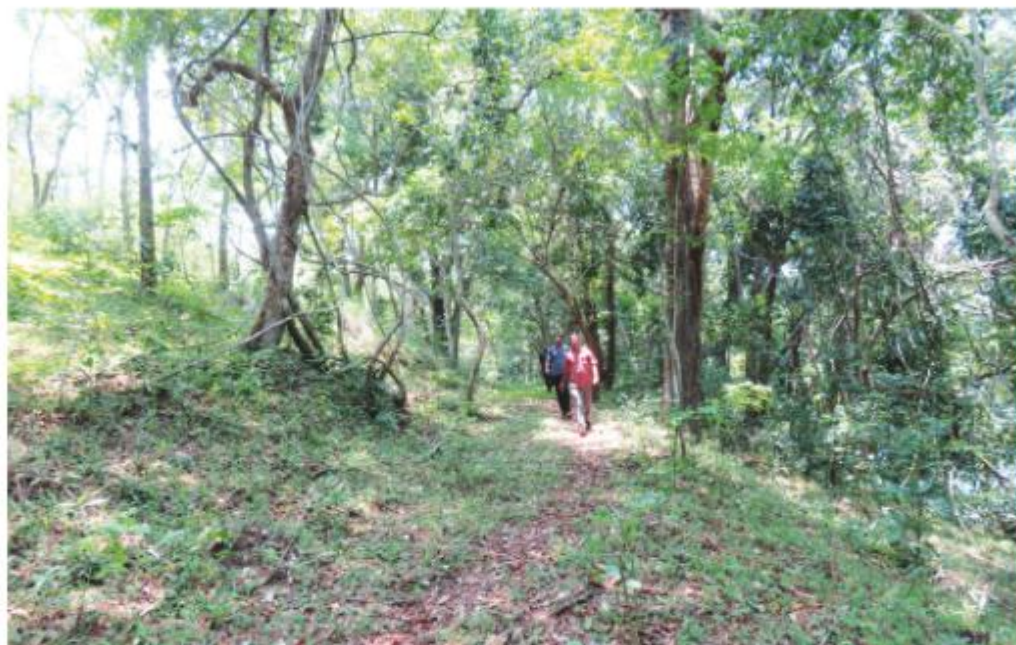
The activities were verified through inspection of records and found correct.

Trek Path at Kanamudiyoram

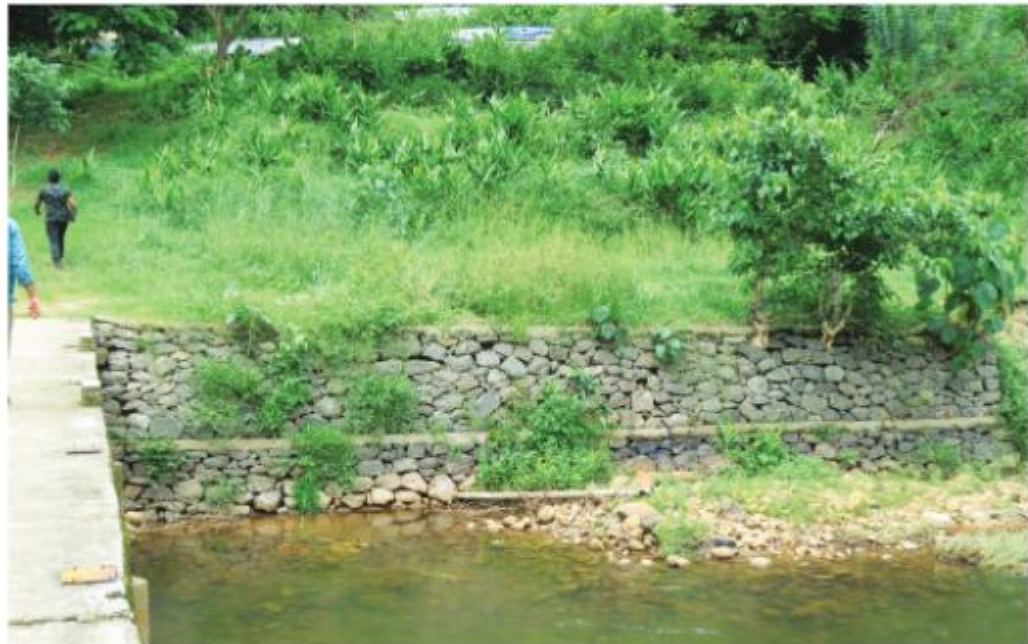
Divisions	Dimensions	Observations of the Evaluation Team
Azutha River Moolikkal area / Pampa / PTR(W)	Foundation: 8.1 m <sup>3</sup> Super structure : 14.49 m <sup>3</sup> Length: 18 m Width: 18 X 0.9 X 0.5 m Height : 18 X 0.7 m	Concrete cement, bricks and dryable hard stone were used for river bank stabilization.

River bank stabilisation along Azutha River

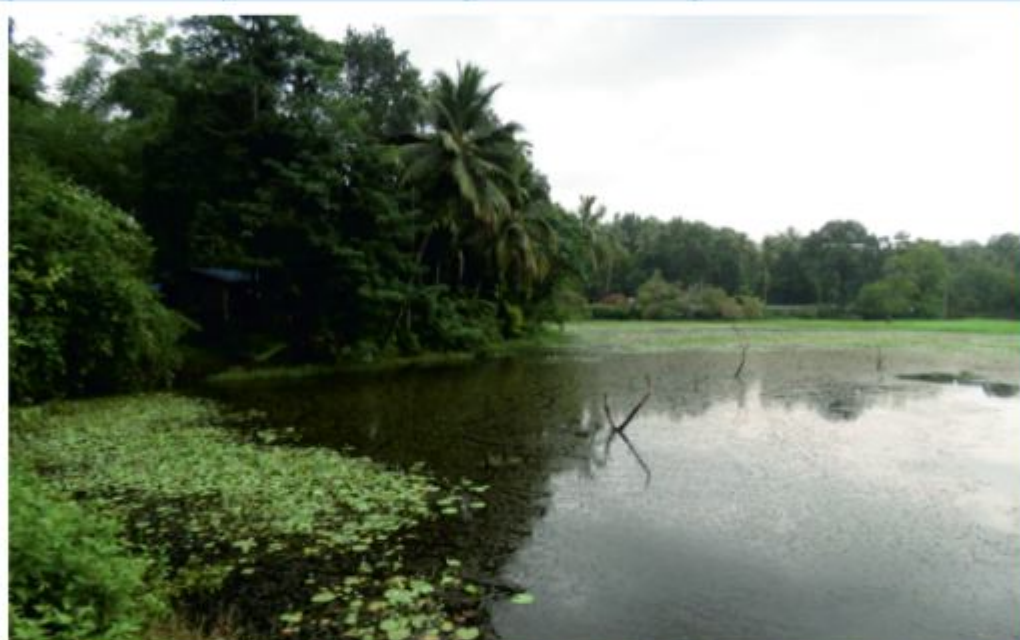
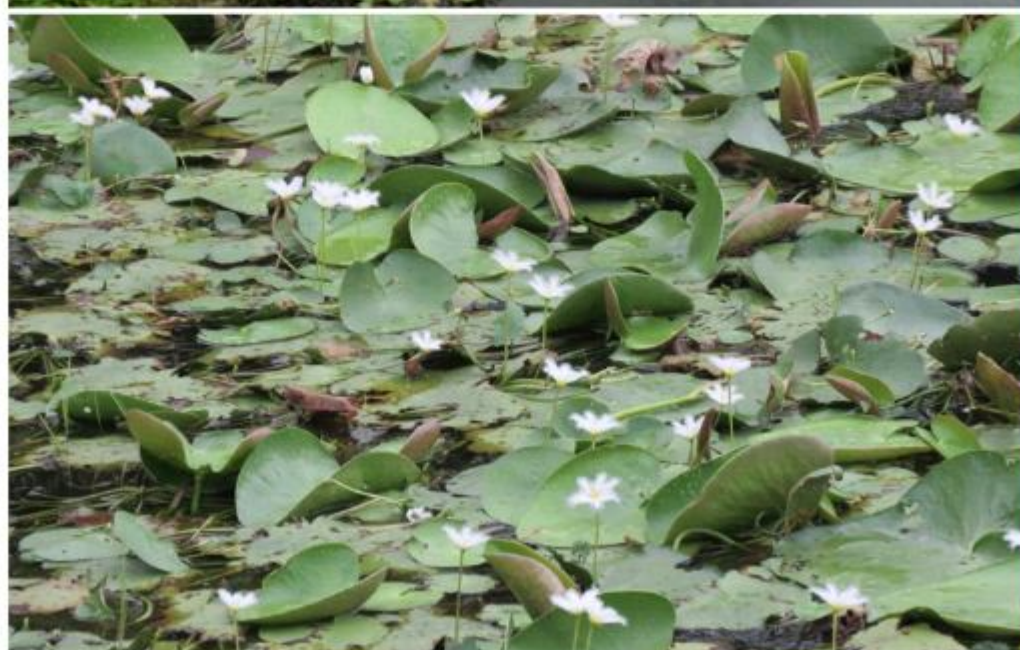
Aquatic weed eradication in Thattekad Bird Sanctuary

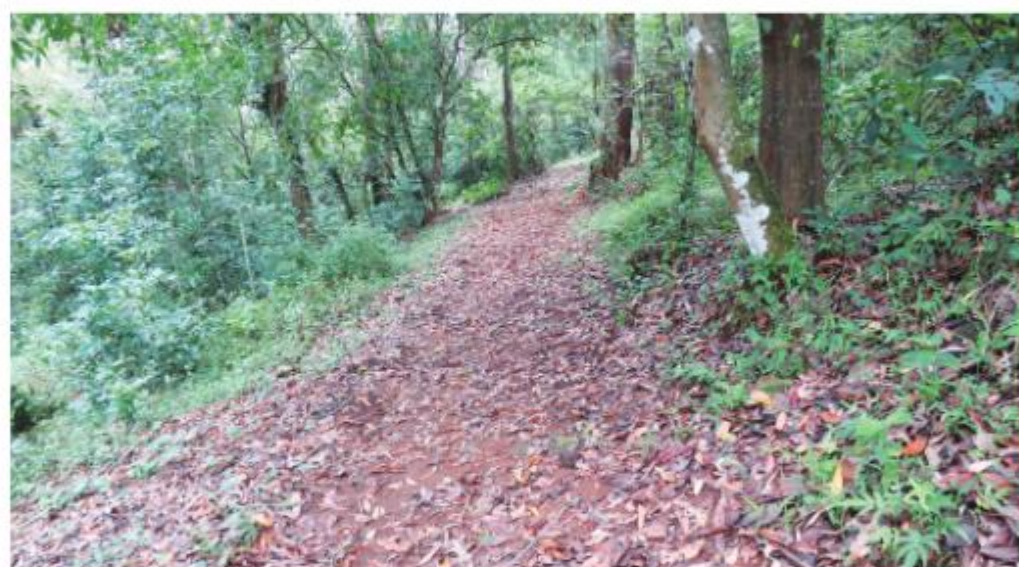
Trek path in PTR (East)

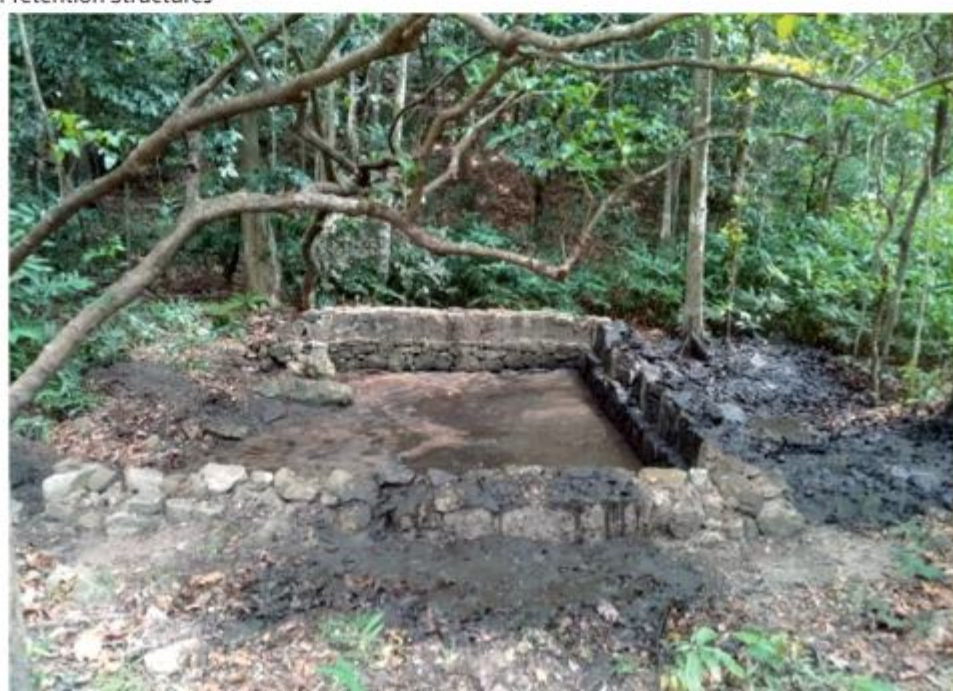
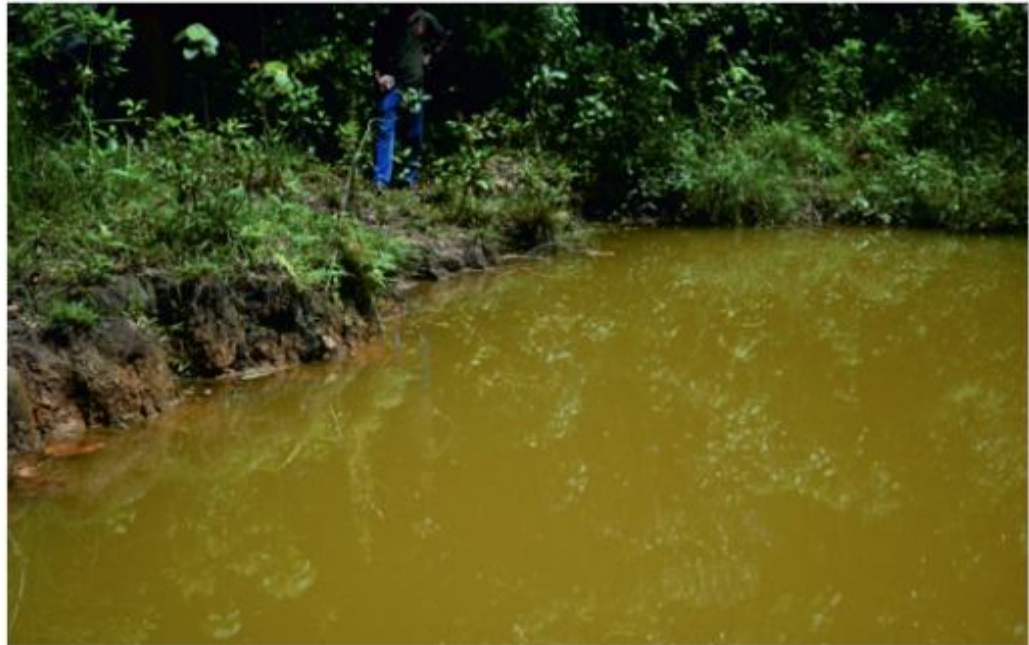
\*The elephant pond at Karingakala has been maintained very well with the structure deepened to meet the requirement of the animals.

Elephant Pond at Karingamala

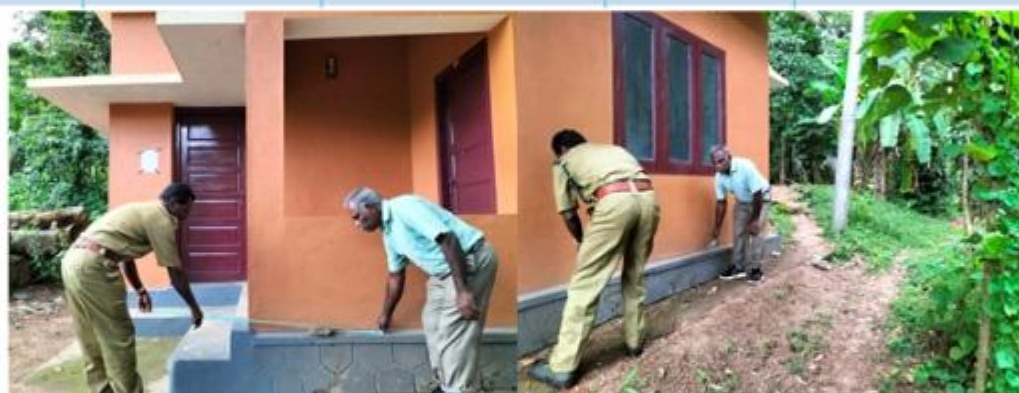
Camp Shed at Chakkapara

The works carried out for interior camp shed was verified for their existence and quality. The specifications of the camp shed were checked by verifying vouchers and the estimates and found correct.

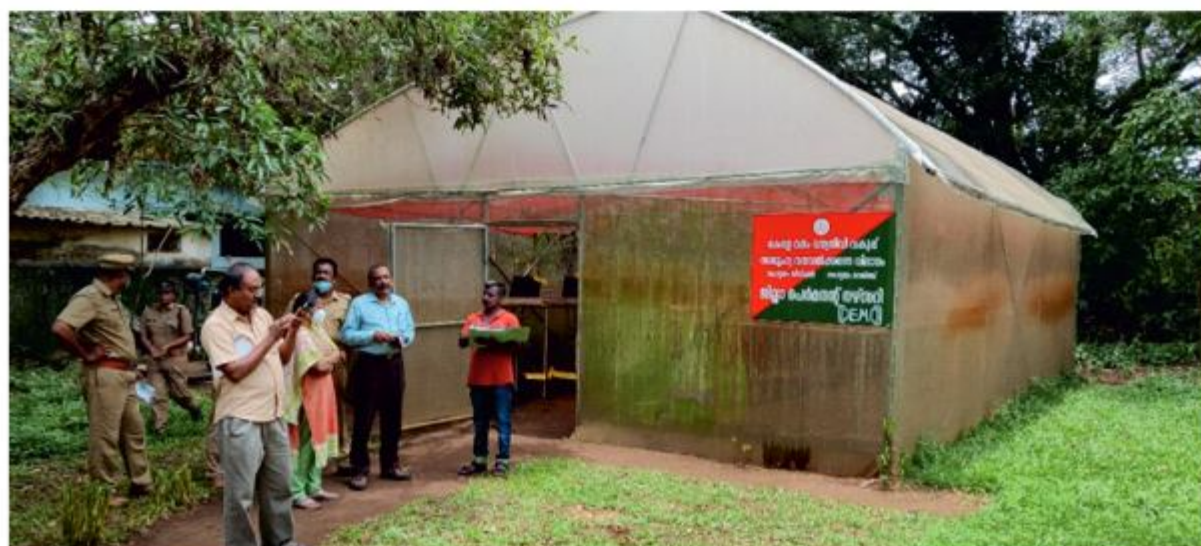
**Compost Mixing Unit & Net Fencing around Central Nursery**
