# **Third Party Monitoring and Evaluation of Compensatory Afforestation Fund Management and Planning Authority (CAMPA) Activities of Andhra Pradesh Forest Department (APFD) During 2017-18**

**INSTITUTE OF WOOD SCIENCE AND TECHNOLOGY**  
**(Indian Council of Forestry Research & Education)**  
18<sup>th</sup> Cross, Malleswaram, Bangalore – 560 003  
October 2025

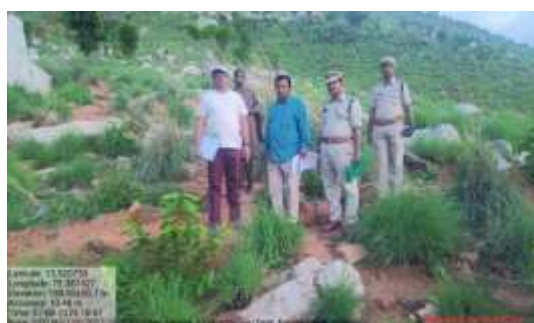
**Rayalacheruvu in Karvetinagar range**

1. Plantation outcomes were polarized: Rayalacheruvu collapsed almost entirely, while Thimmasamudram achieved exemplary survival and growth of *Pterocarpus santalinus*.
2. Maintenance works were widespread but inconsistently executed, with gaps in weed control, fertilizer application, and record-keeping.
3. Fire line creation was adequate in coverage but weak in upkeep, with several lines obscured by weeds.
4. Soil and Moisture Conservation was negligible, with only one trenching work carried out in the entire division.
5. Financial records were strong, but technical documentation and GIS verification revealed persistent mismatches in plantation area.
6. Community participation was entirely absent, undermining the long-term sustainability of plantations.

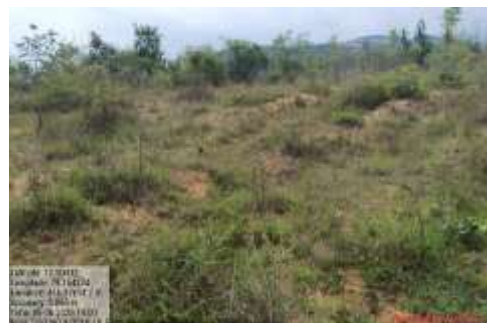
**Nendragunta in Tirupati range**

**Biotic (Human/Cattle) Pressure:** Biotic pressure from grazing and browsing was generally low; only limited incidences were observed at Rayalacheruvu, very few at Kasaram, Thimmasamudram, Ambakam, while comparatively higher grazing and browsing pressure was noted at Nendragunta.

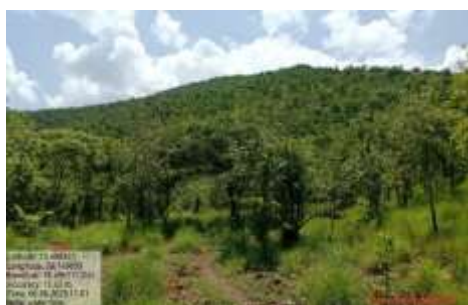
**Fire lines in Vagathur beat**

New fire lines in Vagathur beat of Puttur range and Ambakam beat of Sathyavedu range were monitored and evaluated against the specifications recorded in the measurement book and actual field conditions. At both locations, the fire lines were constructed with a uniform width of 6 meters, while the lengths varied—2,000 meters in Vagathur beat and 2,500 meters in Ambakam beat. In Vagathur beat, the fire line was visible, though moderate grass and weed growth was observed, indicating that the line was maintained but required additional clearing. In Ambakam beat, the fire line was clearly visible along the inspection path with no dense grass or weed growth, reflecting good maintenance throughout the natural forest area.

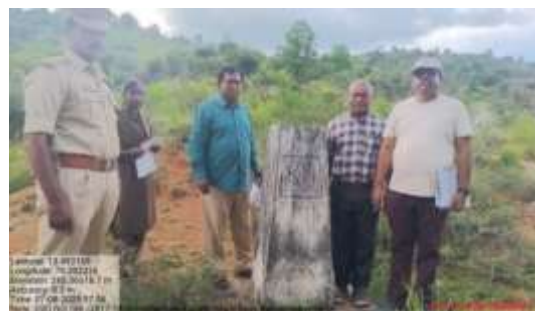
RCC pillars in Karvetinagar section

Karvetinagar Range (Rayalacheruvu, RKM Puram, Bathikandriga beats): 40 pillars were constructed with dimensions of 1.20 m height, 0.45 m top width, and 0.50 m bottom width. Field measurements matched the specifications without deviations. All pillars were in good condition and effectively served their purpose of boundary demarcation.

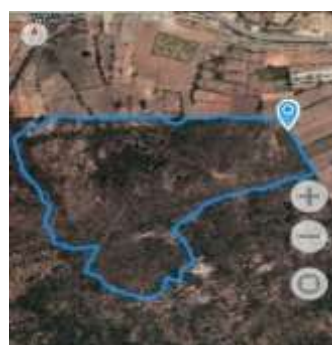
**Thotakanuma 22.27 Ha**

Perambulation of plantation areas revealed that the physically verified extents were consistently larger than the officially recorded areas. At Thotakanuma, the perambulated area exceeded the records by 2.27 hectares, while at Keenatampalle and Santhapeta, the excess areas were 0.72 hectares and 0.53 hectares, respectively. Similarly, at Thettu, the perambulated area was found

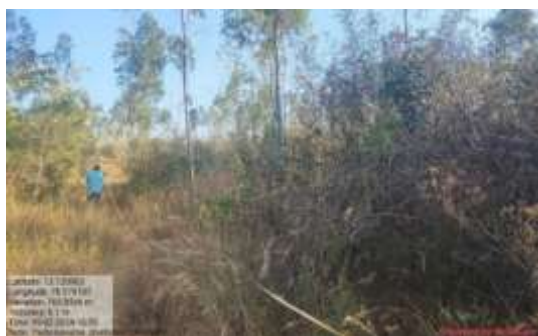
Thotakanuma Plantation

**Health Status of Plantations:** At some sites such as Thotakanuma, visible insect and pest damage to leaves and stems was observed, indicating ongoing infestations that may reduce overall health, growth, and survival rates if not addressed. In other plantations, including, Thettu, Keenatampalle, and Santhapeta, no incidences of pest or insect damage were recorded, and the plantations appeared healthy.

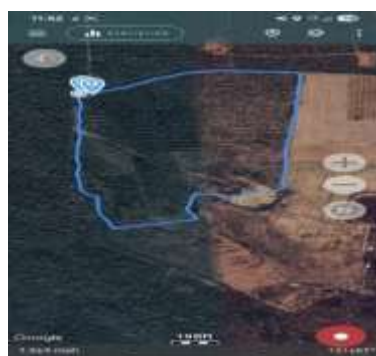
**S.R Palem 10.81 Ha**

- S R palem Plantation (Rajampet range) (28 Ha): 10.81 Ha (lesser by 20.19 Ha but 2.14 Ha exceeded than the affected area)
- Shikaripalem (Sanipaya range) (25 Ha): 59.74 Ha (exceeded by 34.74 Ha)

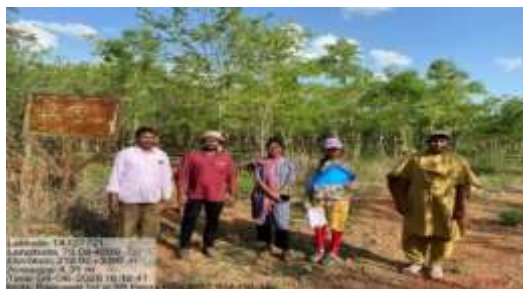
S.R Palem, Rajampet range

**Health Status of Plantations:** Field observations revealed that the overall condition of the plantation was satisfactory; however, pest-related damage was observed in *Terminalia* species at Rajampet range, necessitating close monitoring and timely remedial measures.

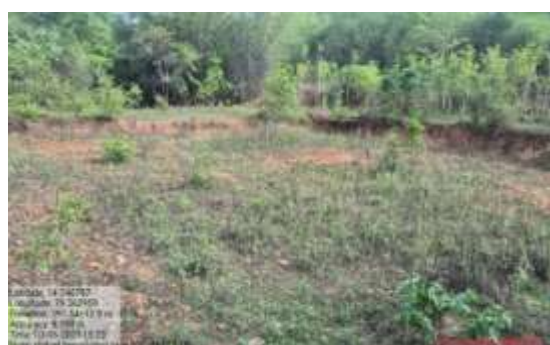
Rajukunta beat, Chitvel range

Mini percolation dam constructed in Rajukunta beat were monitored and evaluated against the specifications recorded in the measurement book and the actual field measurements. The dimensions of the mini percolation tank were: Length- 20 m, width- 15 m and depth- 1.00 m with volume 300 cum. The percolation tank, located in a low-lying area, has accumulated silt due to water overflow during the monsoon. While the structure remains intact, it is covered with silt. De-silting is necessary to restore its full storage capacity.

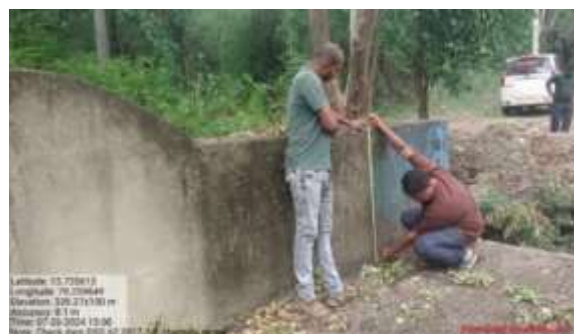
**Pulibonu Bhavi, Chamala range**

Check dam constructed in Pulibonu Bhavi locality was monitored and evaluated against the specifications recorded in the measurement book and the actual field measurements. The dimensions of the check dams were: main dam length – 16 m, breadth – 1.2 m, and depth – 0.45 m. The field measurements matched those in the measurement book, indicating no deviations. Major repairs are required in the apron section of the check dam. De-silting is necessary to

restore and enhance the water storage capacity. Seepage has been observed from both the body wall and the core wall, indicating potential structural concerns. Immediate repair work is recommended for the body wall and apron to prevent further deterioration

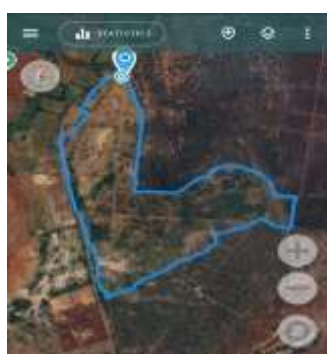
**Marupuru 25.23 Ha**

- 20 Ha NTSH Marupuru plantation (Nellore): Exceeded by 5.23 Ha
- 20 Ha RS Ponugodu plantation (Atmakur): Exceeded by 10.41 Ha
- 20 Ha RS Chowdavaram plantation (Kavali): Exceeded by 0.93 Ha
- 20 Ha NTSH Kaniyamapadu plantation (Udayagiri): Exceeded by 3.08 Ha
- 20 Ha NTSH Sreerampalli plantation (Venakatagiri): Exceeded by 3.07 Ha
- 20 Ha NTSH Yeturu plantation (Rapur): Exceeded by 2.4 Ha

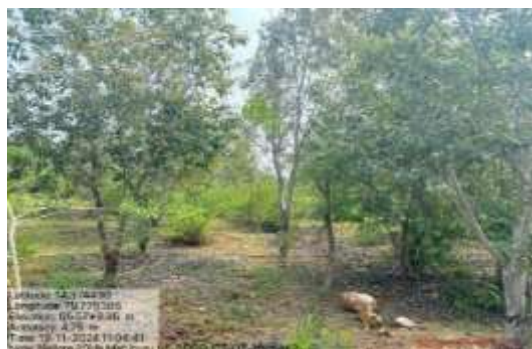
**Marupuru plantation, Nellore range**

During the field visit, it was observed that the plantation board at Marupuru (Nellore range) was damaged. It is recommended that appropriate signage be installed to facilitate site identification, enhance visibility and support ongoing monitoring and management efforts.

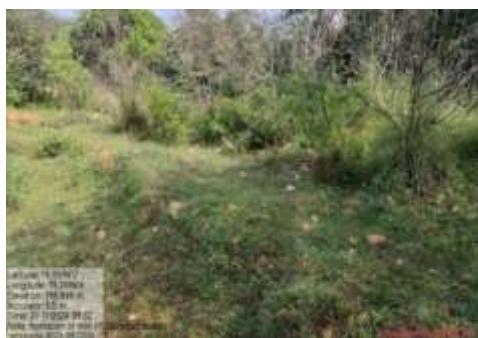
**Mini PT at Arlapadia beat**

The mini percolation tank at Arlapadia beat was monitored and evaluated against the measurement book specifications. Its dimensions- length 23 m, width 4 m and depth 0.90 m- show deviations from the recorded measurements. Silt accumulation has reduced the tank's capacity. However, due to inadequate maintenance, the percolation tank located in a low-lying area has experienced significant silt accumulation. Additionally, overflow during the monsoon has caused displacement and distortion of the stone dry packing along the edges. To restore and maintain the tank's full storage capacity, regular de-siltation and repair of the stone packing are recommended.

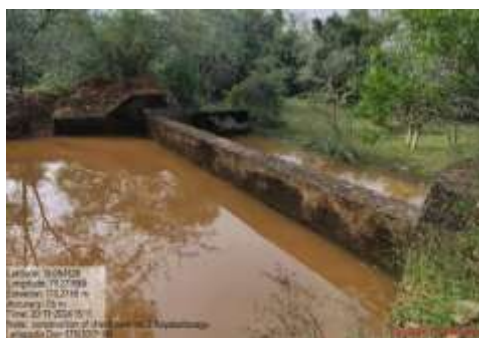
**Check dam in Arlapadia beat**

The check dam constructed across Peddirlapadu in Arlapadia beat was monitored and evaluated against the specifications recorded in the measurement book. The original dimensions were 9 m in length, 1.8 m in width and 1.2 m in depth; however, field measurements showed a reduced depth indicating deviations from the recorded specifications. Despite this, the dam is well maintained. The water holding capacity has decreased due to silt and sediment accumulation which has reduced the total volume. Minor repairs are needed on the apron, and de-silting is recommended to restore the dam's storage capacity.

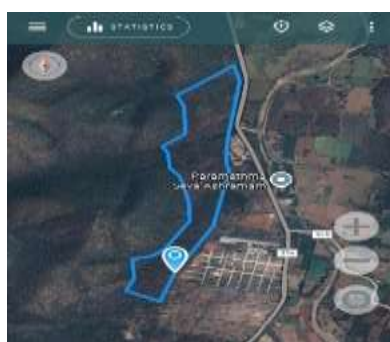
**Kanumalopalli 25.09 Ha**

The Perambulation was done in presence of forest officer and as per the demarcation shown by the watcher/guard working as in-charge of the plantation. The perambulated area was found to be slightly larger than the officially recorded extent. This variation resulted from natural field constraints such as rocky terrain, dense jungle growth, trenches and barren patches which necessitated traversing the outer accessible boundary rather than the exact demarcated limits. At Kanumalopalli plantation, the perambulated area measured 25.09 hectares against the recorded 20 hectares, showing a marginal excess of 5.09 hectares. These findings were validated through spatial data analysis using QGIS software and further confirmed through complete boundary walks with the Geo Tracker mobile application. Photographic evidence collected during the exercise supports the observations.

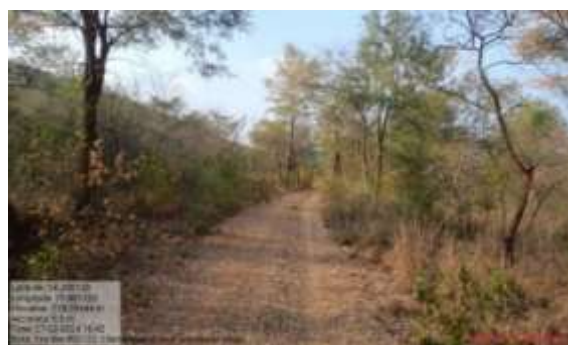
**Chintarajupalli, Vontimitta**

A fire line was created and maintained in Idupulapaya beat and Chintarajupalli section under CAMPA-NPV (forest fire management) scheme was monitored and evaluated against the specifications recorded in the measurement book and the actual field measurements. The dimensions of new fire lines are width – 3 m and length – 2000 rmt. The field measurements matched those in the measurement book, indicating no deviations. Both fire lines is found to be well maintained and clearly visible as it is established along the baseline near the Red Sander Park. No weed growth was observed indicating effective maintenance across the natural forest.

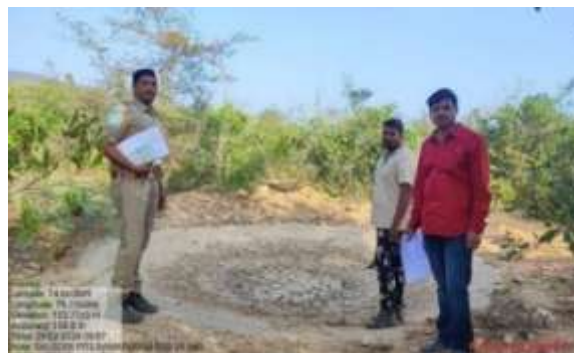
Three saucer pits were constructed across Ramapuram beat, each measuring 3.14 m in length, 7.02 m in width and 0.15 m in depth. Field measurements matched the recorded specifications with no deviations. Of these, two saucer pits were found to be in good condition and well maintained. However, desilting is recommended to increase their storage capacity.

Saucer pits at Ramapuram beat

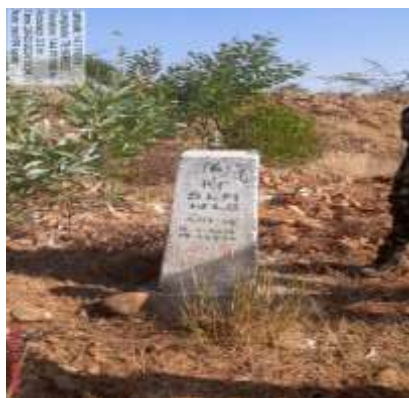
RCC cairns at Lothuvanka beat

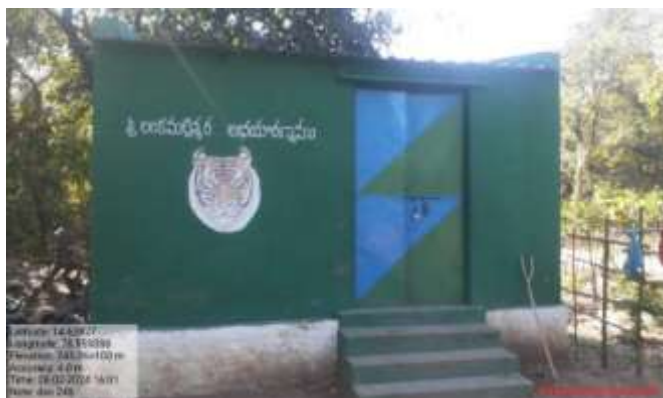
A residential shed was constructed at the Reddibavi base camp in Balayapalli beat. The structure includes long walls (2) measuring  $0.60 \times 4.37 \times 0.60$  m, short walls (2) at  $0.60 \times 2.17 \times 0.60$  m, one door measuring  $0.23 \times 1.20 \times 2.10$  m and three windows each measuring  $0.23 \times 1.20 \times 1.35$  m. Field measurements confirmed full alignment with recorded specifications, with no deviations. The shed is well maintained and in good condition providing a safe and functional living space for forest watchers stationed in this remote area. The facility supports their efforts in monitoring illegal activities and recording wildlife sightings. Both electricity and water facilities have been provided to ensure comfort and operational efficiency.

Residential shed at Balayapalli beat

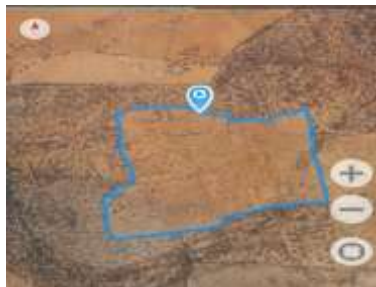
**Belguppa 25.71 Ha**

Measurements were therefore taken along the outer boundary of these natural obstructions rather than the precise plantation limits. Plantation-wise findings Belguppa (20 Ha): 25.71 Ha (exceeded by 5.71 Ha). Verification was carried out with the assistance of the local Forest Beat Officer, using QGIS software and further confirmed through Geo Tracker application. Geotagged images were documented as evidence.

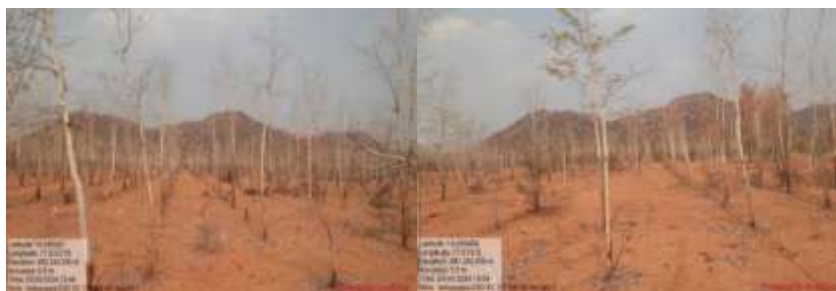
**Belguppa 20 Ha Plantation**

**Health Status of Plantations:** Field inspections revealed visible damage from insect and pest infestations across the plantation sites. While not widespread, the presence of pest activity indicates the need for regular monitoring and early intervention measures.

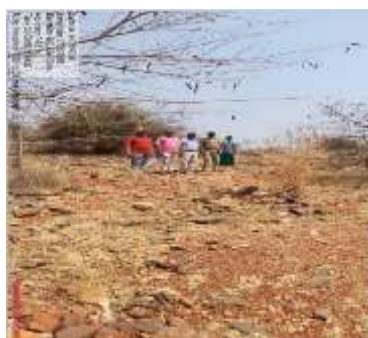
A fire line was created and maintained in the natural forest area of Marutla Beat in the Ananthapuramu Range, and similarly, in Eswaramala Reserve Forest (Compartment Nos. 1 and 3) of Edurudona Beat in the Kadiri Range. These fire lines were monitored and evaluated based on the specifications recorded in the measurement book, and verified through actual field measurements. In the Ananthapuramu Range, the new fire line measured 10 meters in width and 2,000 meters in length. In the Kadiri Range, the fire line measured 6 meters in width and 3,245 meters in length. Field measurements in both locations were consistent with the entries in the measurement book, confirming no deviations. The fire line in Ananthapuramu Range was established along an inspection path, ensuring clear visibility. In contrast, the fire line in Kadiri Range was not aligned with an inspection path or baseline, resulting in limited visibility. However, in both areas, no dense grass/weed growth was observed, indicating that the fire lines were well-maintained across the natural forest areas.

Fire lines in Marutla RF and beat

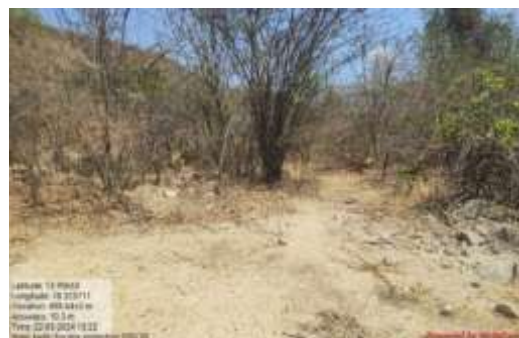
Fire lines in Eswaramala RF of Edurudona beat

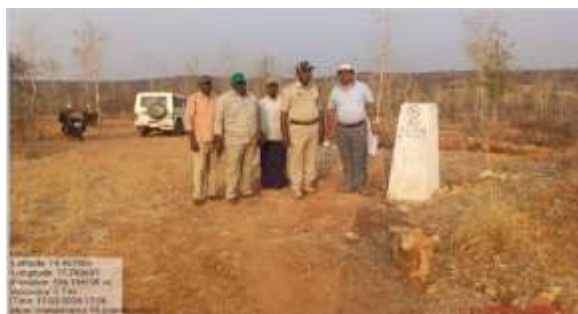
Construction of 15 boundary pillars in Kondapalli reserve forest, 67 RCC boundary pillars in Muchukota additional block-67 and 22 boundary pillars in Jonnavulapalli reserve forest area was monitored and evaluated against the specifications recorded in the measurement book and the actual field measurements. The above-ground dimensions of the RCC boundary pillars at both locations were: height – 1.20 m, top width – 0.30 m, and bottom width – 0.45 m. The field measurements matched those in the measurement book, indicating no deviations. All boundary pillars constructed in Kondapalli reserve forest and Muchukota additional block-67 area were found intact and effectively demarcating the forest boundaries.

Boundary pillars in Kondapalli RF

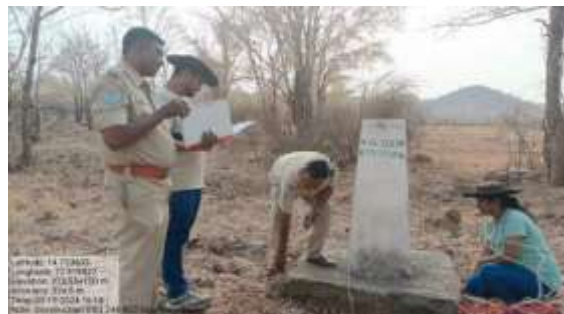
R.C.C. boundary pillars in Maddipalli

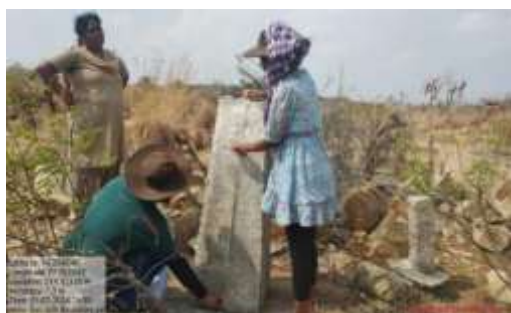
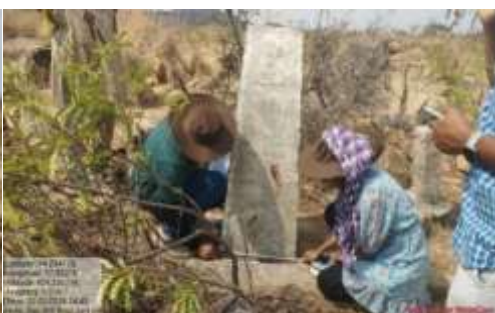
Boundary pillars in Jonnavulapalli RF

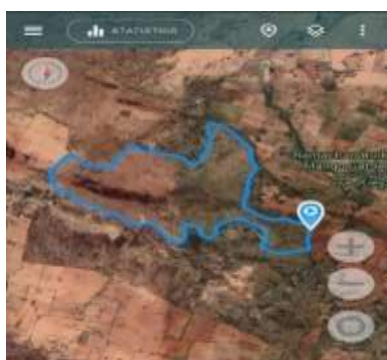
**Malyala 40.65 Ha**

mobile application, which enabled accurate boundary mapping and the collection of GPS coordinates along with geotagged photographs. The spatial data collected during the field visit was subsequently analysed using QGIS software. The analysis revealed that the actual plantation area is 15.65 hectares larger than the area recorded in official documents. This discrepancy is primarily due to the inclusion of rocky terrain, trenches, and barren patches within the plantation boundaries areas that were previously excluded or overlooked during initial documentation. The detailed visual and spatial records obtained during the perambulation are provided below for reference ensuring transparency and accuracy in area verification.

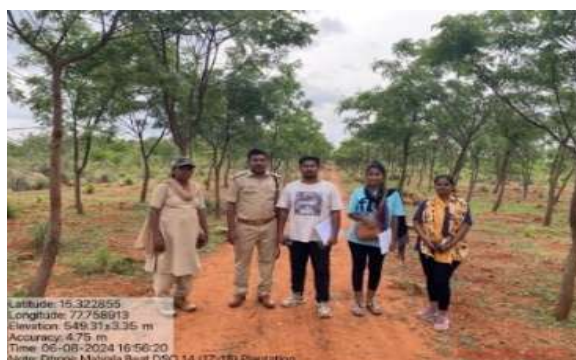
**Malyala plantation**

**Health status of plantation:** The overall health status of plantation in Malyala was found to be satisfactory. There were no observed incidences of insect or pest damage affecting any of the planted species. All plants appeared healthy showing no visible signs of infestation or physiological stress which indicates that the sites were well-maintained and provided a favourable environment for healthy and sustained plant growth.

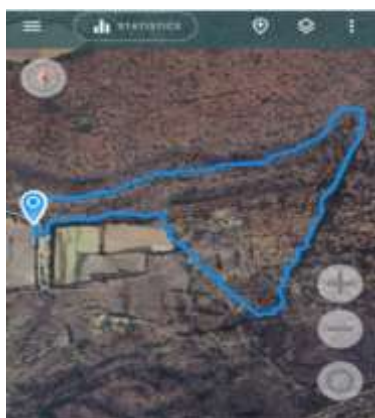
**Gottipadiya 15.54 Ha**

Perambulation of the Gottipadiya plantations was conducted with the assistance of the local Forest Beat Officer using a Geo Tracker. The plantation boundaries are surrounded by dense jungle growth and undulating terrain, which necessitated measuring along the outer boundary rather than the precise plantation limits. Using QGIS software, it was determined that the perambulated area exceeds the recorded area by 5.54 Ha for Gottipadiya. Images of the perambulated areas are provided below.

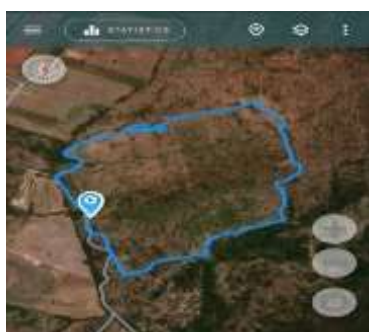
**Badrupalem 21.10 Ha**

During the verification of plantation areas at Badrupalem, Jangameswarapadu, and Enamandala, it was consistently observed that the perambulated extents exceeded the officially recorded areas. The field verification was conducted with the assistance of local forest beat officers, and in all cases, the plantations were surrounded by dense jungle growth, trenches, and natural obstructions. Consequently, the field teams traced the outer boundaries of these physical features, rather than adhering strictly to the originally recorded plantation limits. As a result, the perambulated area was found to be 1.10 Ha hectares larger at Badrupalem, 4.26 hectares larger at Jangameswarapadu, and 13.71 hectares larger at the Enamandala plantation. This discrepancy is attributed to the inclusion of waste, degraded, or rocky patches within the demarcated plantation areas that may not have been reflected in earlier records. Spatial analysis was conducted using QGIS software, and the verification was further supported through physical perambulation using the Geo Tracker mobile application. To substantiate the findings, geo-tagged photographs and GIS-based mapping outputs were generated, providing clear evidence of the verification process. Relevant images documenting this process are provided below.

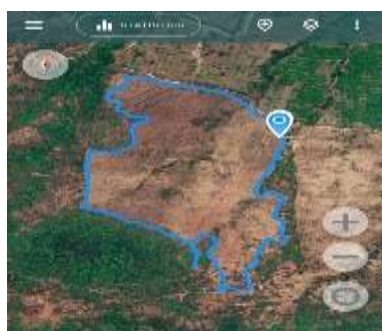
**A. Konduru 20.27 Ha**

- Gandrai Plantation (Vijayawada range) (11.45 Ha): 27.07 Ha (Exceeded by 15.62 Ha)
- A. Konduru Plantation (Mylavaram range) (20 Ha): 20.27 Ha (Exceeded by 0.27 Ha)
- Kakarla plantation (Mylavaram range) (20 Ha): 25.56 Ha (Exceeded by 5.56 Ha)

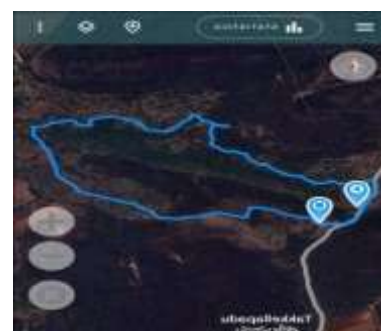
**Gandrai 27.07 Ha**

**Health Status of Plantations:** Field observations confirmed that A.Konduru and kakarla beat plantations were completely free from any visible damage caused by insects or pests. The seedlings and saplings appeared healthy, with no evidence of leaf defoliation, boring marks, fungal growth, or other biotic stress symptoms. This indicates that the plantations are currently not under any significant pest pressure. In Vijayawada range as per field visit observations, an incidence of insect and pest damage was noted in the Gandrai plantation.

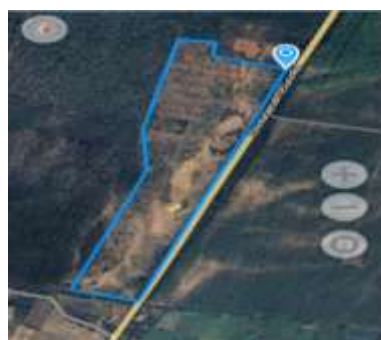
**22.21 Ha Velagalapalli**

- (Eluru range) (20 Ha): 22.21 Ha (exceeded by 2.21 Ha)
- (JR Gudem range) (20 Ha): 21.59 Ha (exceeded by 1.59 Ha)
- (Kannapuram range) (20 Ha): 22.73 Ha (exceeded by 2.73 Ha)

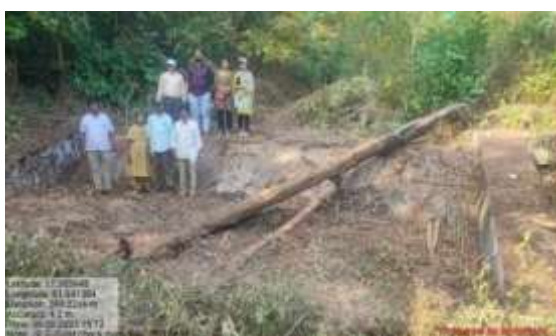
**Kopalli beat, J R Gudem range**

Rock fill dam in kopalli beat were monitored and evaluated against the specifications recorded in the measurement book and the actual field measurements. The dimensions were: length- 6.25 m, breadth-1.55 m and depth-0.75 m. The field measurements were found to be consistent with the entries in the measurement book, indicating no deviations. Major repairs are required in the apron section of the dam. De-silting is necessary to enhance the storage capacity by removing accumulated sediment. Additionally, seepage of water has been observed from both the main dam structure and the apron, indicating potential structural weaknesses. Urgent repair and reinforcement of the main dam and apron are recommended.

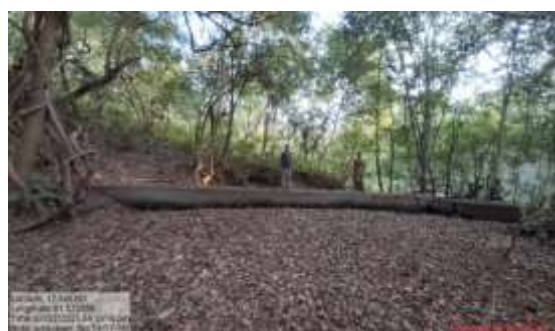
**Thutigunta Polavaram range**

Check dams constructed in chilakaluru, thutigunta and nettapakota beat were monitored and evaluated against the specifications recorded in the measurement book and the actual field measurements. The dimensions were: length- 10m, breadth- 1.50 m and depth-1.40 m. the length in thutigunta is 15 m. The field measurements were found to be consistent with the entries in the measurement book, indicating no deviations. The check dams are visible, but significant damages were observed in the main body wall, side wing walls, and apron. Major repairs and de-silting are required to restore structural integrity and storage capacity.

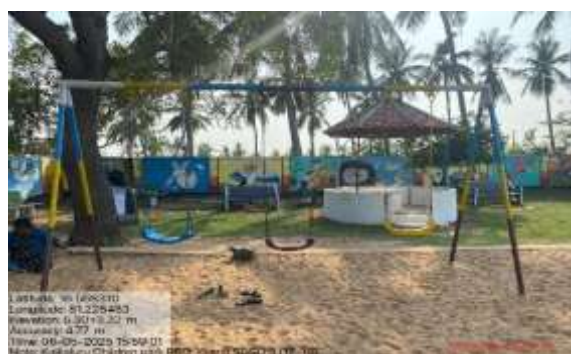
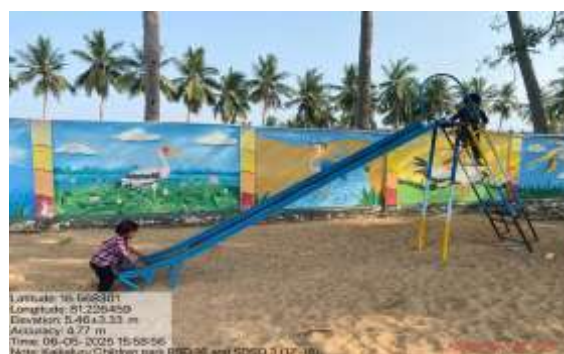
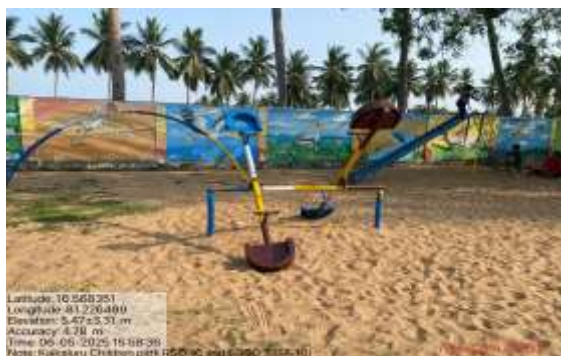
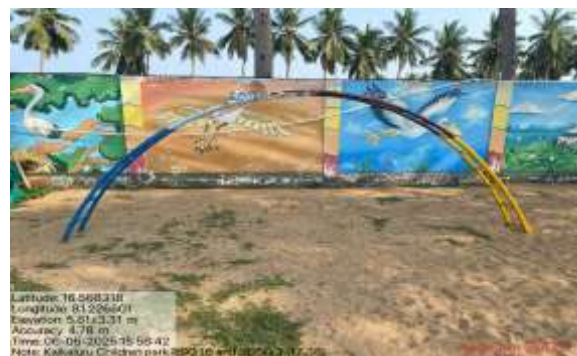
**Children Park at pelican paradise centre, Atapaka in Kaikaluru range WLM**

As per the approved construction plan, several activities were committed, including the repair and replacement of existing equipment as well as the provision of new equipment in the children's park at Atapaka. However, during the recent monitoring visit, only a subset of these activities was observed to have been executed. The Children's Park at Kolleru Wildlife Sanctuary has taken a positive step by introducing well-designed children's play equipment to enhance its recreational value. This initiative not only provides entertainment but also encourages physical activity in a natural environment, which benefits children by improving physical fitness, motor skills, and social interaction. Additionally, the park encourages families to spend quality time outdoors. The equipment has been thoughtfully placed to blend harmoniously with the natural surroundings of the bird sanctuary. The successful procurement and installation of children's play equipment such as the rainbow ladder, swings, family self-Jula, and seesaw is noteworthy. All equipment was found to be in good condition, ensuring that the play area remains a cherished space for children and families.

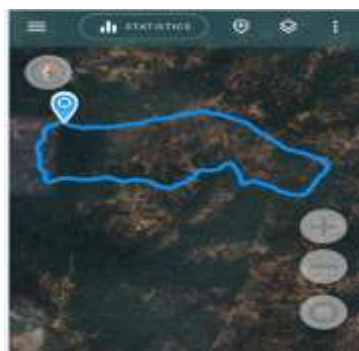
Mattapally 28.88 Ha

As part of the monitoring and evaluation of CAMPA plantation activities in Chintur Forest Division during 2017-18, perambulation and area verification were conducted at two plantation sites: Mattapally and Palamadagu. These exercises were carried out with the active support of local Forest Beat Officers, utilizing GPS-based tracking through the Geo Tracker app and QGIS software for accurate area calculation. To ensure transparency and credibility, photographic documentation was also captured during the visits. At Mattapally plantation, the area calculated from the perambulated boundary when analyzed using QGIS, showed excess of 3.88 hectares, compared to the officially recorded area. The plantation boundaries were surrounded by dense jungle growth and sparsely dispersed trenches which rendered the original demarcated paths largely inaccessible. As a result, the perambulation had to be conducted along the outer edges of the plantations rather than along the precise recorded boundaries. In contrast, Darapally plantation showed a shortfall in the area recorded. The GPS-based measurement revealed only 21.22 hectares, indicating a discrepancy of 3.78 hectares from the area recorded in the plantation journal. The cause of this shortfall could not be conclusively established during the field verification. The perambulation was guided by the boundary demarcation provided by the plantation watcher or guard and conducted under the supervision of the Forest Beat Officer.

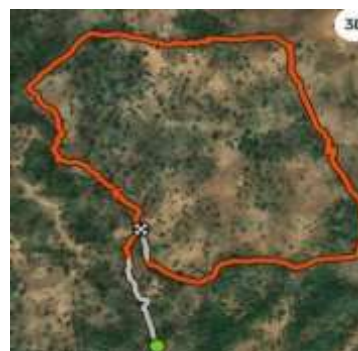
Palamadagu 21.22 Ha

The Palamadugu plantation, established on a site characterized by hard, gravelly red soil has shown very poor survival and limited growth indicating a near-total poor performance. The soil conditions were found to be unsuitable for the major species planted with survival rates recorded at only 6.81 % for both *Syzygium cumini* and *Diospyros melanoxylon*, 6.06 % for *Albizia chinensis* and 2.27 % for *Pongamia pinnata*. Growth performance was weak with average tree height ranging from 1.00 to 3.00 meters and girth from 10.00 to 17.00 cm. Field inspection and sample plot enumeration confirmed that severe grazing pressure, cattle intrusion and possible encroachment were key factors preventing sapling establishment and survival. Patches of natural regeneration of *Wrightia tinctoria* were observed reflecting the adaptability of native species under the prevailing site conditions. Overall, the findings highlight the need for better species-site matching, stronger protection measures and community involvement to ensure plantation success in such challenging environments.

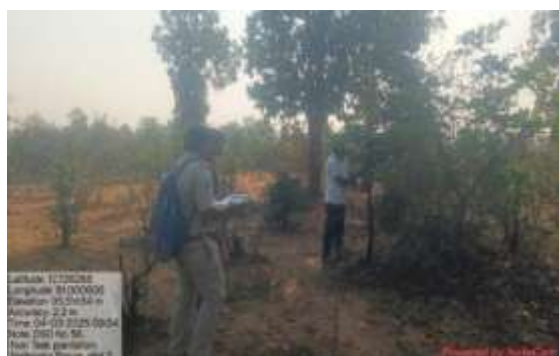
Mattapally plantation, VR Puram

The 25-hectare plantation at Mattapally, evaluated on 05.03.2025 in the presence of forest department staff was found to be a complete poor performance with no evidence of survival or establishment of the intended plantation species. The site, characterized by red soil with poor fertility coupled with inadequate rainfall proved unsuitable for the species selected under the plantation scheme. During field assessment, only natural regeneration of native species like *Diospyros melanoxylon*, *Lannea coromandelica*, *Tephrosia purpurea* and *Wrightia tinctoria* were observed indicating the resilience of indigenous flora under adverse site conditions. This affirms the need for assessing species-site suitability before taking up any plantation work.

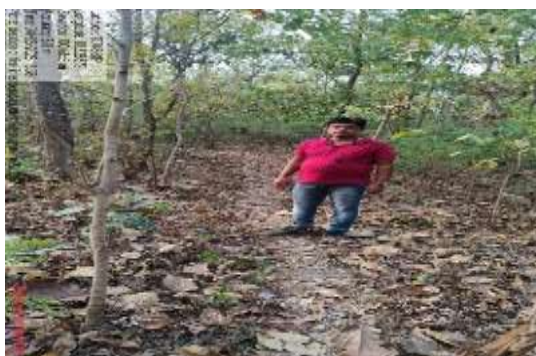
**Fire lines in Buradagudem beat**

Under the CAMPA-NPV scheme, fire lines have been established in both Buradagudem (Kunavaram range) and Lakkavaram beat (Lakkavaram range), measuring 3 m in width and 2000 rmt and 1000 rmt in length respectively, consistent with official records. While the fire lines have been created as planned, lack of proper maintenance has led to poor visibility in both locations. Field observations revealed significant accumulation of grass, dried leaves, and weed growth along the fire lines, reducing their effectiveness. Regular and timely maintenance is recommended to ensure these fire lines serve their intended purpose in preventing and controlling forest fires.

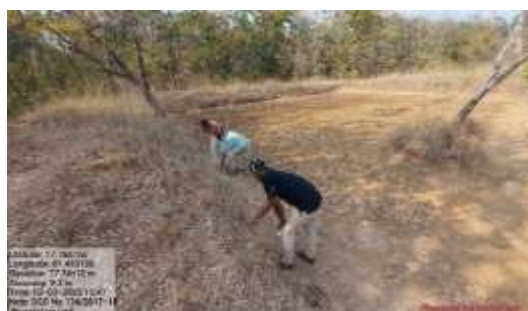
**Percolation tank in Pothampally beat**

Percolation tanks constructed at Pothampally (Chintur range), Buradagudem (Kunavaram range), Lakkavaram (Lakkavaram range) and Bandirevu beats (Nellipaka range) along with staggered trenches at Bandirevu (Nellipaka range) were monitored and evaluated against specifications recorded in the measurement book (MB). Field measurements confirmed that all structures adhered to the approved dimensions—percolation tanks measured 10 m in length and width with depths ranging from 1 to 1.5 m and staggered trenches measured 10 m in length, 0.5 m in width and 0.5 m in depth. No deviations were noted from the MB records. However, varying degrees of silt accumulation damaged or displaced stone dry packing and weed or plant residue growth were observed across most sites, primarily due to monsoon overflows and low-lying locations. While the tanks at Buradagudem and Lakkavaram were generally better maintained, the tank at Pothampally showed significant degradation and trenches at Bandirevu were largely filled. Regular de-siltation and minor structural repairs are recommended across all sites to restore and maintain their full water storage and soil moisture retention capacity.

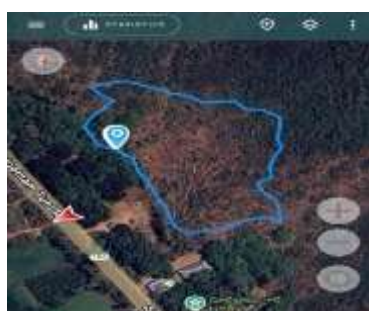
**Atchutapuram 1.22 Ha**

- 2 Ha Teak Atchutapuram plantation (Kakinada): Lesser by 0.78 Ha
- 5 Ha Teak Chavitidibbalu plantation (Addatheegala): Exceeded by 1.27 Ha
- 5 Ha Teak Addatheegala plantation (Addatheegala): Lesser by 0.39 Ha
- 3 Ha Teak P.Patnam plantation (Gokavaram): Exceeded by 1.12 Ha
- 2 Ha Teak Jaddangi plantation (Rajavommangi): Exceeded by 0.28 Ha
- 6 Ha Teak Thimmapuram plantation (Rajavommangi): Lesser by 0.9 Ha

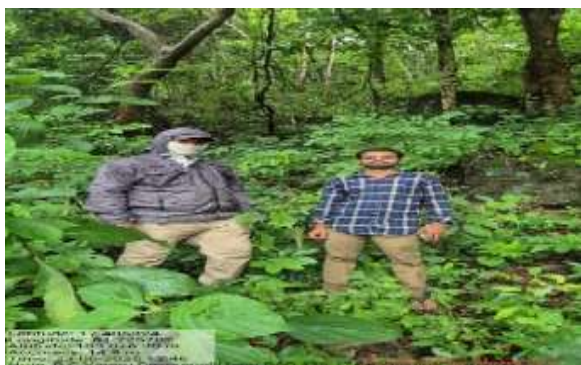
**Fire lines at Devarapalli beat**

The fire lines established in Devarapalli and Maredumilli South beats under the CAMPA-NPV scheme were verified against official records, which specify dimensions of 3 metres in width and lengths of 3400 running metres (rmt) and 3000 rmt, respectively. Field inspection confirmed the presence of these fire lines at both locations; however, their visibility and effectiveness have been significantly reduced due to the profuse growth of grasses, weeds, and

other ground vegetation. This unchecked growth has diminished the intended functionality of the fire lines as barriers for halting or slowing the spread of forest fires. For these structures to serve their purpose effectively, regular upkeep and clearing of vegetation along the fire lines is essential. Periodic maintenance schedules particularly before and during the fire-prone summer season—should be strictly enforced. This includes mechanical or manual removal of weeds, controlled burning where appropriate, and ensuring that the lines remain clear to act as effective firebreaks. Without such timely interventions, the substantial investment made under CAMPA may fail to yield the desired level of forest fire prevention and control.

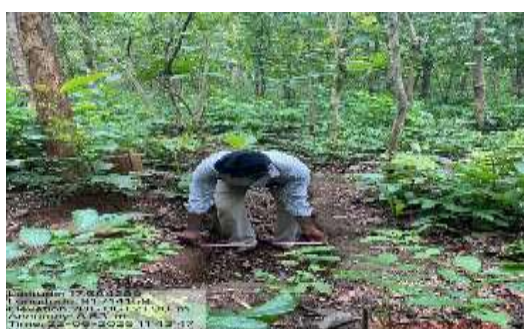
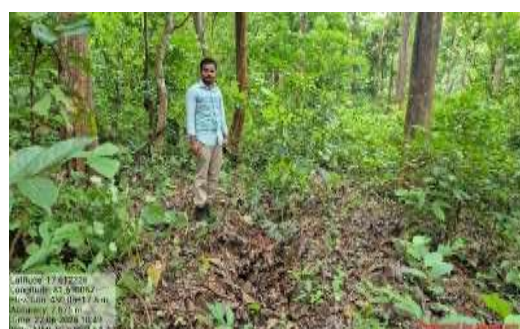
**Staggered trenches in Maredumilli South and North beat**

The staggered trenches constructed in Maredumilli (South and North), Donkarai, Kutrawada, and Chintalapudi beats were subjected to monitoring and evaluation against the specifications recorded in the Measurement Book (MB). As per field verification, the trenches conformed to the design in terms of length (10 meters) and width (0.5 meters), and were broadly consistent with the MB records. However, minor deviations were noted in the depth, with several trenches found to be shallower than the approved design of 0.3 meters. On-site inspection revealed that

the trenches, being located in low-lying plantation areas, had accumulated substantial silt deposits and dried plant residues, which significantly reduced their storage and infiltration capacity. This filling is likely due to natural processes such as surface runoff, soil erosion, and overflow of water during heavy rainfall events, leading to gradual loss of functionality. Although the trenches remain physically visible, their effectiveness as soil and moisture conservation (SMC) structures is compromised. To ensure that these trenches continue to serve their intended purpose of enhancing groundwater recharge, reducing runoff, and supporting plantation survival, it is strongly recommended that regular de-siltation and cleaning be undertaken. Periodic maintenance, particularly prior to the monsoon season, will help restore their full water-holding capacity and improve the long-term efficiency of plantation and watershed management efforts. Additionally, integrating maintenance with community participation through VSS involvement could ensure sustainability and reduce the recurrence of siltation problems.

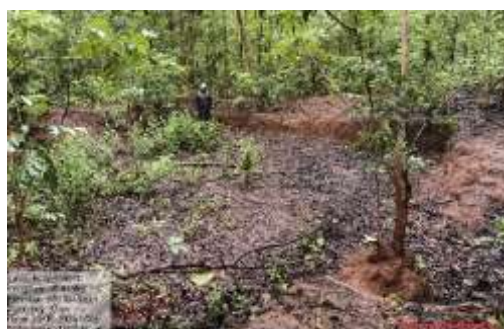
**PT at Donkarai beat**

The percolation tanks at Donkarai, Kakuru, Geddada, AM Kota, Gurthedu and Devarapalli beats were monitored and evaluated against the specifications recorded in the measurement book. The tanks at Donkarai, Kakuru, Geddada, AM Kota and Gurthedu were recorded to have dimensions of 10 meters in length, 10 meters in width and 0.60 meters in depth. However, deviations in depth were observed during field verification. Similarly, the Devarapalli tank, with a recorded dimension of 20 meters in length, 20 meters in width and 1 meter in depth, also showed depth deviations. In all cases, silt accumulation has significantly reduced the storage capacity of the tanks. While the tanks are generally well maintained their low-lying locations have contributed to silt build-up and monsoon overflows have resulted in damage to the stone dry packing along the edges. To restore and maintain optimal water retention capacity regular de-silting is strongly recommended.

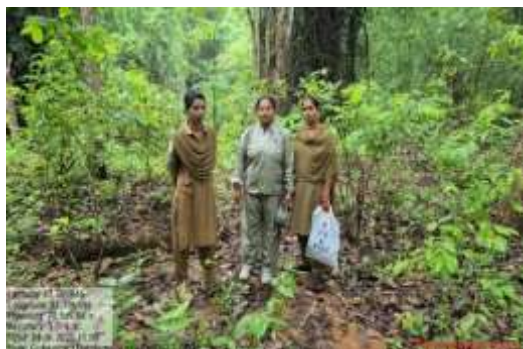
**Staggered trenches in Dandangi (N) beat**

The staggered trenches constructed at Dandangi and P. Patnam beats were monitored and evaluated against the specifications recorded in the measurement book (MB). Field measurements confirmed the trenches to be 10 meters in length, 0.5 meters in width and 0.3 meters in depth, consistent with the MB records, although depth deviations from the approved design were noted. Due to their location in a low-lying plantation area, significant accumulation of silt and dried plant residue was observed. While the trenches remain visible, they are largely filled, likely as a result of water overflow during rains. It is recommended that regular de-siltation be carried out to restore and maintain their full water-holding capacity.

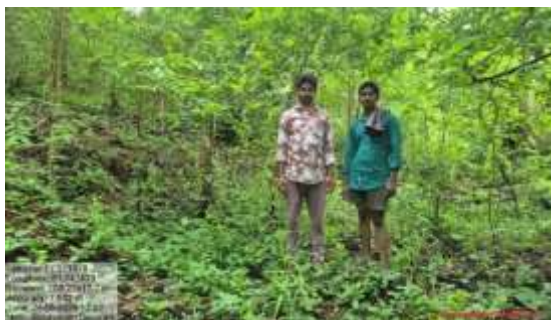
PT at Devaram beat

The percolation tanks at Devaram and Dandangi (North and South) beats were monitored and evaluated against the specifications recorded in the measurement book. All four tanks were recorded with dimensions of 10 meters in length, 10 meters in width and 0.80 meters in depth. However, deviations in depth were observed during field verification. In all cases, silt accumulation has significantly reduced the storage capacity of the tanks. While the tanks are generally well maintained, their low-lying locations have contributed to silt build-up, and monsoon overflows have caused damage to the stone dry packing along the edges. To restore and maintain optimal water retention capacity, regular de-silting is strongly recommended.

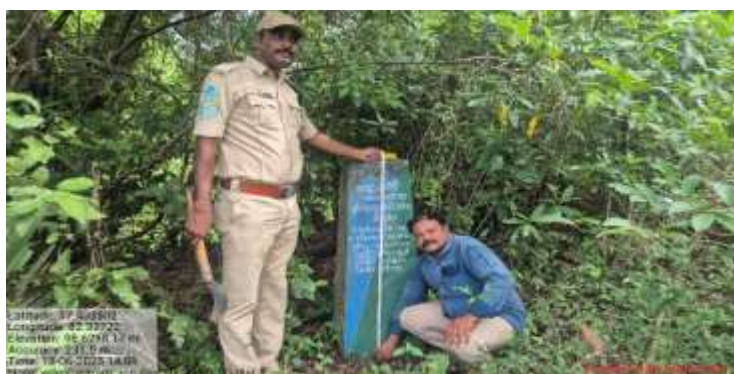
The construction of 6 RCC boundary pillars in Lingamparthi RF area was monitored and evaluated against the specifications recorded in the measurement book. The above-ground dimensions of RCC pillars at both locations: 1.20 m in height, 0.30 m top width and 0.45 m bottom width matched the recorded specifications with no deviations noted. Field verification confirmed that all boundary pillars were intact and effectively demarcating the forest boundaries at their respective sites.

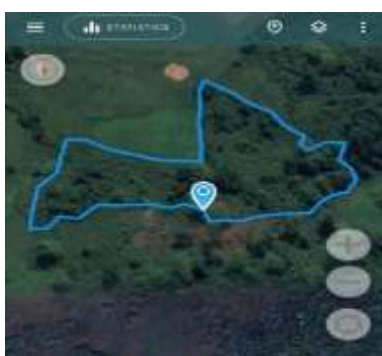
- B. kothuru Plantation (KD Peta range) (10 Ha): 9.27 Ha (lesser by 0.73 Ha)
- Kotha regallu Plantation (Lothugedda range) (10 Ha): 11.26 Ha (Exceeded by 1.26 Ha)
- Gummirevula Plantation (Sileru range) (10 Ha): 10.78 Ha (Exceeded by 0.78 Ha)

9.27 Ha B. Kothuru

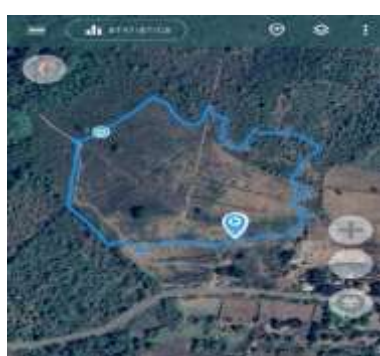
11.26 Ha Kotha regallu

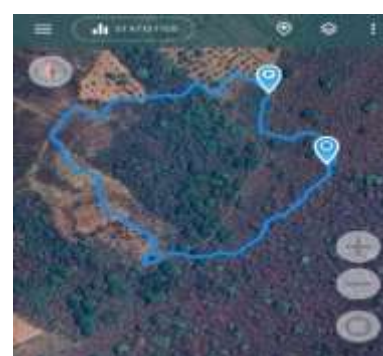
10.78 Ha Sileru

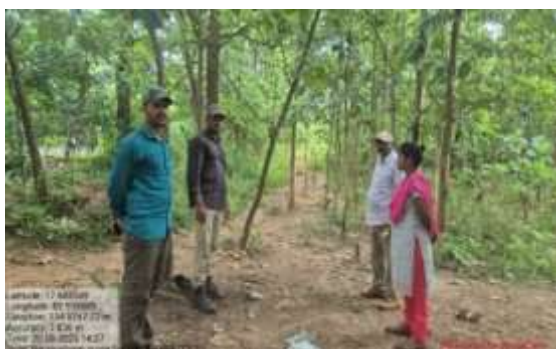
**Narsipatnam range**

A fire line was created and maintained in Narsipatnam section under the CAMPA-NPV (Forest Fire Management) scheme. It was monitored and evaluated against the specifications recorded in the measurement book. The dimensions of the fire line are 3 meters in width and 1500 running meters in length. The actual field measurements matched the recorded values, indicating no deviations. The visibility of the fire line was clear, as it was established along the inspection path. No dense grass or weed growth was observed, indicating that the fire line has been well-maintained throughout the natural forest area.

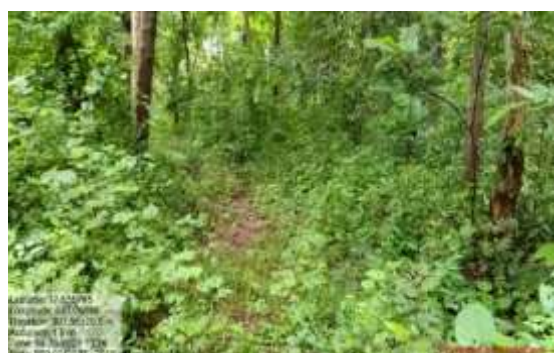
**Marripakala range**

In Marripakala section, a fire line was established and maintained under the CAMPA-NPV scheme. The fire line measures 3 meters in width and 970 running meters in length. Field verification confirmed that the measurements matched the specifications in the measurement book. However, the visibility was poor, with dense grass and weed growth observed along the fire line. This suggests a need for routine maintenance to ensure the fire line remains effective.

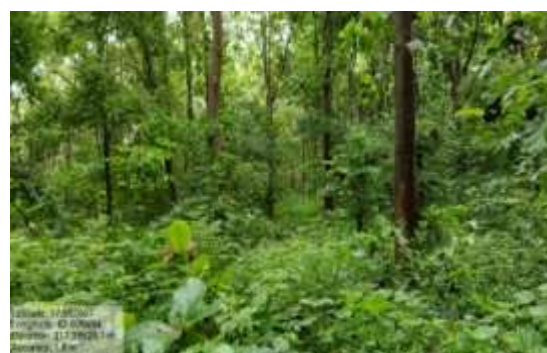
**R V Nagar range**

A fire line was created in R.V. Nagar section under the CAMPA-NPV scheme, with dimensions of 3 meters in width and 2000 running meters in length. The field measurements were consistent with the entries in the measurement book. However, the visibility of the fire line was very poor. The entire stretch was covered with jungle growth and dense weeds, indicating a complete lack of maintenance. Immediate attention is required to clear the fire line and restore its functionality to mitigate forest fire risks.

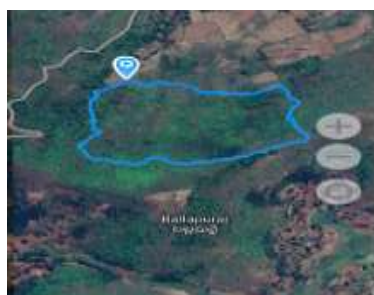
- Seekari (20 Ha): 21.77 Ha (exceeded by 1.77 Ha)
- Peddapadu (20 Ha): 29.05 Ha (exceeded by 9.05 Ha)
- Thotalagondhi (20 Ha): 23.24 Ha (exceeded by 3.24 Ha)

**Seekari plantation 21.77 Ha**

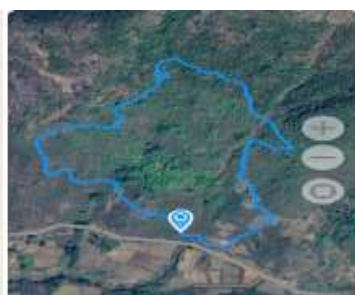
**Peddapadu 29.05 Ha**

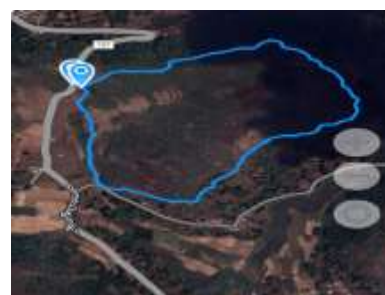
**Thotalagondhi 23.24 Ha**

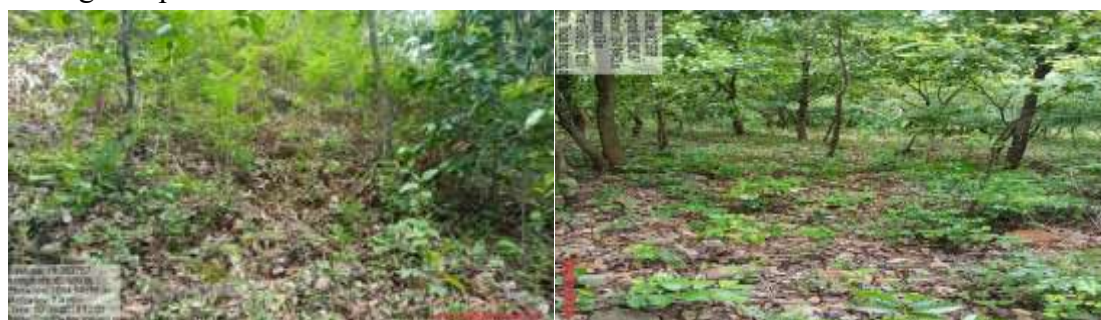
Fire tracing operation at Thadda village of Araku (T) range

A fire line was created and maintained in Tadda village of Araku (T) range under CAMPA-NPV (forest fire management) scheme was monitored and evaluated against the specifications recorded in the measurement book and the actual field measurements. The dimensions of new fire line are width – 3 m, and length – 10000 rmt. The field measurements matched those in the measurement book, indicating no deviations. The visibility of the fire line was not clear, moderate grass or weed growth was observed, indicating that periodic maintenance is needed.

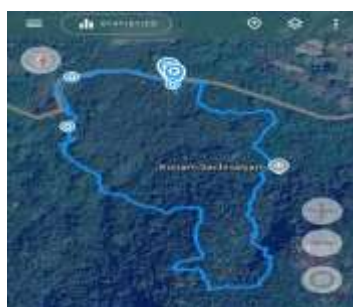
**Sirasavalasa plantation 10.17 Ha**

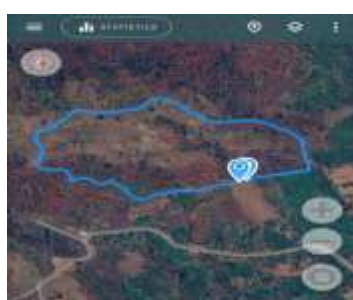
- Rellabanda (10 Ha): 14.34 Ha (exceeded by 4.34 Ha)
- Krishnapuram (10 Ha): 10.54 Ha (exceeded by 0.54 Ha)
- Damsarai (10 Ha): 9.89 Ha (lesser by 0.11 Ha)
- Nallaregupalem (10 Ha): 15.94 Ha (Exceeded by 5.94 Ha)

**Damsarai plantation 11.51 Ha**

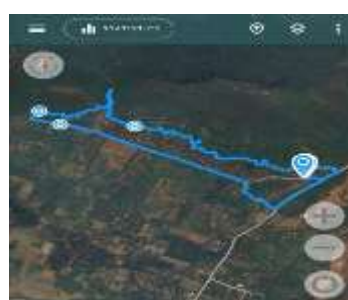
**Nallaregupalem plantation 15.94 Ha**

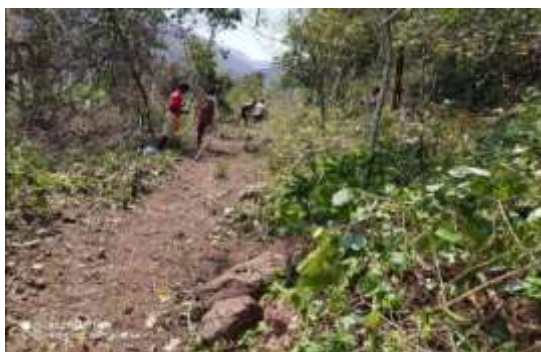
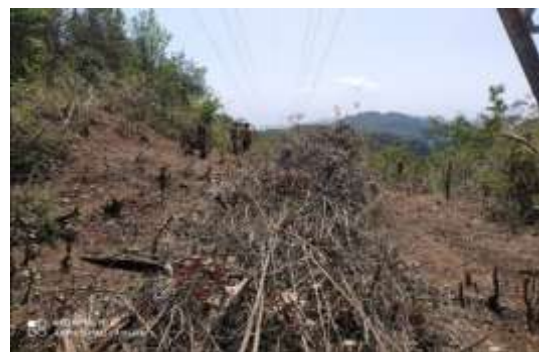
**Fire tracing operation at Ananthagiri range**

Fire line was created and maintained in Ananthagiri range under CAMPA-NPV (forest fire management) scheme was monitored and evaluated against the specifications recorded in the measurement book and the actual field measurements. The dimensions of fire line with the width of 3 m, and length – 3000 m. The field measurements matched those in the measurement book, indicating no deviations. The visibility of the fence was clear, as it was established in the RF of Ananthagiri indicating that periodic maintenance is needed.

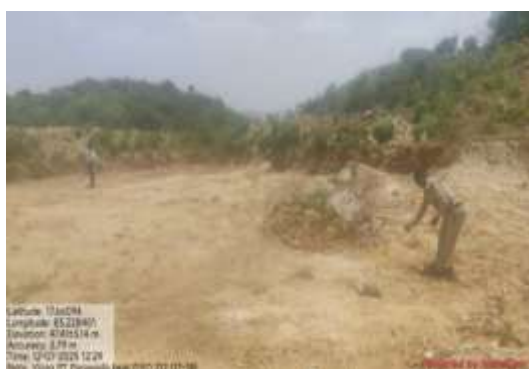
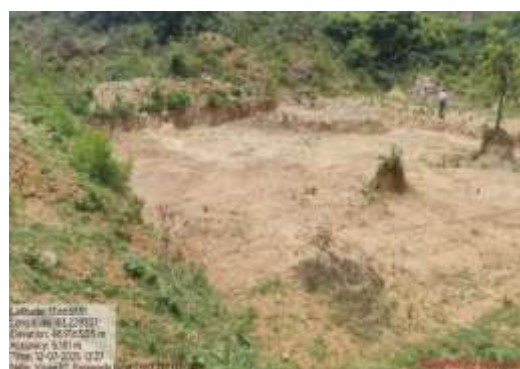
**Mini percolation tank in Visakhapatnam range**

Mini percolation tank was created and maintained at Parawada beat in Visakhapatnam range under CAMPA-NPV (forest fire management) scheme was monitored and evaluated against the specifications recorded in the measurement book and the actual field measurements. The dimensions of mini percolation tank are width – 30 m, and length – 30 m and Depth with 0.80 m. The field measurements matched those in the measurement book, indicating no deviations. While the structure remains in intact and well maintained, but it is covered with silt. De-silting is necessary to restore its full storage capacity.
