# **Third Party Monitoring and Evaluation of Compensatory Afforestation Fund Management and Planning Authority (CAMPA) Activities of Andhra Pradesh Forest Department (APFD) During 2017-18**

**INSTITUTE OF WOOD SCIENCE AND TECHNOLOGY**  
**(Indian Council of Forestry Research & Education)**  
18<sup>th</sup> Cross, Malleswaram, Bangalore – 560 003  
October 2025

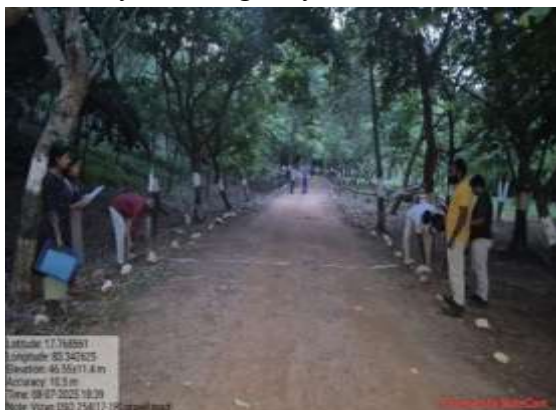
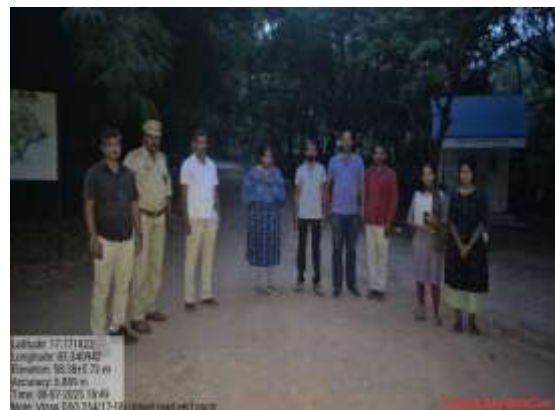
**Renovation of existing gravel road in Kambalakonda park nursery**

The renovation of the existing gravel road in Kambalakonda Park Nursery was undertaken with a width of 3 meters and a total length of 750 running meters. The road was constructed to facilitate smooth movement of nursery staff, visitors, and transportation within the premises. During the inspection, the gravel road was found to be intact and in good condition, reflecting proper maintenance and upkeep. Regular upkeep of this road will ensure its continued functionality and longevity.

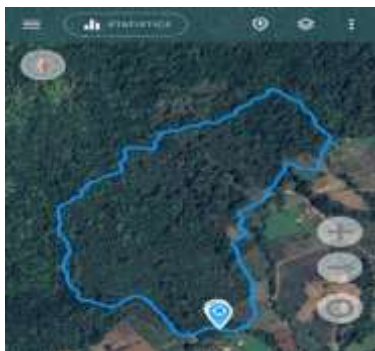
19.38 Ha Kumbivalasa

- Kumbivalasa: Recorded 10.00 Ha → Perambulated 19.38 Ha (+9.38 Ha)
- Narlavalasa: Recorded 10.00 Ha → Perambulated 10.12 Ha (+0.12 Ha)
- S.K. Padu: Recorded 10.00 Ha → Perambulated 10.01 Ha (+0.01 Ha)

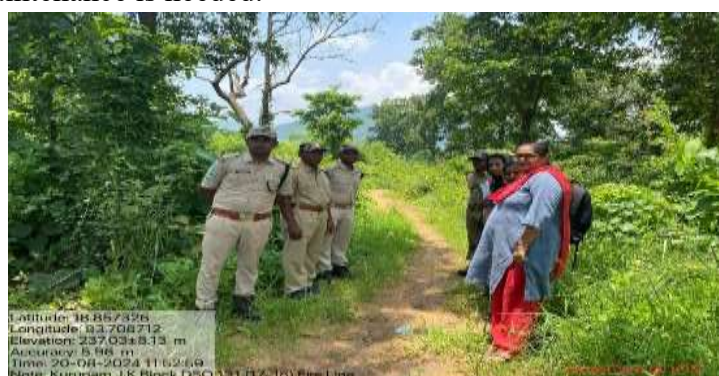
Fire lines in JK block RF of Kurupam range

A fire line was created and maintained in J K block RF of Kurupam range under CAMPA-NPV (forest fire management) scheme was monitored and evaluated against the specifications recorded in the measurement book and the actual field measurements. The dimensions of new fire line are width – 3 m, and length – 2000 rmt. The field measurements matched those in the measurement book, indicating no deviations. The visibility of the fire line was not clear, as it was established along the inspection path. moderate grass or weed growth was observed, indicating periodic maintenance is needed.

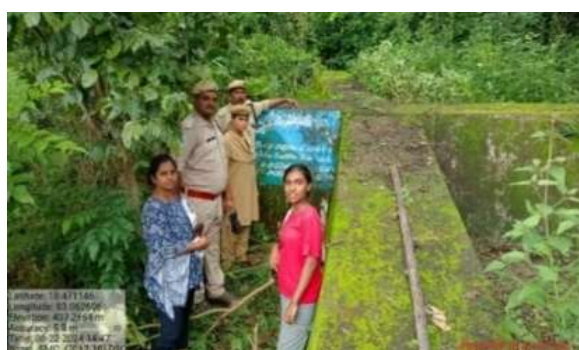
**Check dam in Pachipenta beat**

In Pachipoenta beat of Saluru range, the check dam across Kuntam ( $14 \text{ m} \times 1.20 \text{ m} \times 0.70 \text{ m}$ ) and three mini percolation tanks across Kummarivalasa ( $6 \text{ m} \times 5.37 \text{ m} \times 1.17 \text{ m}$  each) were evaluated. In both cases, field measurements matched the specifications in the measurement book with no deviations. The structures are well maintained and effective in water storage, though regular de-siltation is recommended to enhance capacity, improve infiltration, and sustain soil moisture. However, regular de-siltation is recommended to enhance its storage capacity, improve water infiltration, and maintain soil moisture levels effectively.

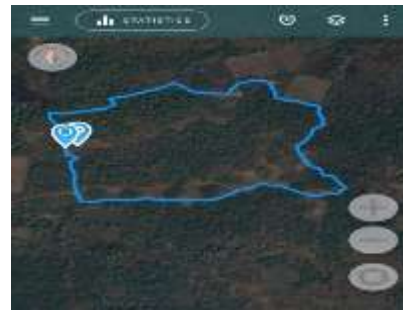
Haripuram-Pallapuram plantation 4.71 Ha

Haripuram-Pallapuram plantation (5 Ha): The actual perambulated area was 4.71 Ha, which is 0.29 Ha less than the recorded extent. The shortfall could not be conclusively explained but was based on demarcation shown by the plantation watcher/guard in the presence of the Beat Officer.

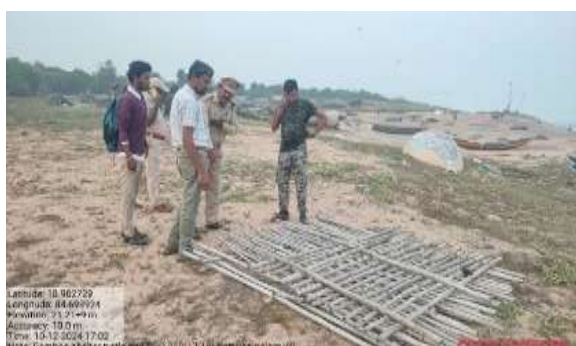
**Turtle hatching in Kasibugga range**

A bamboo shelter measuring 140 ft × 28 ft was constructed at Kovvada in Srikakulam range, same was constructed in Vonturu and Battivanipalli in Kasibugga range and in Amplam beat of Tekkali range during 2017–18 to protect turtle eggs by providing a safe environment against predators, human disturbance, and environmental hazards. During the recent field visit, the shelter was not found at the site. The Beat Officer explained that it is re-constructed and relocated every nesting season based on turtle activity and site conditions.

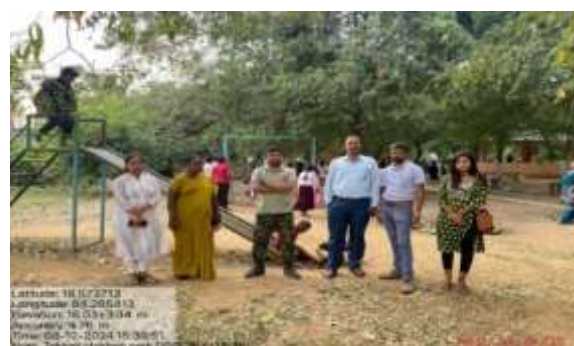
**Children's Park in Tekkali range**

A children's play area has been set up at Telineelapuram Bird Sanctuary, adding recreational value and supporting children's physical activity, skill development, and social interaction. The equipment blends well with the natural surroundings, encouraging family visits. The structures are in good condition, with only minor repairs needed. Regular upkeep will ensure the facility remains useful and attractive to visitors.

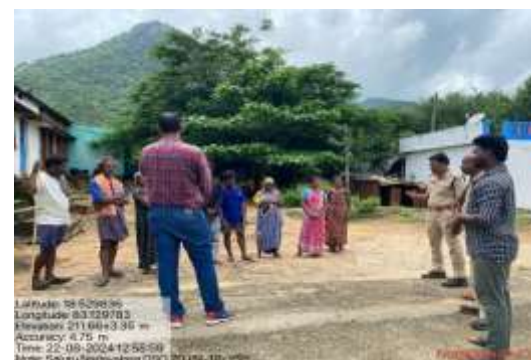
**VSS in Saluru range, Vizianagaram division**
