# **Third Party Monitoring and Evaluation of Compensatory Afforestation Fund Management and Planning Authority (CAMPA) Activities of Andhra Pradesh Forest Department (APFD) During 2018-19**

**INSTITUTE OF WOOD SCIENCE AND TECHNOLOGY**  
**(Indian Council of Forestry Research & Education)**  
18<sup>th</sup> Cross, Malleswaram, Bangalore – 560 003  
October 2025

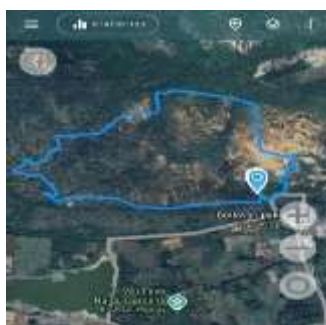
**15.72 Ha Pathagunta**

During the verification of plantation areas at Pathagunta, Ambakam BHA, and Nandanam, it was consistently observed that the perambulated extents exceeded the officially recorded areas. The field verification was conducted with the assistance of local forest beat officers, and in all cases, the plantations were surrounded by dense jungle growth, trenches, and natural obstructions. Consequently, the field teams traced the outer boundaries of these physical features, rather than adhering strictly to the originally recorded plantation limits. As a result, the perambulated area was found to be 0.72 hectares larger at Pathagunta, 0.32 hectares larger at Ambakam BHA, and 6.79 hectares larger at the Nandanam plantation. This discrepancy is attributed to the inclusion of waste, degraded, or rocky patches within the demarcated plantation areas that may not have been reflected in earlier records. Spatial analysis was conducted using QGIS software, and the verification was further supported through physical perambulation using the Geo Tracker mobile application. To substantiate the findings, geo-tagged photographs and GIS-based mapping outputs were generated, providing clear evidence of the verification process.

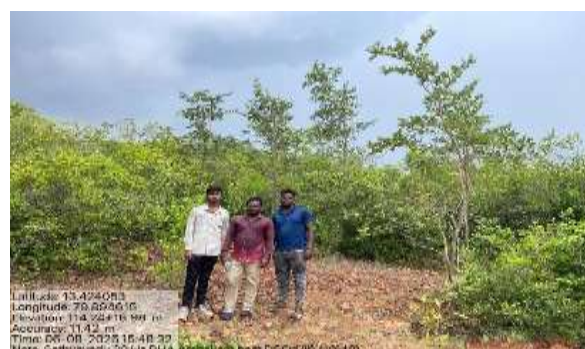
**Ambakam (BHA) in Sathyavedu range**

**Maintenance of plantation journals and records:** Journals were reported to be systematically maintained, certain issues were noted: the journal was unavailable at Pandur beat (under Ambakam BHA), and regular updating of journal parameters is still required at all sites to ensure data accuracy and reliability. Plantations are inspected by the concerned forest officials, and their observations are duly recorded.

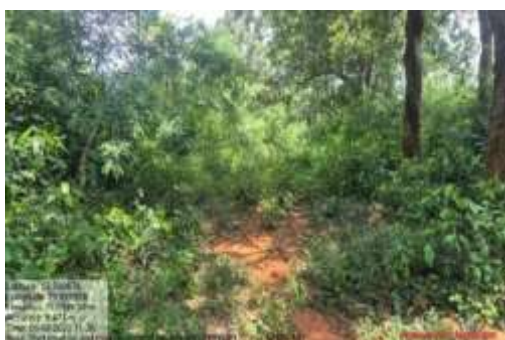
**Fire lines in Ambakam beat**

In Sathyavedu Range, fire lines were created and maintained in both Sathyavedu beat and Ambakam beat. These works were monitored and evaluated against the specifications recorded in the measurement book, and the field measurements corresponded accurately with the documented dimensions, confirming no deviations. The newly created fire line in Sathyavedu beat measured 3 meters in width and 6000 meters in length, while in Ambakam beat it measured 3 meters in width and 1500 meters in length. Although the fire lines were established as per specifications across the natural forest areas of both beats, visibility was poor due to dense growth of grasses and weeds along the lines. This indicates the need for more frequent maintenance to ensure their effectiveness as protective barriers against fire.

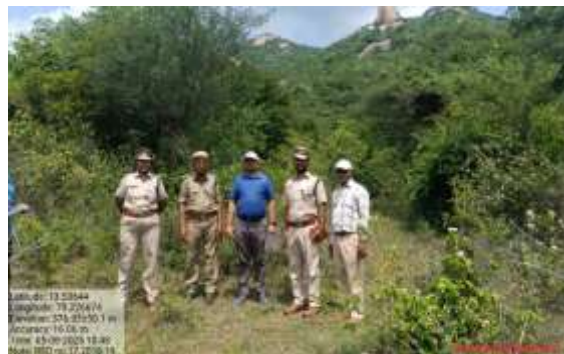
**Fire lines in Mungilipattu beat**

**Mungilipattu beat (Tirupati range):** The fire line measured 3 m in width and 1000 m in length, with field measurements matching the records. However, dense weed and grass growth was observed all along the fire line, compromising its visibility. The line was not well maintained and therefore did not provide a clear barrier.

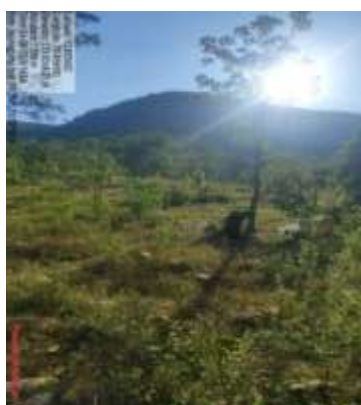
**Fire lines in Kalavagunta beat**

- **Katur beat:** The fire line was clear and well maintained, with no noticeable grass or weed growth. Visibility was good throughout the natural forest area, indicating proper upkeep.
- **Kalavagunta beat:** Although the fire line was created as per specifications, visibility was poor due to dense growth of grasses and weeds along the line. This highlights the need for more frequent maintenance to ensure its effectiveness as a protective barrier against fire.

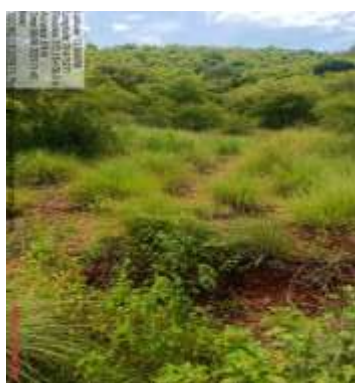
**Fire lines in Kollagunta section**

A fire line was created and maintained in the natural forest of Kollagunta section of Karvetinagar range and Diguvaputtur beat of Puttur range. These works were monitored and evaluated against the specifications recorded in the measurement book and verified with actual field measurements. In Kollagunta section (Karvetinagar range) the fire line measured 6 m in width and 6000 m in length. Field measurements matched the records, showing no deviations. However, dense weed and grass growth was observed all along the fire line, compromising its visibility. The line was not well maintained and therefore did not provide a clear barrier. In Diguvaputtur beat (Puttur range) the fire line measured 3 m in width and 1000 m in length, with field measurements matching the records. The fire line was well maintained, free from noticeable weed or grass growth, and ensured clear visibility throughout. No fire incidences have been reported since its establishment, demonstrating its effectiveness in fire prevention.

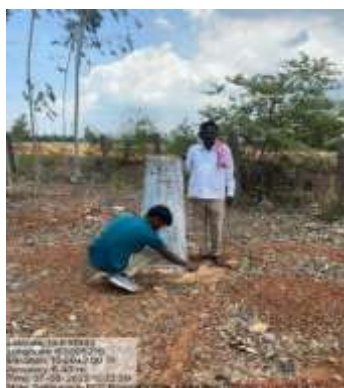
RCC pillars in Kadur beat

Ten RCC boundary pillars constructed in Kadur beat (Kambakam section, Sathyavedu range) and ten RCC boundary pillars in Ganugapenta beat (Mangalampeta section, Piler range) were monitored and evaluated against the specifications recorded in the measurement book. The above-ground dimensions of all pillars were 1.20 m in height, 0.30 m in top width, and 0.45 m in bottom width. Field measurements matched the recorded specifications, with no major deviations observed. All pillars were intact, in good condition, and effectively demarcated the boundaries between reserve forest and adjoining revenue land in both beats.

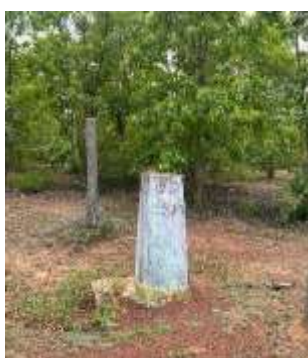
**RCC pillars in Nagari beat**

Twenty RCC boundary pillars ten in Nagari beat (Puttur range) and twenty in Kukkambakam beat (Sri Kalahasti section, Sri Kalahasti range) were monitored and evaluated against the specifications recorded in the measurement book. The above-ground dimensions of all pillars were 1.20 m in height, 0.30 m in top width, and 0.45 m in bottom width. Field measurements matched the recorded specifications, with no major deviations observed. All pillars were intact, in good condition, and effectively demarcated the boundaries between reserve forest and adjoining revenue land in both beats. A total of 20 boundary pillars were constructed across the two beats for boundary demarcation, all of which are in good condition and adequately marking the forest boundaries.

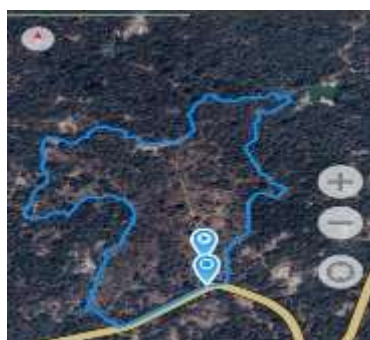
**Kuppam 15.02 Ha**

In Kuppam beat plantation the perambulated area exceeded the recorded area by 0.02 hectares, while at Valligatla plantation the area was larger by 5.73 hectares. All measurements were carried out using QGIS software for spatial analysis and verified through physical perambulation with the Geo Tracker mobile application. Geo tagged photographs and GIS mapping outputs were generated to provide evidence of the verification process. The images documenting this process are provided below.

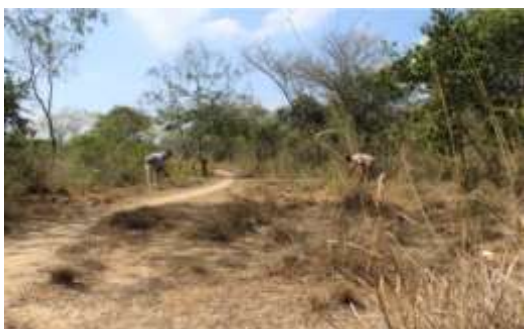
BM Chenlu beat of Kuppam range

A fire line was created and maintained in BM Chenlu beat of Kuppam range, M.M. West beat of Punganur range and Kandlamadugu beat of Madanapalle range was monitored and evaluated against the specifications recorded in the measurement book and the actual field measurements. The dimensions of new fire line are width – 6 m in all beat/ranges, however length is 5000 rmt, 2000 rmt and 4000 rmt in BM Chenlu beat, M.M. West beat and Kandlamadugu beat respectively. The field measurements matched those in the measurement book, indicating no deviations. The fire line is well maintained, though slight grass growth has been observed ensuring clear visibility throughout. Fire incidents have been recorded once a year.

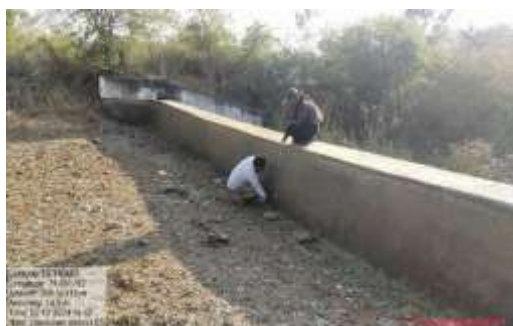
Keenatampalli of Chittoor West range

Newly constructed cement check dam located in Tayamma Vanka in compartment no.228, Keenatampalli RF & beat, Chittoor West range and Balappagaripalli Vanka in compartment no. 243, Allapalle RF of Thotakanuma beat of Palamaner range was monitored and evaluated with reference to the specifications recorded in the measurement book and actual field measurements. The recorded dimensions of the structure are: Length: 20 m, Width: 1.5 m and Depth: 0.6 m in Keenatampalli beat and Length: 20 m, Width: 1.8 m and Depth: 0.3 m in Thotakanuma beat. Field measurements accurately matched the specifications noted in the measurement book, indicating no deviations from the approved design. The structure is currently well maintained and functions effectively. However, total water holding capacity of the check dam has been reduced due to the accumulation of silt and sediment, which has filled up the storage space. Minor repairs are needed on the apron, and desilting should be carried out to restore and increase the storage capacity of the check dam

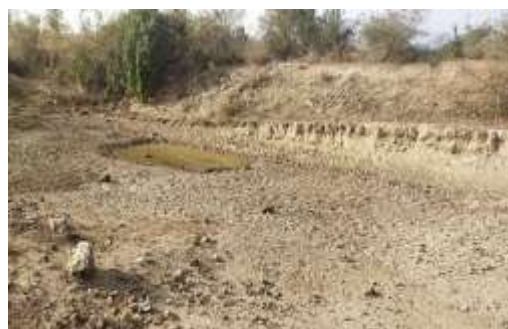
Ramiganipalle beat of Madanapalle

Percolation tanks located at Neredikonda beat of Burakayalakota section in Madanapalle range and Ramiganipalle beat of Burakayalakota section, Madanapalle range was inspected and evaluated against the specifications recorded in the measurement book. Tank dimensions as per measurement book are; length: 50 m, width: 2 m, depth: 1 m and volume: 100 cum in Neredikonda beat and length: 30 m, width: 10 m, depth: 1.17 m and volume: 350 cum in Ramiganipalle beat. The field measurements were found to be consistent with the entries in the measurement book, confirming that the construction was carried out as per approved specifications, with no deviations observed. The percolation tank is well maintained and located in a catchment area, allowing all the rainfall water to accumulate. However, along with the water, there is a significant accumulation of silt, which reduces the tank's volume and storage capacity over time.

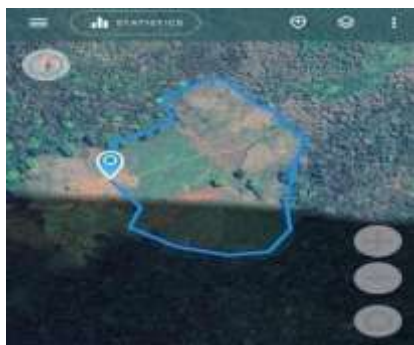
44.99 Ha Annasamudram

During the verification process, it was observed that the perambulated area exceeded the officially recorded area by 14.99 hectares at annasamudram and 4.22 hectares at Rajukunta. This discrepancy is likely due to the inclusion of certain patches within the demarcated plantation boundaries that comprise waste, degraded, or rocky land. The verification was carried out through physical perambulation using the Geo Tracker application, with on-ground validation provided by the local Forest Beat Officer. Geotagged images captured during the perambulation are provided below for reference.

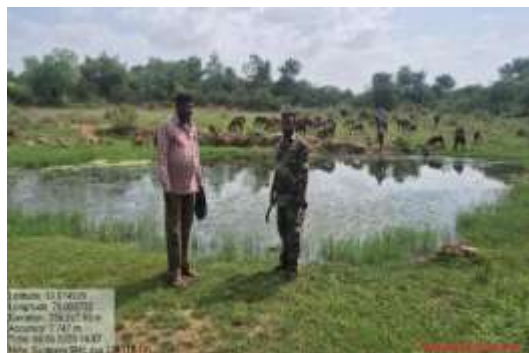
**Jillellamanda beat, sanipaya range**

The percolation tanks constructed in Jillellamanda beat were monitored and evaluated against the specifications recorded in the measurement book and verified through field measurements. The tanks measured 10–13 m in length, 10 m in width, and 1.5 m in depth, with a storage capacity ranging between 98.38 cubic meters and 100 cubic meters. Both structures are located in low-lying areas and have accumulated silt due to water overflow during the monsoon. While the structural integrity of the tanks remains intact, they are largely covered with silt. De-silting is essential to restore their full storage capacity and ensure effective groundwater recharge.

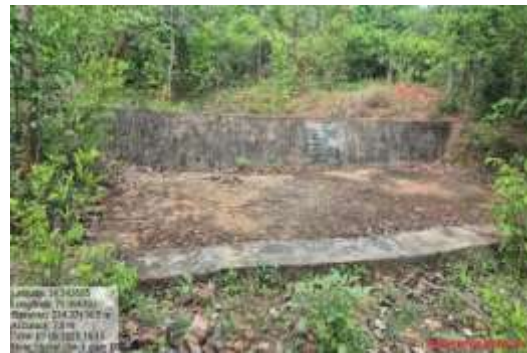
**Rajukunta beat, chitvel range**

Check dam constructed in Rajukunta beat were monitored and evaluated against the specifications recorded in the measurement book and the actual field measurements. The dimensions of the check dam were: Length- 14 m, breadth- 1.50 m and depth- 1.20 m. The field measurements matched those in the measurement book, indicating no deviations. Minor repair required in apron. Total water holding capacity (total volume of the check dam) has been reduced due to the accumulation of silt and sediment. De-silting is to be done to increase the storage capacity.

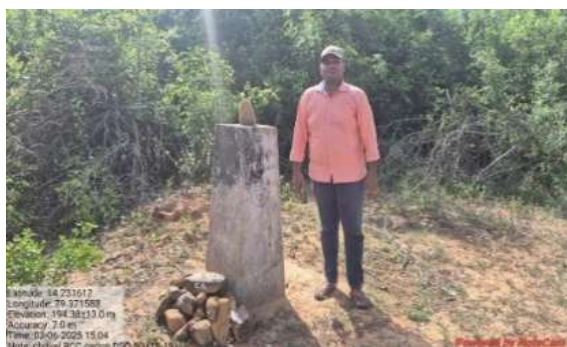
**Rajukunta beat, Chitvel range**

Construction of permanent cairns at Rajukunta beat was monitored and evaluated against the specifications recorded in the measurement book and the actual field measurements. The dimensions of the permanent cairn's enclosure are as follows; Height: 1.20 m, Top width: 0.30 m and bottom width: 0.45 m. The field measurements matched those in the measurement book, indicating no deviations. Boundary pillars are intact and covering the boundary, demarcating the boundary of reserve forest and revenue land. Total of 5 boundary pillars are constructed for the boundary demarcation and were in good condition. The basal part of the pillar has been submerged.

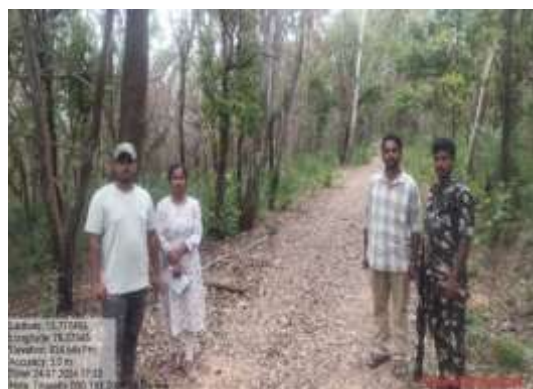
**T.N. Palem central beat of Tirupati range**

book, indicating no deviations. The visibility of the fire line was clear, as it was established along the inspection path. No dense grass or weed growth was observed, indicating that the fire line has been well-maintained.

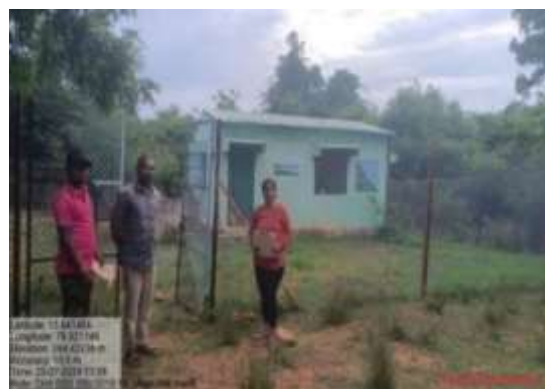
**Eathagunta base camp in Chamala**

Erection of chain link mesh around ethagunta base camp under CAMPA-NPV (forest fire management) scheme was monitored and evaluated against the specifications recorded in the measurement book and the actual field measurements. The dimensions of chain link mesh are Height– 2 m, length – 75rmt and gate-2. The field measurements matched those in the measurement book, indicating no deviations. The chain-link mesh fence is well maintained with intact pillars and no visible damage along its entire length. It was installed to prevent the entry of animals and to provide protection to the base camp.

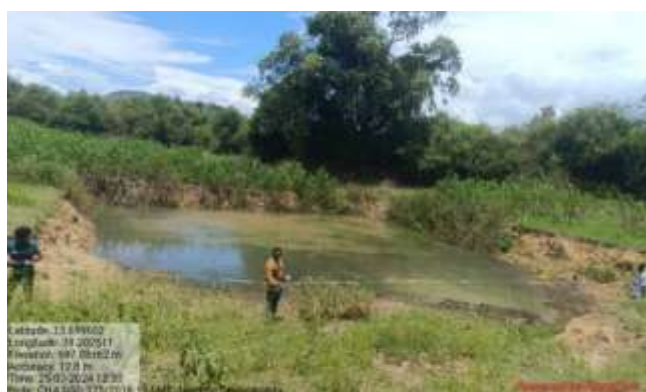
Devarakonda beat of Chamala range

- Kunta 1: Width - 30 m, length – 40 m, depth – 1 m and volume – 1200 cum.
- Kunta 2: Width – 21.9 m, length – 40 m, depth – 1 m and volume – 876 cum.

The field measurements matched those in the measurement book, indicating no deviations. The percolation tank is relatively wide and holds substantial water during the monsoon season. However, regular de-silting is necessary to maintain and enhance its storage capacity.

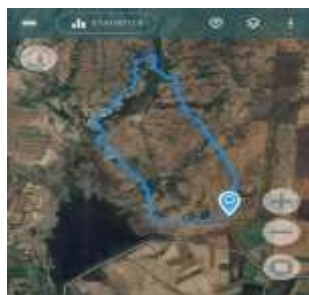
**Vinduru 26.93 Ha**

- 20 Ha NTSH Vinduru plantation (Nellore): Exceeded by 6.93 Ha
- 20 Ha NTSH Madamanuru bit-III plantation (Nellore): Exceeded by 8.65 Ha
- 20 Ha RS Maddurupadu plantation (Kavali): Exceeded by 3.48 Ha
- 20 Ha NTSH Dakkanuru plantation (Udayagiri): Exceeded by 2.49 Ha

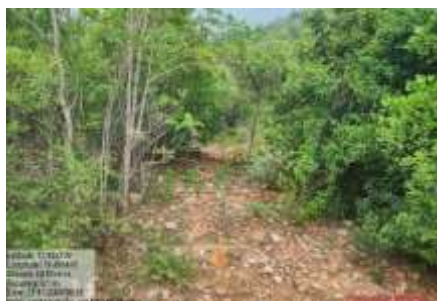
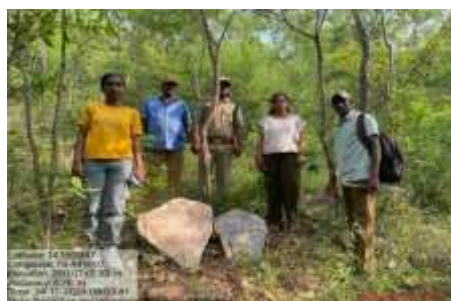
Under the CAMPA-NPV (Forest Fire Management) scheme, fire lines were established across three locations with consistent adherence to specifications recorded in the measurement books and no observed deviations. In Sangam beat, a fire line measuring 3 m in width and 5000 rmt in length was created; however, its visibility has been reduced due to dense grass and weed growth necessitating regular clearing to maintain its effectiveness. In Kurjagunta beat, a 3-m in width and 2500 rmt long fire line was laid along an inspection path within the natural forest. This line is clearly visible and well maintained with no significant grass or weed growth. In Veligonda Reserve Forest, a fire line of 3 m in width and 2000 rmt in length was also established along a forest inspection path. While it remains visible, it is not well maintained with rocky patches and moderate grass and weed growth observed highlighting the need for periodic maintenance to ensure continued fire prevention effectiveness.

**Fire lines in Venkatagiri**

**Fire lines in Veligonda RF, Rapur**

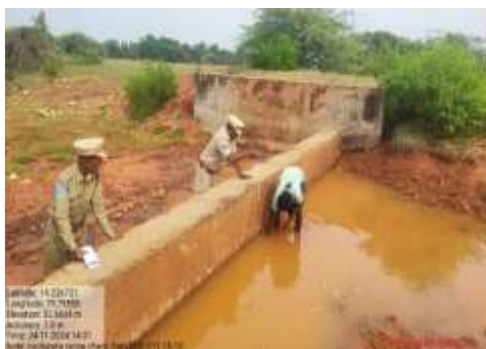
Check dam in Mittatmakur RF

A check dam constructed across Yerragunta Vagu in Mittatmakur RF was monitored and evaluated against the specifications recorded in the measurement book and actual field measurements. The check dam's dimensions—length of 10 meters, width of 1.0 meter and depth of 1.20 meters- matched perfectly with the recorded specifications indicating no deviations. The structure was found to be well maintained; however, its total water holding capacity has decreased due to the accumulation of silt and sediment. Minor repairs are needed for the apron and de-silting is recommended to restore and increase the storage capacity.

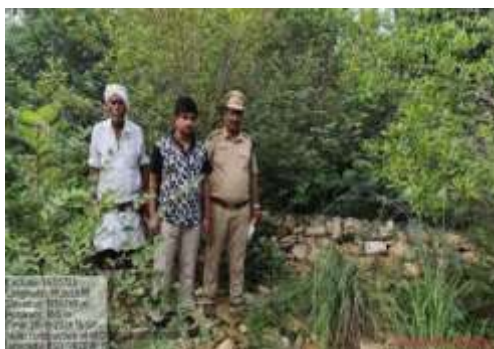
RFD in Bhairavanikonda RF

Rock Fill Dam was constructed across Resubandavagu in Bhiaravanikonda RF was monitored and evaluated against the specifications recorded in the measurement book and the actual field measurements. The dimensions of the rock fill dam: length - 7.60 m, width - 3.0 m and depth - 0.30 m. Field measurements showed reduced depth compared to records but the rock fill dam is maintained. It stores water well in monsoons, though regular de-silting and repairs are needed due to overflow damage. Jungle growth was also noted around the dam.

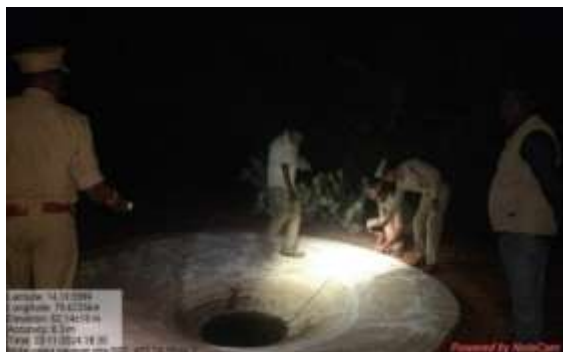
Saucer pits in Kandaleru dam area

Eight saucer pits were constructed across Deer Park at Kandaleru dam, each measuring 2 meters in diameter and 0.10 meters deep. Field measurements matched the recorded specifications, with no deviations. All pits were in good condition and well maintained though cleaning and cement plastering are recommended to improve storage capacity.

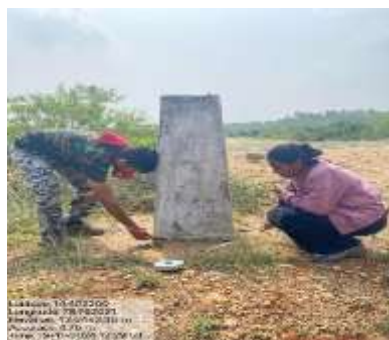
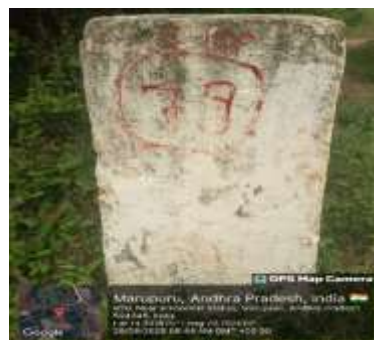
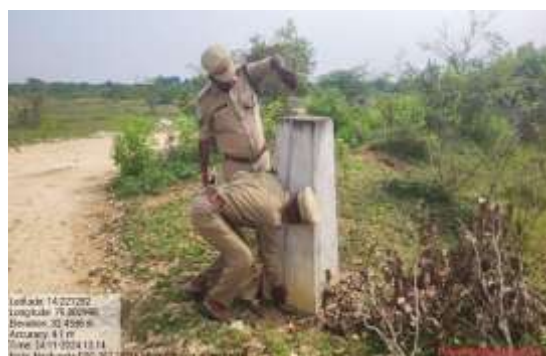
Construction activities involving RCC cairns at Toderu, Mittatmakuru and Marupuru beats were monitored and evaluated against the specifications recorded in the measurement book. Field verification confirmed that carins at all three sites had consistent on-site measurements: length: 1.20 m, width: 0.45 m and height: 1.20 m which matched the recorded specifications, with no deviations observed. A total of 60 RCC cairns were installed at Toderu, 40 at Mittatmakuru and 120 at Marupuru. All cairns were found to be intact and effectively serving their purpose of demarcating forest boundaries, offering consistent and visible boundary markings that contribute significantly to forest protection and management. However, it was noted that the bases of several cairns were partially covered with soil, and the cement plastering had deteriorated in places due to weathering. Periodic maintenance is recommended to preserve their visibility and structural integrity over time.

Carins in Toderu

Carins in Marupuru

Carins in Mittatmakuru

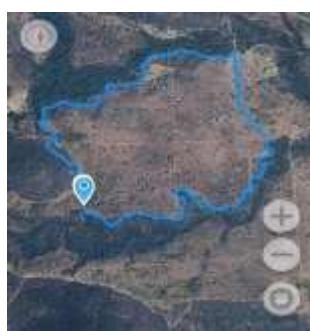
**Itukulapadu bit-I 18.96 Ha**

- 15 Ha Misc Itukulapadu plantation (Porumamilla): Exceeded by 3.96 Ha
- 5 Ha Itukulapadu plantation (Porumamilla): Exceeded by 0.58 Ha
- Gandlur bit-I plantation (Muddanur): Exceeded by 0.16 Ha
- Gandlur bit-II plantation (Muddanur): Exceeded by 13.98 Ha

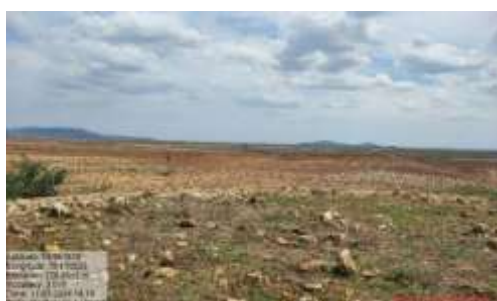
**Gandlur bit-I plantation**

**Health Status of Plantation:** The overall health condition of the plantations in Itukulapadu (15 Ha and 5 Ha) was found to be satisfactory. No incidences of insect or pest infestations were observed across any of the planted species. The plants appeared healthy exhibiting no visible signs of physiological stress or disease. This suggests that the plantations are being properly maintained and that the prevailing environmental conditions at these sites are conducive to sustained and healthy plant growth. In contrast, at Gandlur (bit-I and bit-IV), the plantations were found to be submerged under water with no live plants observed. Due to the submergence, it was not possible to assess the health status of these plantations.

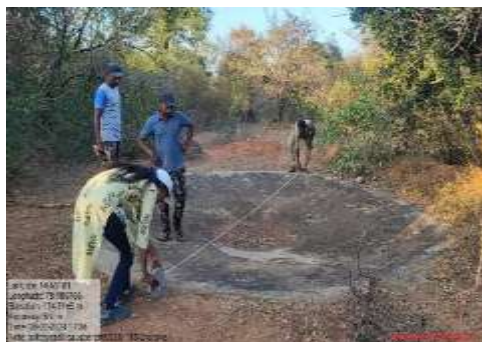
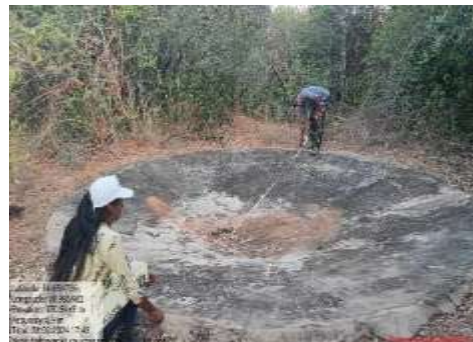
**Saucer pits at Balayapalli beat**

Three saucer pits were constructed at Balayapalli beat, each measuring 3.14 m in length, 4.51 m in width and 0.93 meters in depth. Field measurements confirmed that the dimensions matched the recorded specifications with no deviations. All three pits were found to be in good condition and well maintained. However, to enhance their storage capacity, it is recommended to remove the accumulated dirt and re-plaster the cement lining of the pits.

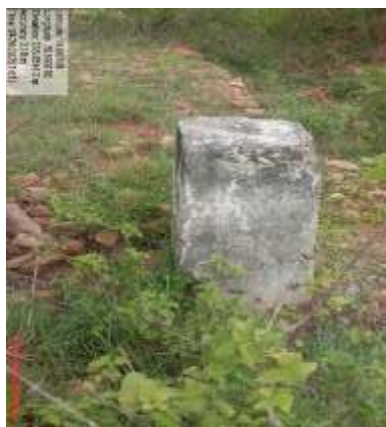
**RCC Cairns at Balayapalli beat**

A construction activity involving RCC cairns at Balayapalli beat was monitored and evaluated against the specifications recorded in the measurement book and the actual field measurements. The dimensions of the RCC Cairns were as follows; Total no of Cairns- 16 with length - 1.20 m, width - 0.45 m and height - 1.20 m. The field verification confirmed that the measurements on site correspond precisely with those recorded in the measurement book, indicating no deviations. A total of 16 R.C.C. cairns have been installed, all of which were found to be intact and effectively serving their intended purpose of demarcating the boundary. These cairns provide consistent and visible boundary markers, supporting effective forest protection and management. However, it was observed that the bases of the cairns are partially covered with soil, and the cement plastering has deteriorated due to weathering over time. Periodic maintenance is recommended to preserve their visibility and structural condition.

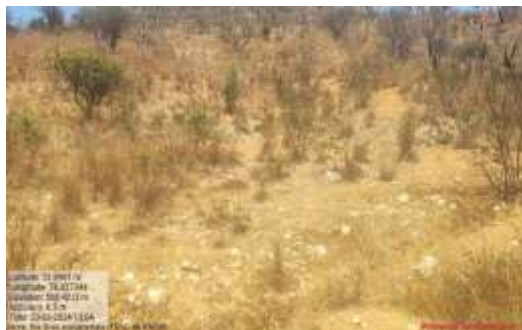
**Edurudona beat, Kadiri Range**

The creation of new fire lines across natural forest areas in the Edurudona and Motukupalli beats of Kadiri Range, Jambugumpala Reserve Forest of Kalyandurg Range, and Thummalamula beat in Mudigubba Section of Bukkapatnam Range was monitored and evaluated against the specifications recorded in the measurement book and verified through actual field measurements. In Edurudona beat, the fire line was constructed with a width of 10 meters and a length of 2,000 meters, while in both the Motukupalli and Thummalamula beats, fire lines were created with the same width of 10 meters and a length of 1,000 meters each. In Jambugumpala RF, the fire line measured 6 meters in width and 3,000 meters in length. The

field measurements matched the specifications recorded in the measurement book, indicating no deviations. The visibility of the fire lines was clear, as they were aligned along inspection paths, ensuring ease of monitoring. Additionally, no dense grass or weed growth was observed, suggesting that the fire lines are well-maintained throughout the respective forest areas.

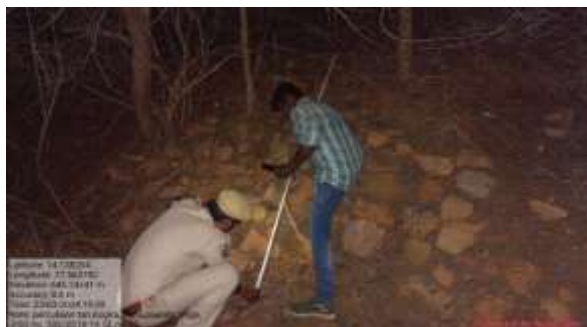
**Maddi Chetla Vank, Kogira block**

Percolation tanks located at Maddi Chetla Vank in Survey No. 669 of Kogira Block, Penukonda Range, and in the Thummalamala Reserve Forest area, Nallamada Beat, Mudigubba Section of Bukkapatnam Range, were inspected and evaluated against the specifications recorded in the measurement book. Tank Dimensions in Penukonda Range (Maddi Chetla Vank); length: 40 m, width: 3 m, depth: 1 m and volume: 120 cum and in Bukkapatnam Range (Thummalamala RF); length: 23 m, width: 6 m, depth: 1.65 m and net volume: 227.70 cum. The field

measurements for both locations were found to be consistent with the entries in the measurement book, confirming that the construction was carried out as per approved specifications, with no deviations observed. All three tanks are currently in good condition and demonstrate effective water retention during the monsoon season. However, due to their location in low-lying areas, there is noticeable silt accumulation, which may reduce storage capacity over time. Additionally, stone dry packing along the tank edges shows signs of distortion, likely caused by surface runoff or prolonged water exposure.

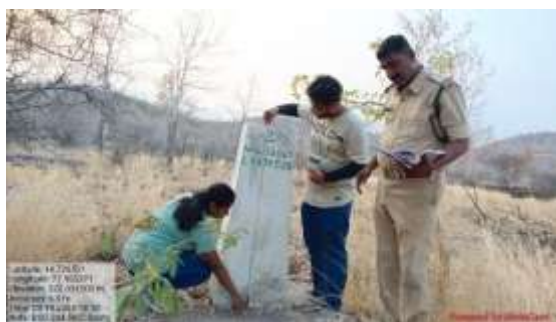
**Muchukota additional block – 21**

Construction of 53 boundary pillars in Kurli beat of Kurli section of Kadiri range, 16 RCC boundary pillars in Kalyandurg south RF in Kalyandurg beat of Kalyandurg range and 21 RCC boundary pillars in Muchukota additional block - 21 area was monitored and evaluated against the specifications recorded in the measurement book and the actual field measurements. The above-ground dimensions of the RCC boundary pillars at both locations were: height – 1.20 m, top width – 0.30 m, and bottom width – 0.45 m. The field measurements matched those in the measurement book, indicating no deviations. All boundary pillars constructed were found intact and effectively demarcating the boundaries between the reserve forest and revenue land.

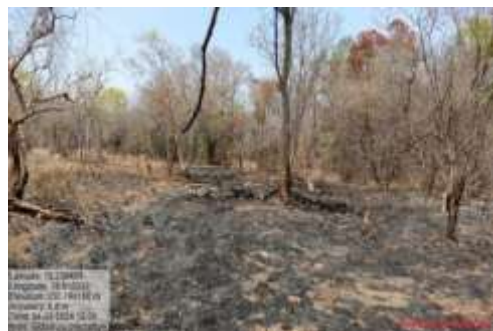
**Fire line at Bodi beat**

A fire line was created and maintained in Bodi beat under CAMPA-NPV (forest fire management) scheme was monitored and evaluated against the specifications recorded in the measurement book and the actual field measurements. The dimensions of fire line are: width -

3 m and length - 8000 rmt. The field measurements matched those in the measurement book, indicating no deviations. The visibility of the fire line was clear with burnt litter and tree stumps. No dense grass or weed growth was observed indicating that the fire line has been well-maintained.

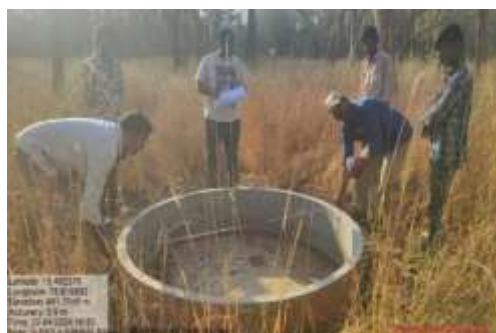
**Saucer pits in Malakondapenta**

Saucer pits constructed in both Malakondapenta section and Papinenipalli beat were monitored and evaluated against the specifications recorded in the measurement book and actual field measurements. In Malakondapenta section, 23 saucer pits with dimensions of 2 meters in diameter and 0.5 meters in depth were inspected. In Papinenipalli beat, 14 saucer pits measuring 6 meters in diameter and 0.5 meters in depth were evaluated. In both cases, the field measurements matched those recorded in the measurement book, indicating no deviations. All pits were found to be in good condition and well maintained. However, to further enhance their water storage capacity and durability, removal of accumulated silt and re-plaster cracks.

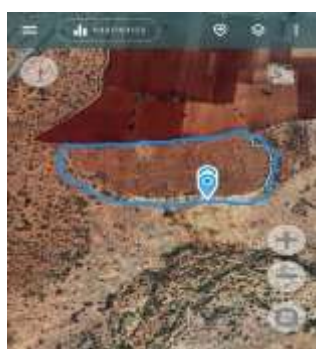
**Tungabhadra 10.14 Ha**

- 6.60 Ha Tungabhadra plantation (Adoni): Exceeded by 3.54 Ha
- 1 Ha Ramallakota plantation (Kurnool): Exceeded by 0.11 Ha

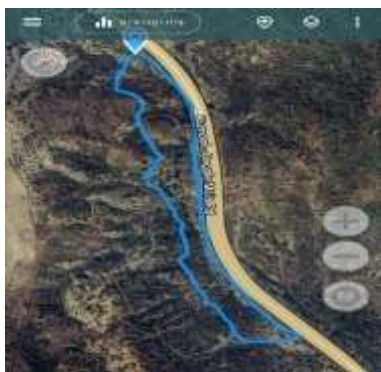
Konidedu 26.15 Ha

The area verified during perambulation was found to be larger than the area recorded in official documents by 1.15 Ha in Konidedu beat. This discrepancy is likely due to the inclusion of certain patches within the demarcated plantation boundaries that comprise waste, degraded, or rocky land. The verification was carried out by physically Perambulation of the entire area using a Geo Tracker. The Perambulation was done in presence of forest officer and as per the demarcation shown by the watcher/guard working as in-charge of the plantation.

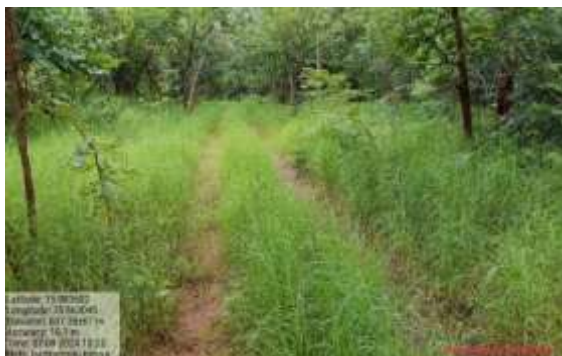
Fire lines in Pecheruvu East beat

Fire prevention measures were evaluated in Pecheruvu East Beat and Sundipenta, where both a fire line and a view line were established and maintained as per the approved specifications. The fire line from the main power line to Pulicheruvu Rasta measured 3 m in width and 1,035 rmt in length, while the view line from the district boundary line to the Biopark at Sundipenta measured 10 m in width and 4,142 rmt in length. Field verification confirmed that both structures matched the measurement book with no variation recorded. While the lines were found to be clear and effective, moderate to significant growth of weeds and grasses was observed during the monsoon season, which could contribute to the spread of fire in summer. Therefore, annual maintenance is essential to control vegetation growth, sustain visibility, and ensure that these fire prevention structures remain effective for protection and monitoring.

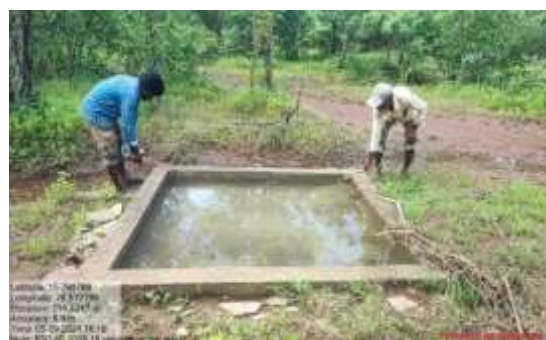
Water pit in Velgode West beat

A mini percolation tank was constructed in Indireswaram West Beat of Nagaluty Range with dimensions of 10 m × 10 m × 1 m, and a basement-cum-water pit was constructed in Velgode West Beat of Velgode Range with dimensions of 2.6 m × 2.6 m × 0.2 m. Field verification confirmed that both structures matched the measurement book with no variation recorded. The mini percolation tank was found to be functional; however, regular de-siltation is necessary to maintain and enhance its water retention efficiency, as silt accumulation and vegetative growth in and around the tank reduce its storage potential over time. The concrete water pit was observed to be well maintained and in good condition, effectively storing rainwater during the summer and serving as a vital water source for wildlife. To ensure the long-term functionality of both structures, annual maintenance is essential, particularly de-siltation of the percolation tank and upkeep of the water pit, thereby strengthening their role in water conservation and wildlife support.

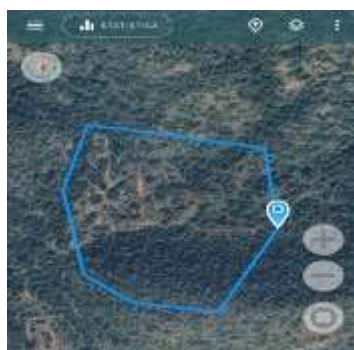
**Chilakacharla 3.27 Ha**

Perambulation of the Chilakacherla plantations was conducted with the assistance of the local Forest Beat Officer using a Geo Tracker. The plantation boundaries are surrounded by dense jungle growth and undulating terrain, which necessitated measuring along the outer boundary rather than the precise plantation limits. Using QGIS software, it was determined that the perambulated area exceeds the recorded area by 0.27 Ha. Images of the perambulated areas are provided below.

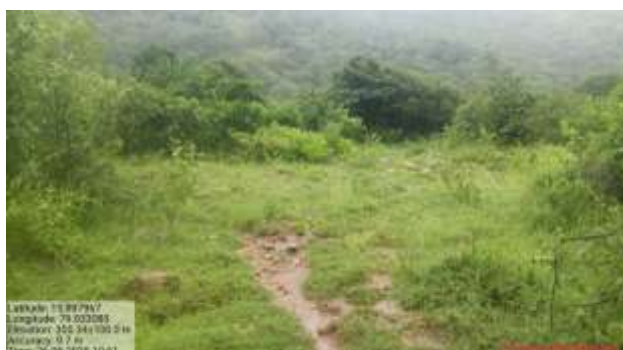
**Dornala, Chilakacharla plantation**

**Health Status of Plantation:** In Chilakacherla plantation, no live plants were observed indicating that the plantation was unsuccessful. Due to the poor establishment and complete absence of surviving individuals, the health condition of the plantation could not be assessed in detail.

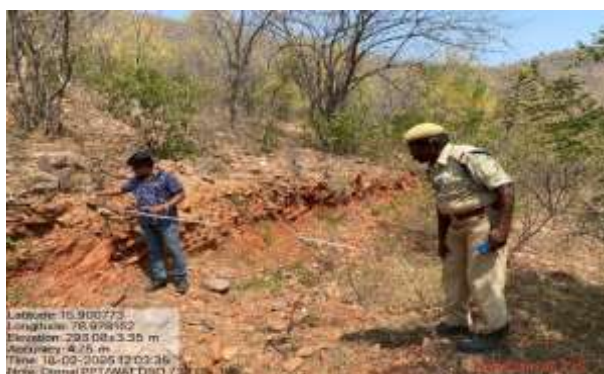
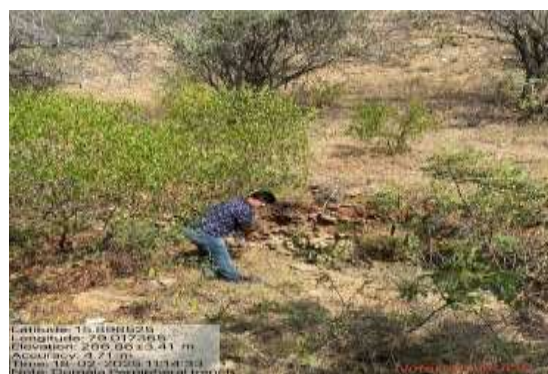
**Peripheral trench around Inamukkala CA land bit II, IV in Dornala range**

A peripheral trench was constructed around the Inamukkala Compensatory Afforestation (CA) land in Bit II and Bit IV, as per the sanctioned specifications recorded in the measurement book. The prescribed dimensions were 2.5 meters in breadth, 3 meters in depth, and lengths of 3,300 running meters (Bit II) and 2,000 running meters (Bit IV). During the field verification, the trench alignment and overall construction were found to be in accordance with the measurement book. The breadth and length were consistent with the prescribed dimensions, indicating satisfactory execution of the sanctioned work. However, in both bits, the depth of the trench was reduced by approximately 0.5 meters due to natural silt deposition, bringing the effective depth to 2.5 meters instead of the planned 3 meters. While the trenches remain structurally visible and intact, grass growth, weed proliferation, and silt accumulation were clearly observed along the trench bed and sides. Peripheral trenches play a crucial role in preventing soil erosion, restricting cattle entry, acting as fire barriers, and improving moisture retention in plantation areas. If left without maintenance, siltation and vegetative growth may progressively reduce their functional efficiency. Therefore, timely interventions are essential to restore their designed capacity.

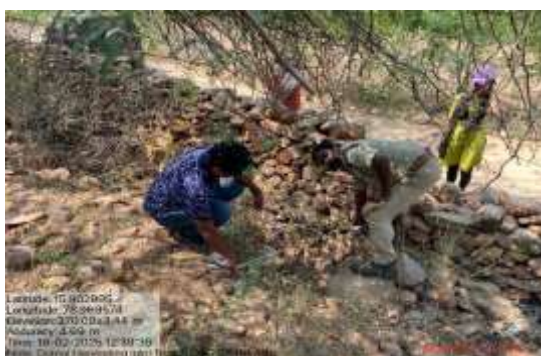
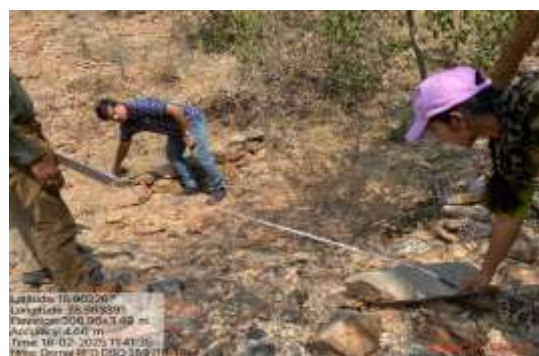
**Rock fill dam and mini trenches in Dornala range**

At Inamukkala CA land of Dornala section, a rock fill dam was constructed with specifications as per the measurement book comprising a main dam of 5.00 m × 3.00 m × 0.25 m, upstream and downstream side walls of 2.50 m × 0.25 m × 0.60 m each, and an apron of 5.00 m × 0.90 m × 0.60 m. During field verification, the dimensions were largely consistent in length and breadth, but the depth was slightly reduced, resulting in a lower storage capacity. The total volume of the structure was recorded at 647 cum compared to 276 cum in the MB. Major repairs are required for the apron, and de-silting should be undertaken to enhance storage capacity, as seepage was observed both from the main dam and the apron. Additionally, at the same location, 500 mini trenches were created with measurement book dimensions of 1.30 m × 0.45 m × 0.30 m; however, in the field, the depth was reduced to 0.20 m due to siltation. Being situated in a low-lying area, silt accumulation is significant, and the stone dry packing along trench edges has been displaced by water overflow during the monsoon.

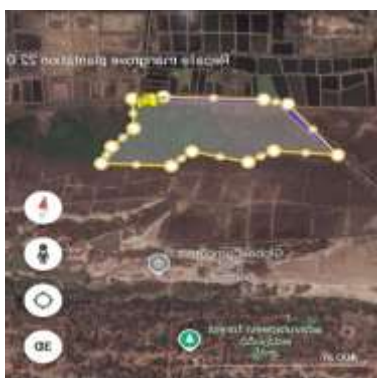
**Adavuladeevi bit-I plantation 12.19 Ha**

During the verification of mangrove plantation areas at Adavuladeevi it was observed that the perambulated extents exceeded the officially recorded areas. However, Tummalapalli VSS 10 Ha Shelterbelt plantation the perambulated area was less than area in records. The field verification was conducted with the assistance of local forest beat officers, and in all cases, the plantations were surrounded by water. Consequently, the field teams traced the outer boundaries of these physical features, rather than adhering strictly to the originally recorded plantation limits. As a result, the perambulated area was found to be 0.19 hectares larger at Adavuladeevi and 4.2 hectares lesser at Tummalapalli plantation. This discrepancy is attributed to the inclusion of water area without proper boundary pillar markings. Spatial analysis was conducted using QGIS software, and the verification was further supported through physical perambulation using the Geo Tracker mobile application. To substantiate the findings, geo-tagged photographs and GIS-based mapping outputs were generated, providing clear evidence of the verification process. Relevant images documenting this process are provided below.

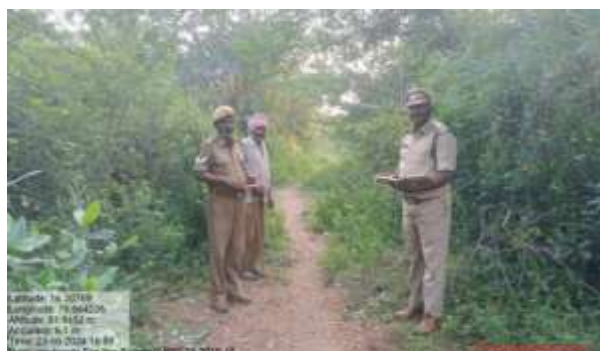
**Fire line in Bollapalli beat**

In the Bollapalli Beat, a fire line of 3000 running meters was established around the Bollapalli Reserve Forest boundary. The fire line was clearly visible and well-maintained, with minimal growth of grass and weeds observed. However, coppice growth during the monsoon season presents a potential fire hazard in the summer months, highlighting the need for consistent annual maintenance.

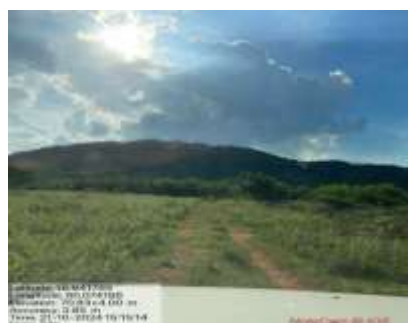
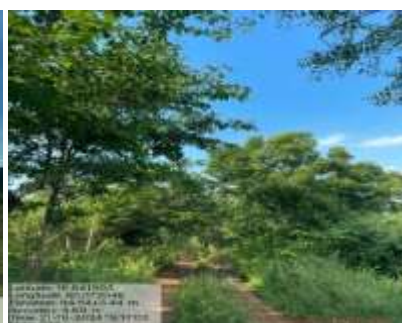
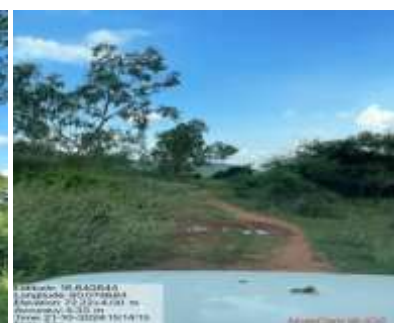
**Fire line in Venkatayapalem Extn-V RF of Atchempet section and beat in Guntur range**

In Atchempet Beat of the Guntur Range, a 5000-meter fire line was established along inspection paths within the existing plantations. These fire lines were visible and well-maintained, which helped in controlling the growth of dense grasses and weeds. However, no fire lines were observed in and around the previously established plantations in the Venkatayapalem Extension-V RF area.

This lack of coverage poses a potential fire risk. In the areas where fire lines were present, their maintenance was effective, although coppice growth during the monsoon season remains a recurring challenge. Overall, while the existing fire lines are effective and constructed as per the prescribed specifications, regular annual maintenance is essential, especially before the summer season, to manage regrowth and prevent fire hazards. It is also recommended that fire lines be established in uncovered areas such as the Venkatayapalem Extension-V Reserved Forest to ensure comprehensive fire protection.

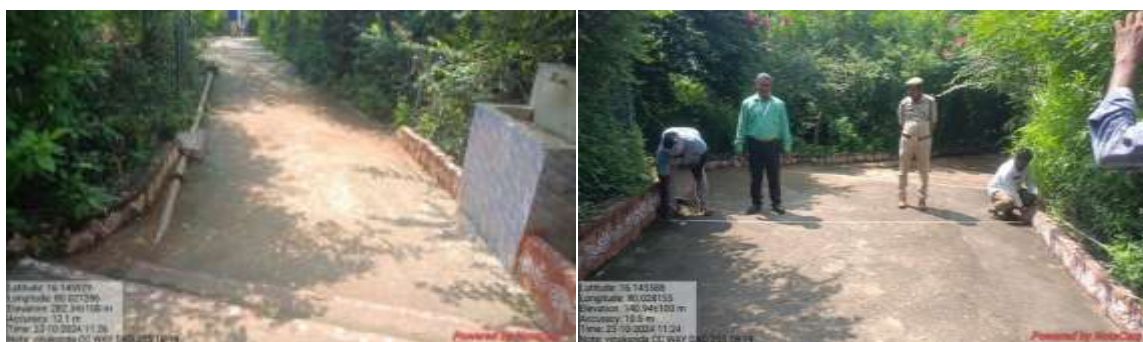
**CC way from back side to aquarium to painted strocks of Kotappakonda**

Monitoring and evaluation were carried out by comparing the field measurements with the specifications recorded in the measurement book. The actual field measurements were consistent with the recorded data, indicating no deviations from the specified dimensions.

The constructed CC pathway is structurally sound and undamaged, providing safe and convenient access for visitors to the aquarium and nearby scenic areas. To ensure its long-term durability and usability, regular maintenance of the pathway is recommended.

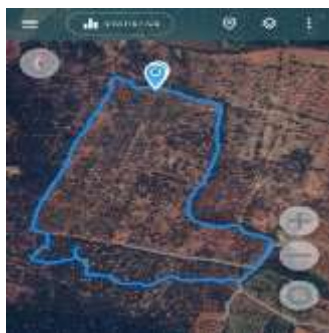
Katrenipadu 27.07 Ha

The area verified during perambulation was found to be larger than the area recorded in official documents by 4.41Ha in Katrenipadu. This discrepancy is likely due to the inclusion of certain patches within the demarcated plantation boundaries that comprise waste, degraded, or rocky land. The verification was carried out by physically Perambulation of the entire area using a Geo Tracker. The Perambulation was done in presence of forest officer and as per the demarcation shown by the watcher/guard working as in-charge of the plantation. Geotagged images captured during the perambulation are provided below for reference.

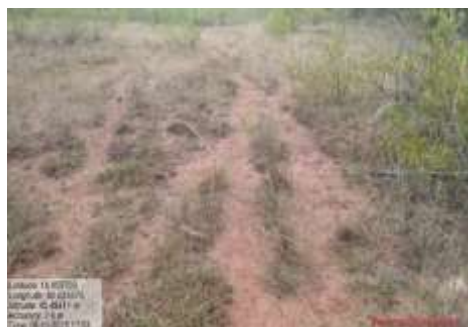
**A. Konduru beat Mylavaram range**

A fire line was created A.Konduru beat under CAMPA-NPV (forest fire management) scheme was monitored and evaluated against the specifications recorded in the measurement book and the actual field measurements. The dimensions of new fire line are width – 3 m, and length – 3300rmt. The field measurements matched those in the measurement book, indicating no deviations. The visibility of the fire line is limited, despite its location within the Reserve Forest (RF). Moderate growth of grass and weeds has been observed along the fire line, indicating the need for regular maintenance. Periodic clearing is recommended to improve visibility and ensure the fire line remains effective in controlling the spread of forest fires.

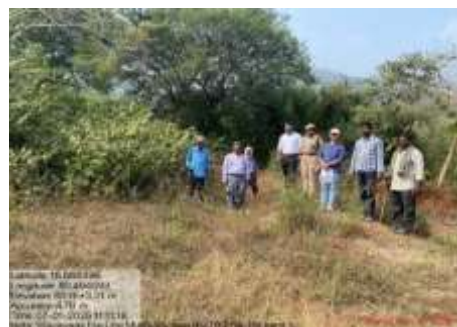
**Mulapadu beat Vijayawada range**

A fire line was created Mulapadu beat under CAMPA-NPV (forest fire management) scheme was monitored and evaluated against the specifications recorded in the measurement book and the actual field measurements. The dimensions of new fire line are width – 3 m, and length – 2500rmt. The field measurements matched those in the measurement book, indicating no deviations. The visibility of the fire line is not clearly evident, suggesting that the fire line might

not be well-maintained or visible enough for effective fire control. Additionally, the growth of dense grass or weeds along the fire line has been observed, which can reduce its effectiveness. Regular maintenance is recommended to clear the vegetation, ensuring the fire line remains functional and capable of preventing the spread of forest fires.

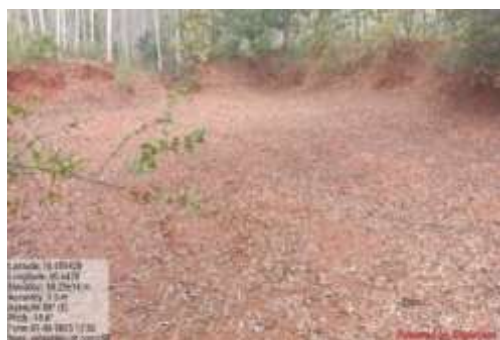
**Kothuru RF Vijayawada range**

Percolation tank in Kothuru RF, Gandrai (RSO 5, 6 and 51) and Tadepalli beat was monitored and evaluated against the specifications recorded in the measurement book and the actual field measurements. The dimensions of the percolation tank were: length – 10 m, width – 10m, and depth – 1.00 m with volume of 205 cum. The field measurements matched those in the measurement book, indicating no deviations. Due to accumulation of silt, tank capacity has been reduced. Hence, there is a need for de-siltation activity. Well maintained, as the tank is present in a low ground more accumulation of silt is observed. The stone dry packing in the tank length has been distorted at the edges due to the overflow of water in the tank during monsoon. Regular de-siltation of the percolation tank is required to maintain the storage capacity to its fullest extent.

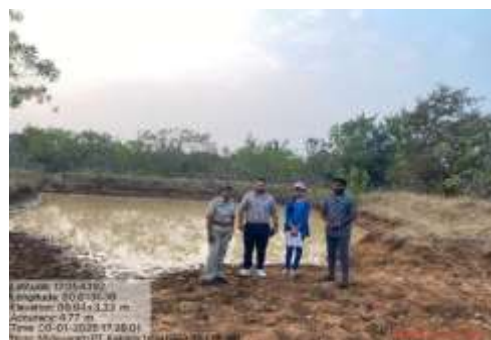
**Kakarla beat Mylavaram range**

Percolation tank in Kakarla beat was monitored and evaluated against the specifications recorded in the measurement book and the actual field measurements. The dimensions of the percolation tank were: length – 10 m, width – 10m, and depth – 1.00 m with volume of 205 cum as per measurement book. The dimensions of the percolation tank in field: length – 12m, width – 12 m, and depth – 1 m with volume less than 205 cum. Well maintained and in effective use field measurements were more than the actual measurements noted in the records. The percolation tank is well maintained, and water storage was observed during the visit, owing to its location in a low-lying area. However, the stone dry packing along the tank's length has been distorted at the edges due to water overflow during the monsoon season. Regular desilting is necessary to maintain the tank's storage capacity at its fullest extent.

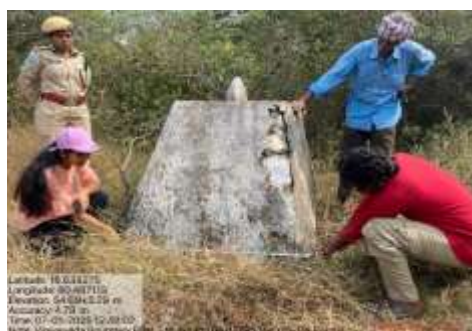
**Boundary pillars at Mulapadu beat**

Construction of boundary pillars at Mulapadu beat was monitored and evaluated against the specifications recorded in the measurement book and the actual field measurements. The dimensions of the boundary pillars enclosure are as follows; Height-1.20 m, top width-1 m and bottom width-1.30 m. The basal part of the pillar has been submerged under the soil. These pillars are intact and effectively mark the boundary. Furthermore, all the pillars are reported to be in **good condition**, indicating that the construction work was carried out successfully and the pillars are effectively serving their role in preventing encroachments and ensuring proper land management.

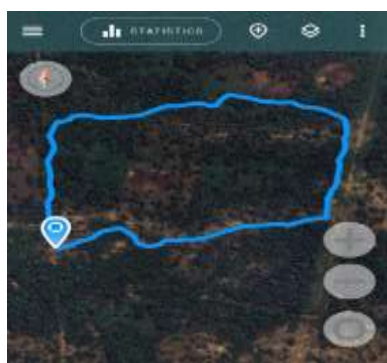
**Tellavarigudem 13.64 Ha**

- 10 Ha Bamboo Tellavarigudem plantation (Chintur): Exceeded by 3.64 Ha
- 5 Ha NTSH Dabbagudem north plantation (Lakkavaram): Exceeded by 1.4 Ha
- 20 Ha Bamboo Mattapally plantation (VR Puram): Exceeded by 11.16 Ha
- 15 Ha Bamboo Palamadagu plantation (Nellipaka): Exceeded by 7.41 Ha

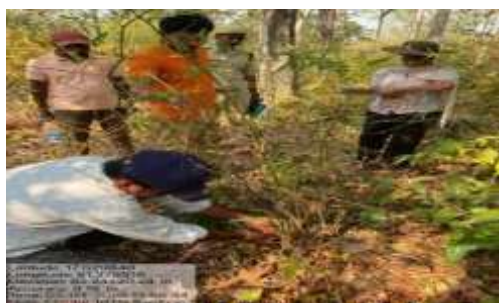
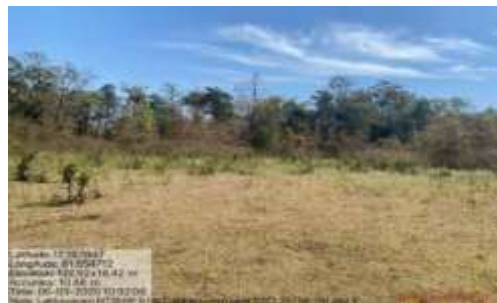
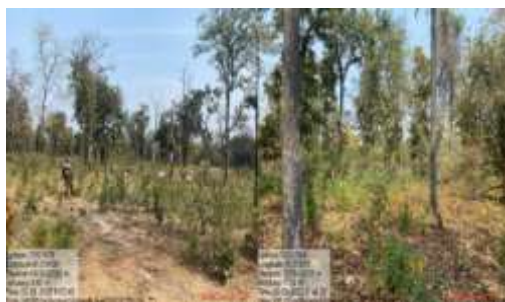
**Health Status of Plantation:** In all four plantations, the overall survival rate and growth performance of the plants were found to be low. Due to poor establishment and limited development of the species, health condition of the plantations could not be assessed in detail. While the naturally regenerated plants showed no visible signs of physiological stress or disease.

**Maintenance of Plantation Journals and Records:** Although plantation journals were maintained at all four sites, they were not regularly updated. Additionally, the absence of plantation display board at all four locations reduced visibility and awareness of the plantation sites. Inspection remarks by department officials are not seen.

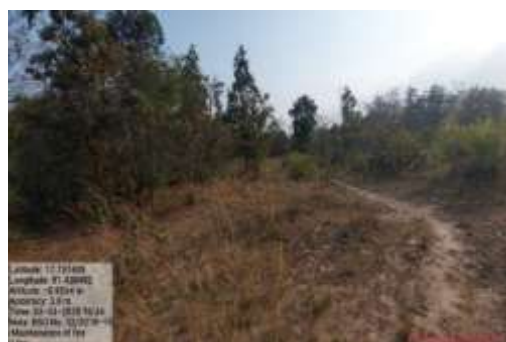
Fire lines at Chintur section

The fire line established under the CAMPA-NPV scheme in Chintur section measures 3 m in width and 2,500 rmt in length consistent with official records. Although the fire line is present throughout the Chintur section, it is poorly visible due to moderate to dense growth of grass and weeds. Regular maintenance is recommended to ensure the fire line remains functional and effective.
