# **Third Party Monitoring and Evaluation of Compensatory Afforestation Fund Management and Planning Authority (CAMPA) Activities of Andhra Pradesh Forest Department (APFD) During 2018-19**

**INSTITUTE OF WOOD SCIENCE AND TECHNOLOGY**  
**(Indian Council of Forestry Research & Education)**  
18<sup>th</sup> Cross, Malleswaram, Bangalore – 560 003  
October 2025

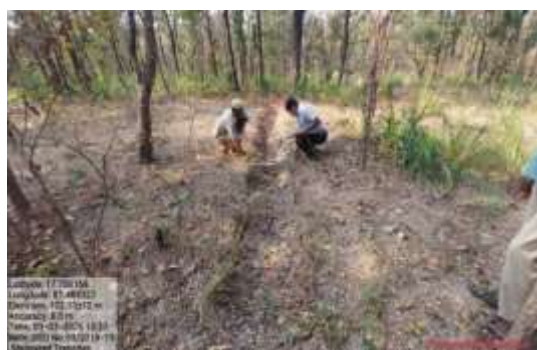
Staggered trenches constructed at Pothampally beat were monitored and evaluated against the specifications recorded in the measurement book (MB). Field measurements confirmed the dimensions as 10 m in length, 0.5 m in width and 0.5 m in depth fully matching the MB records with no deviations from the approved design. However, heavy accumulation of silt and plant residues was observed in the trenches impairing their capacity and functionality. This build up restricts proper water percolation and soil moisture retention. Regular maintenance has not been evident and immediate de-siltation is necessary to restore the trenches' efficiency.

**Staggered trenches in Pothampally beat    Percolation tank at Pothampally beat**

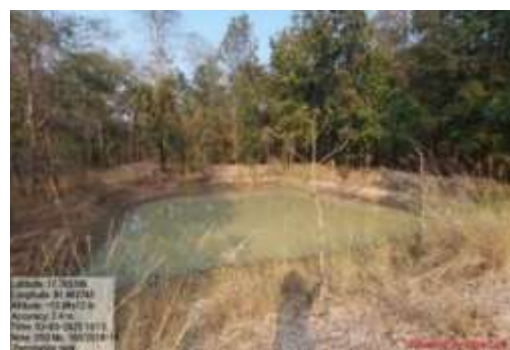
Percolation tanks at Pothampally and Kansuluru beats were found to match the approved dimensions of 10 meters in length, 10 meters in width, and 1 meter in depth. However, excessive silt, damaged stone packing and weed growth were observed reducing their effectiveness. Regular de-siltation is necessary to maintain full water storage capacity.

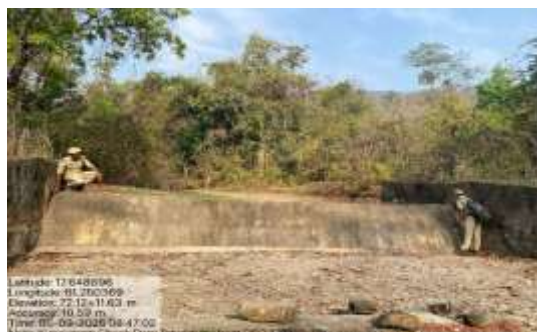
**Check dam at Tekulaboru beat**

Check dams constructed across Maddigudem, E.D. Pally, and Tekulaboru beats were monitored and evaluated against the specifications recorded in the measurement book (MB) and verified through field measurements. All three check dams have identical dimensions: 12.00 m in length, 1.40 m in width and 1.20 m in depth. Field verification confirmed that these measurements matched the MB specifications, with no deviations from the approved design. The structures were found to be well maintained; however, their total water holding capacity has been reduced due to silt and sediment accumulation. Additionally, minor repairs are needed in the apron sections. It is recommended that de-silting operations be carried out to restore storage capacity and ensure the continued effectiveness of the check dams.

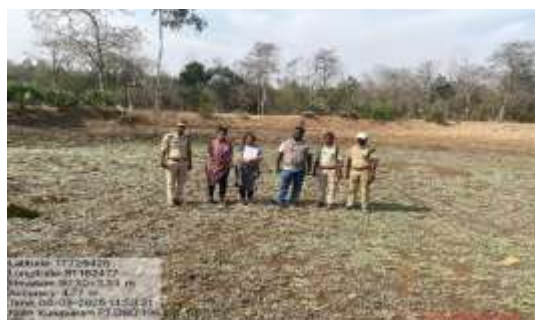
Percolation tanks at Thatilanka beat was found to match the approved dimensions of 10 m in length, 10 m in width, and 1 m in depth. However, excessive silt, damaged stone packing and weed growth were observed reducing their effectiveness. Regular de-siltation is necessary to maintain full water storage capacity.

**New percolation tank at Thatilanka beat    Mini Percolation tank at Gondhigudem**

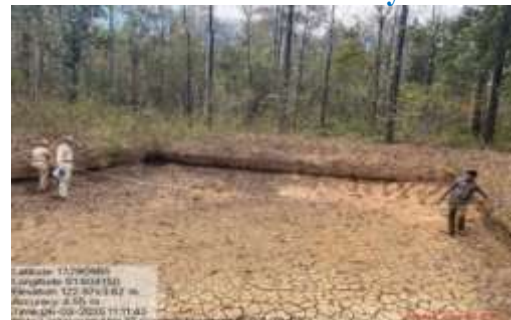
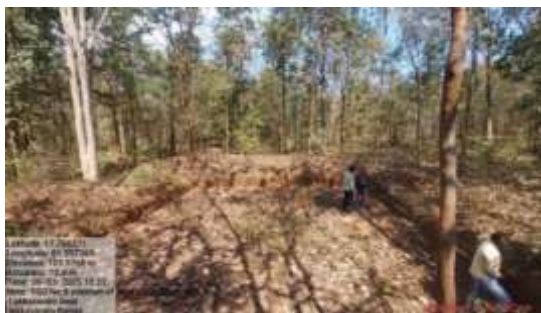
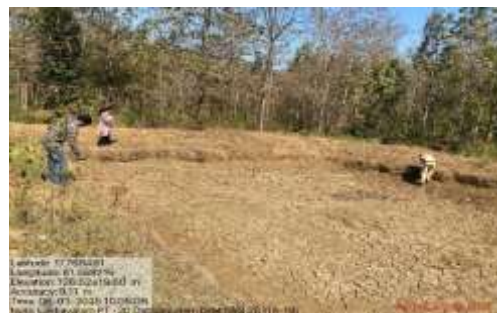
All six percolation tanks at Gondhigudem, Lakkavaram and Dabbagudem North beats were found to match the approved dimensions of 10 m in length, 10 m in width, and 1 m in depth. However, excessive silt accumulation, damaged stone packing and weed growth were observed reducing their effectiveness. Regular de-siltation is necessary to maintain full water storage capacity.

**Mini percolation tank-7 of Lakkavaram beat**

**Mini percolation tank-20 of Dabbagudem**

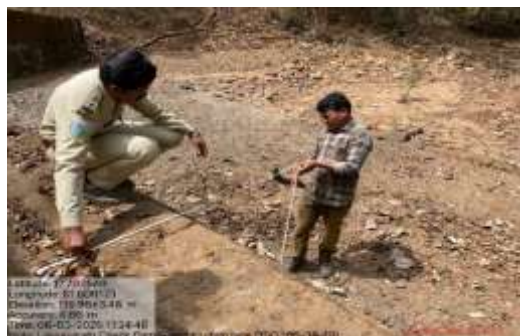
**Check dam of Gondhigudem beat**

Check dam constructed across Gondhigudem beat was monitored and evaluated against the specifications recorded in the measurement book (MB) and verified through field measurements. The dimensions of the check dam: 14.00 m in length, 1.55 m in width and 1.0 m in depth. Field verification confirmed that these measurements matched the MB specifications, except for a reduced depth compared to the approved design. The structures were found to be well maintained; however, their total water holding capacity has been reduced due to silt and sediment accumulation. Additionally, minor repairs are needed in the apron sections. It is recommended that de-silting operations be carried out to restore storage capacity and ensure the continued effectiveness of the check dams.

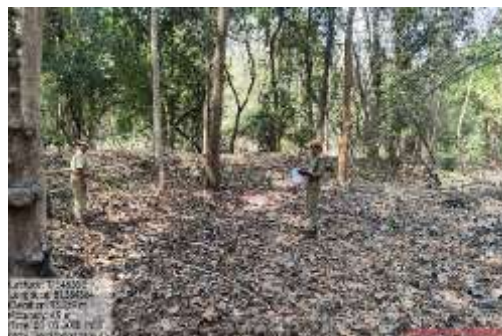
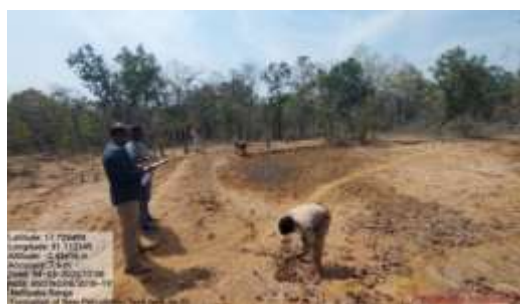
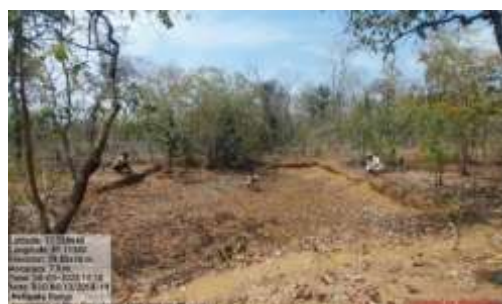
One percolation tank at Darapalli and four at Visapuram beat were found to match the approved dimensions, each measuring 10 m in length, 10 m in width and 1 m in depth. However, excessive silt accumulation, damaged stone packing and weed growth were observed reducing their effectiveness. Regular de-siltation is necessary to maintain full water storage capacity.

**Percolation tank of Darapalli beat**

**Mini percolation at Vissapuram beat**

**Mini percolation tank- 38 of Vissapuram**

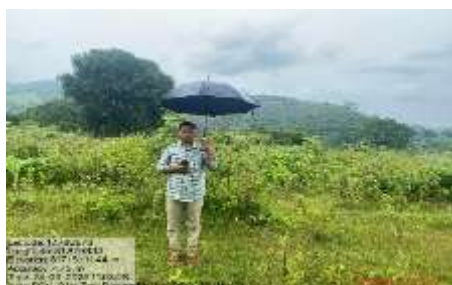
**Daragedda plantation, RC Varam**

The 10-hectare *Tectona grandis* plantation located in the Daragedda beat of Rampachodavaram range was found to be unsuccessful due to encroachment issues and grazing activities. Some stunted Teak plants were observed with an approximate height of 0.5 m and a girth of around 12 cm.

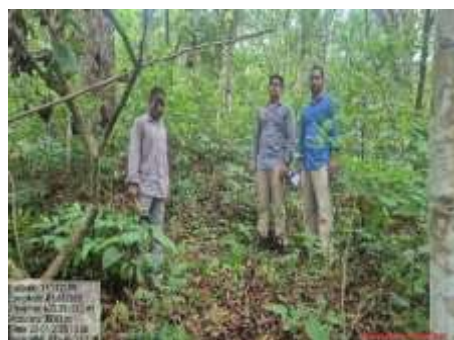
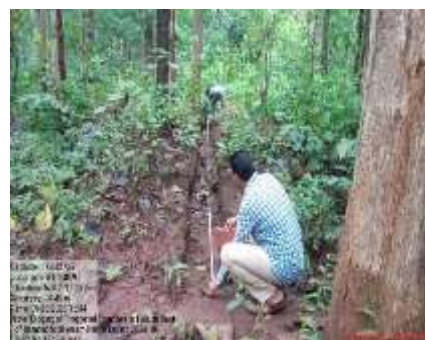
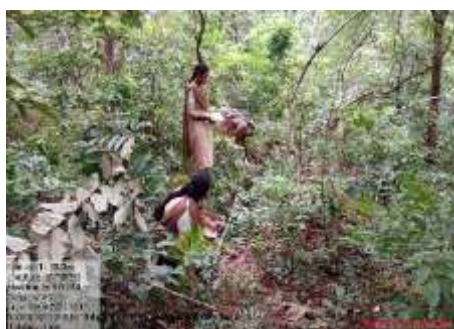
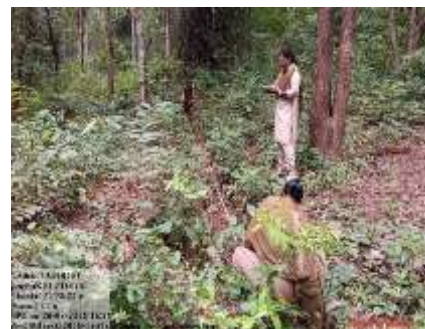
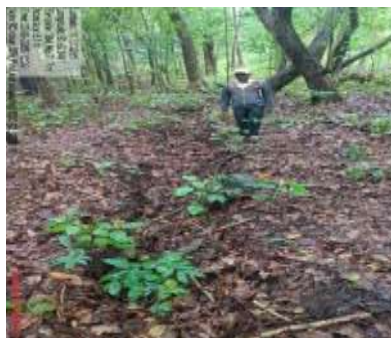
The staggered trenches constructed at Pindukuruvalasa, Kutrawada, Kakuru and Dandangi (North and South) beats were monitored and evaluated against the specifications recorded in the measurement book (MB). Field measurements confirmed the trenches to be 10 m in length, 0.5 m in width and 0.3 m in depth consistent with the MB records, although depth deviations from the approved design were noted. Due to their location in a low-lying plantation area, significant accumulation of silt and dried plant residue was observed. While the trenches remain visible, they are largely filled, likely because of water overflow during rains. It is recommended that regular de-siltation be carried out to restore and maintain their full water-holding capacity.

**Staggered trenches Kutrawada**

**Staggered trenches in Kakuru**

**Staggered trenches in Dandangi South**

**Staggered trenches in Dandangi North**

**Staggered trenches in Pindukuruvalasa**

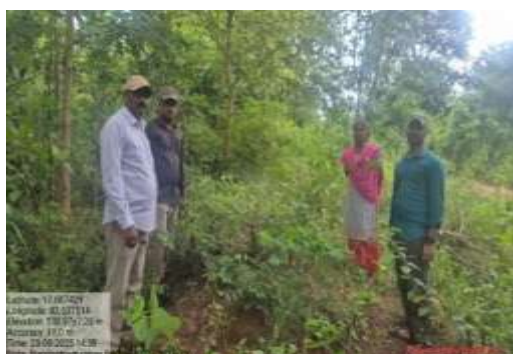
Narsipatnam range

A fire line was created and maintained in narsipatnam and KD Peta beat under CAMPA-NPV (forest fire management) scheme was monitored and evaluated against the specifications recorded in the measurement book and the actual field measurements. The dimensions of new fire line are width – 3 m, and length – 1000 rmt. The field measurements matched those in the measurement book, indicating no deviations. The visibility of the fire line was not clear, as it was established along the inspection path. Dense grass or weed growth was observed, indicating that the fire line has been not well-maintained throughout the natural forest area.

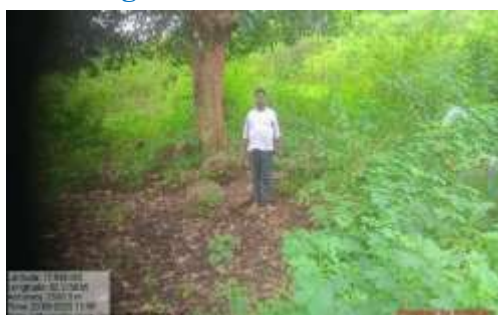
Lothugedda range

A fire line was created and maintained in Lothugedda under CAMPA-NPV (forest fire management) scheme was monitored and evaluated against the specifications recorded in the measurement book and the actual field measurements. The dimensions of new fire line are width – 3 m, and length – 2000 rmt. The visibility of the fire line was not clear, Dense grass or weed growth was observed, it is recommended that the fire line has be maintained regularly to avoid forest fires and sustainable growth of the forest.

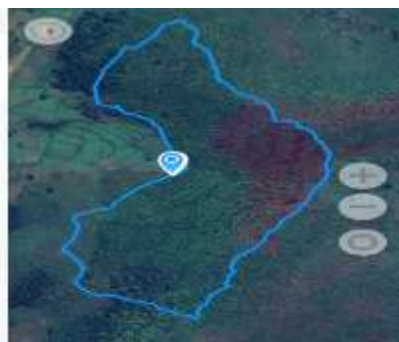
- Tulabarangi (20 Ha): 20.38 Ha (exceeded by 0.38 Ha)
- Jangadivalasa (20 Ha): 25.76 Ha (exceeded by 5.76 Ha)
- Munthamamidi (20 Ha): 24.78 Ha (exceeded by 4.78 Ha)
- Vanthomoru (20 Ha): 20.40 Ha (exceeded by 0.40 Ha)

Tulabarangi plantation 20.38 Ha

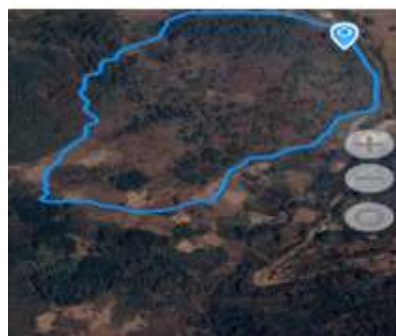
Jangadivalasa plantation 25.76 Ha

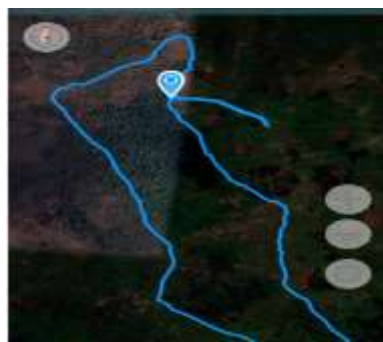
Munthamamidi plantation 24.78 Ha

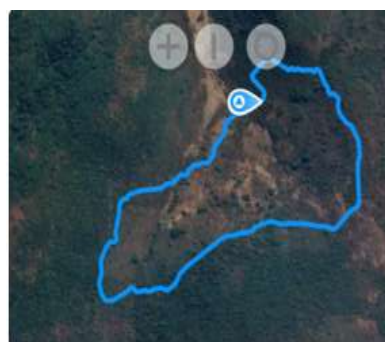
Vanthomoru plantation 20.40 Ha

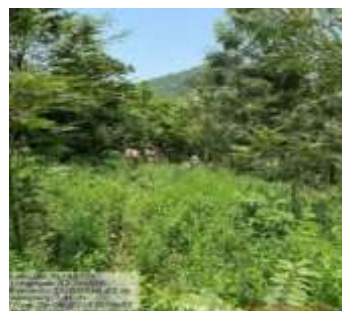
A fire line was created and maintained in Korra RF of Paderu (T) range under CAMPA-NPV (forest fire management) scheme was monitored and evaluated against the specifications recorded in the measurement book and the actual field measurements. The dimensions of new fire line are width – 3 m, and length – 1750 rmt. The field measurements matched those in the measurement book, indicating no deviations. The visibility of the fire line was not clear, moderate grass or weed growth was observed, indicating that periodic maintenance is needed.

Fire line in and around the RF areas of Paderu (T) range

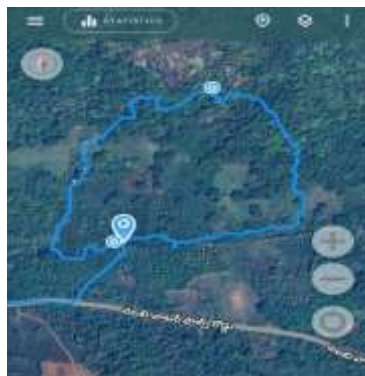
- K Valabu (10 Ha): 10.21 Ha (exceeded by 0.21 Ha)
- Nallakonda (10 Ha): 13.34 Ha (exceeded by 3.34 Ha)
- Gunupudi (10 Ha): 9.67 Ha (lesser by 0.33 Ha)

**K Valabu**  
plantation 10.21 Ha

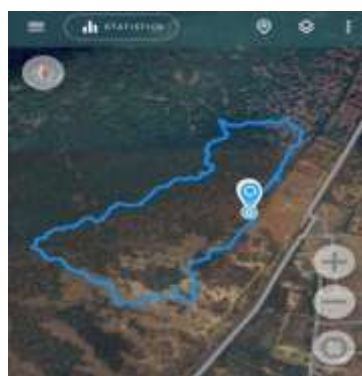
**Nallakonda**  
plantation 13.34 Ha

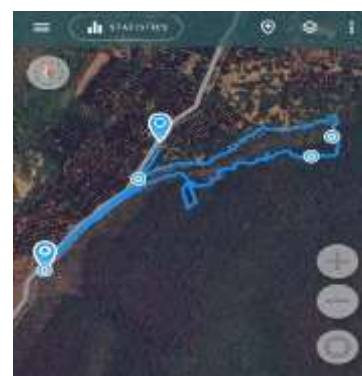
**Gunupudi**  
plantation 9.67 Ha

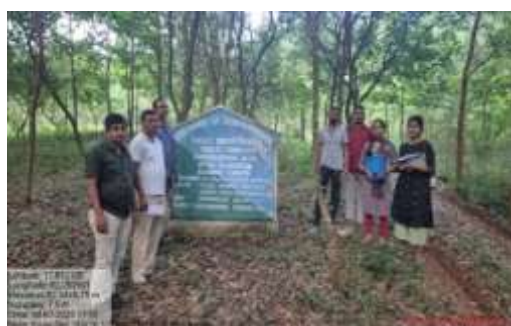
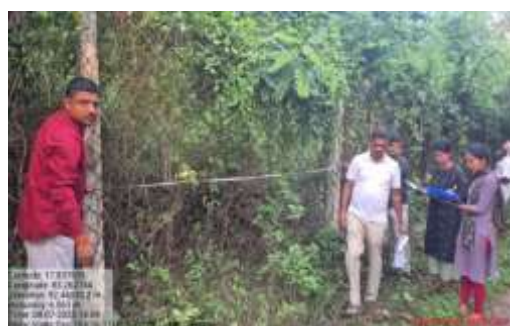
A RCC fence was created and maintained at Gandigudem PCA plantation of Mudasarlova beat in Visakhapatnam range under CAMPA-NPV (forest fire management) scheme was monitored and evaluated against the specifications recorded in the measurement book and the actual field measurements. The dimensions of RCC fence are width – 3 m, and length – 261 rmt and Depth with 0.5 below the ground. The field measurements matched those in the measurement book, indicating no deviations. The visibility of the fence was clear, as it was established around the PCA plantation. Minor damages were observed, indicating that periodic maintenance is needed.

#### RCC Fence posts and Chain-link Fence fixing in Mudasarlova beat

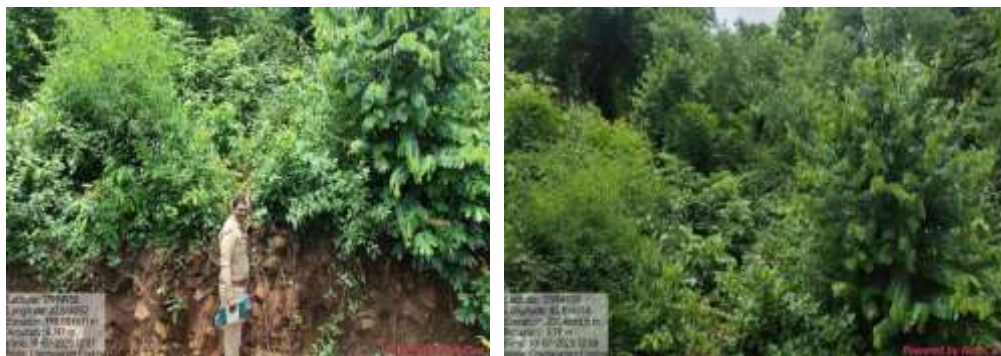
Fire line was created and maintained in Chodavaram range under CAMPA-NPV (forest fire management) scheme was monitored and evaluated against the specifications recorded in the measurement book and the actual field measurements. The dimensions of fire line with the width of 3 m, and length – 11000 rmt. The field measurements matched those in the measurement book, indicating no deviations. The visibility of the fire line was not clear due to

dense growth of grass and weeds, as it was established in the RF of Chodavaram. indicating that periodic maintenance is needed.

**Fire tracing operation in Chodavaram range**

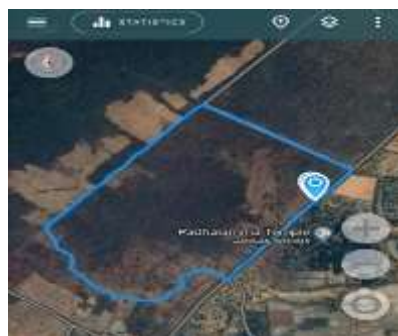
- Puligummi: Recorded 10.00 Ha → Perambulated 32.93 Ha (+22.93 Ha)

### Geo tracker of Puligummi plantation 32.93 Ha

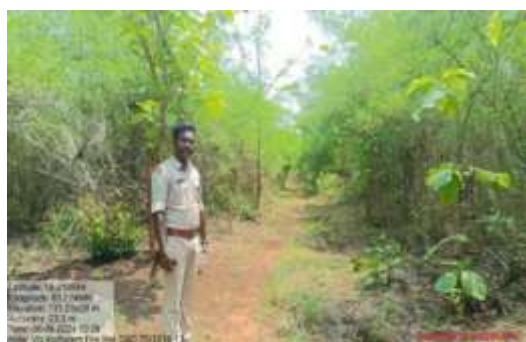
**Andra beat, Vizianagaram range**

A fire line was created and maintained in Andra RF of Vizianagaram range under CAMPA-NPV (forest fire management) scheme was monitored and evaluated against the specifications recorded in the measurement book and the actual field measurements. The dimensions of new fire line are width – 3 m, and length – 1100 rmt. The field measurements matched those in the measurement book, indicating no deviations. The visibility of the fire line was not clear, as it was established along the inspection path. moderate grass or weed growth was observed, indicating periodic maintenance is needed.

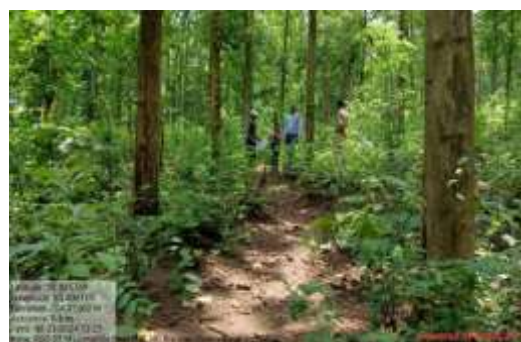
**Masimnda beat, Parvathi Puram range**

A fire line was created and maintained in old teak plantations at Masimanda beat of Parvathi Puram range under CAMPA-NPV (forest fire management) scheme was monitored and evaluated against the specifications recorded in the measurement book and the actual field measurements. The dimensions of new fire line are width – 3 m, and length – 3000 rmt. The field measurements matched those in the measurement book, indicating no deviations. The visibility of the fire line was reduced, moderate grass or weed growth was observed, indicating periodic maintenance is needed.

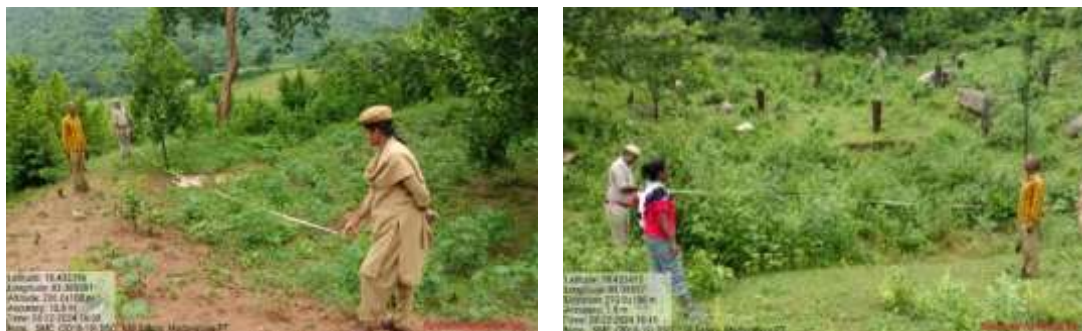
**Percolation tank in Pachipenta beat, Saluru range**

Total six percolation tanks were constructed across Madavalasa in Pachipenta beat of Saluru range was monitored and evaluated against the specifications recorded in the measurement book and the actual field measurements. The dimensions of the mini percolation tanks; length – 10 m, width – 10 m, and depth – 1 m for four percolation tanks and the other two tanks with the dimensions of length – 15 m, width – 15 m, and depth – 1 m. The field measurements matched those in the measurement book, indicating no deviations. The tank structure is well maintained, and its measurements align with the recorded specifications. However, regular de-siltation is recommended to enhance its storage capacity, improve water infiltration, and maintain soil moisture levels effectively.

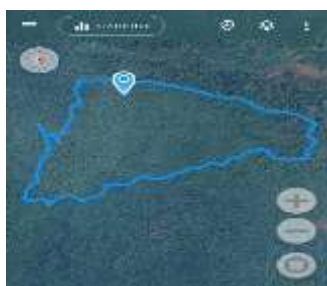
**Koradabadi plantation 8.88 Ha**

Perambulation was carried out with the assistance of local Forest Beat Officers and verified using QGIS software and the Geo Tracker application with geotagged/ documentation. In Koradabadi (5 Ha Plantation) the perambulated area measured 8.88 Ha, which is 3.88 Ha more than the official record. The variation arose because the outer boundary included rocky patches and trenches within the plantation limits. In Pathuru (5 Ha Teak Plantation): The perambulated area was 5.95 Ha, i.e., 0.95 Ha more than the official record. This difference was due to dense jungle growth and trenches around the site, which made it difficult to trace the exact boundary.
